Expertise

Protocol number: 41804884  
Order number / reference: 24983671  
Inspection date: 1 Oct 2025

Manufacturer: Mercedes-Benz

Model: GLE 350 e 4Matic 9G-TRONIC Exclusive

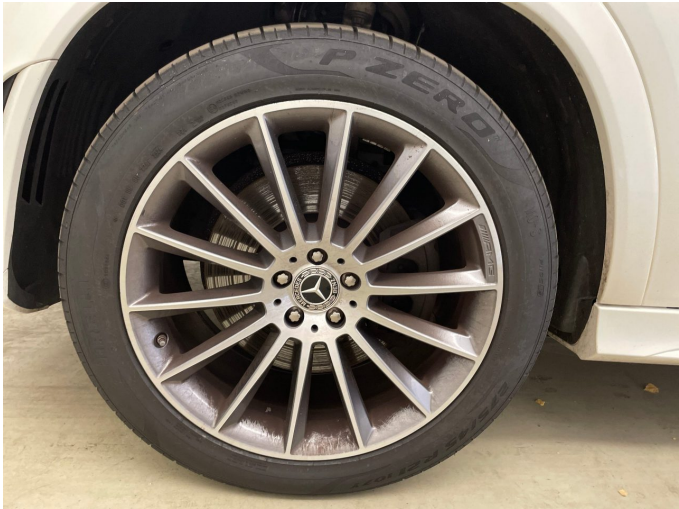
Figure 12: Mounted tyres

#	Tyre size	Type of tyre	Manufacturer	Tread depth
1)	275/45 R21 107Y	Summer tyres on Light alloy	Pirelli	7mm / 7mm
2)	315/40 R21 111Y	Summer tyres on Light alloy	Continental	4mm / 4mm

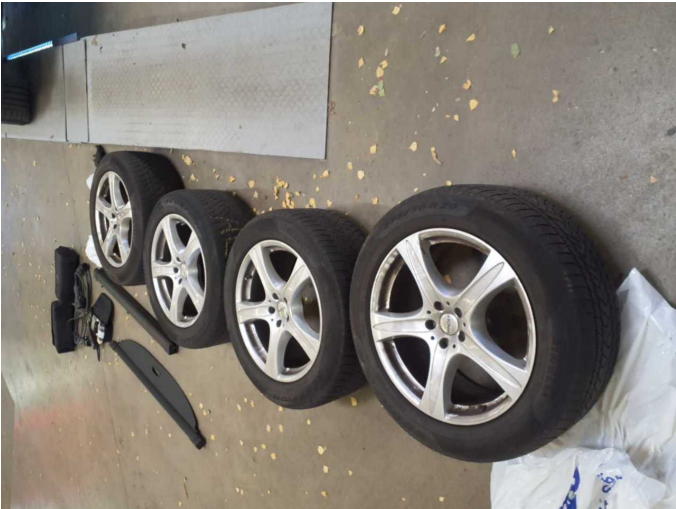
Figure 15: Additional tyres

#	Tyre size	Type of tyre	Manufacturer	Tread depth
1)	275/50 R20 113V	Winter tyres on Light alloy	Pirelli	4mm / 4mm
2)	275/50 R20 113V	Winter tyres on Light alloy	Pirelli	4mm / 4mm

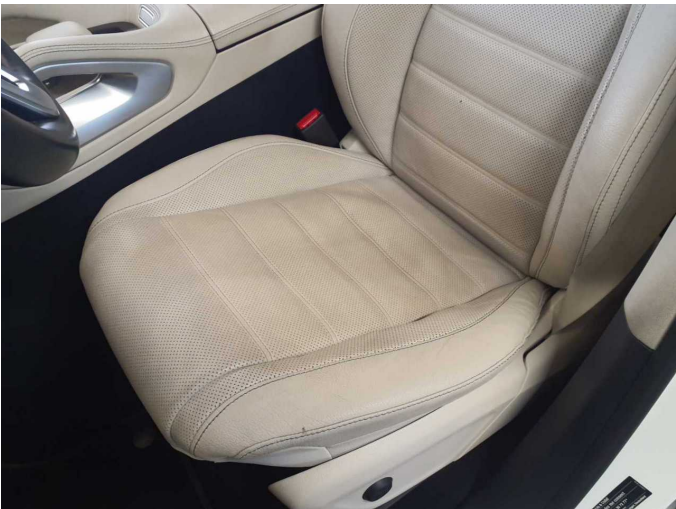
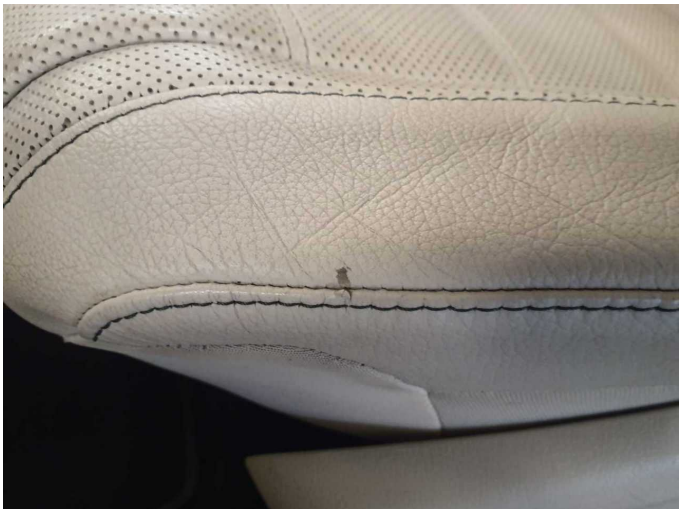
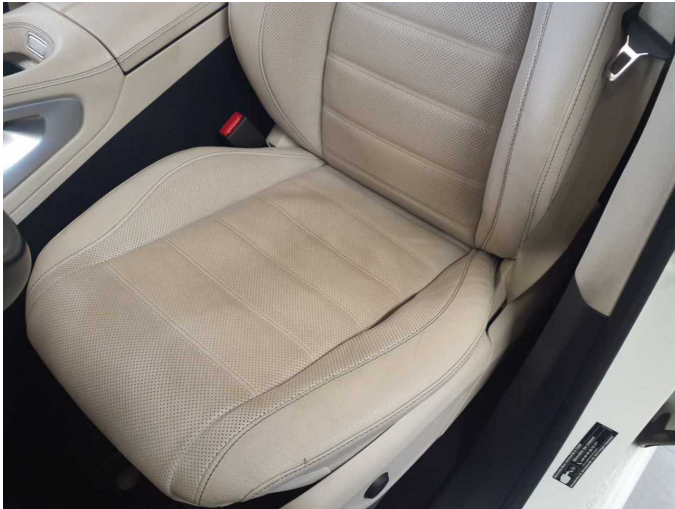
Damage 2: Seat - front: Seat cover - left side - Abrasion - Smart repair

**Damage 2:** Seat - front: Seat cover - left side - Abrasion - Smart repair

No.	Component group	Description
1	Misc.	Main inspection - No evidence - No deduction
2	Seat - front	Seat cover - left side - Abrasion - Smart repair
3	Vehicle glazing	Windscreen - Broken / torn - repair according to calculation

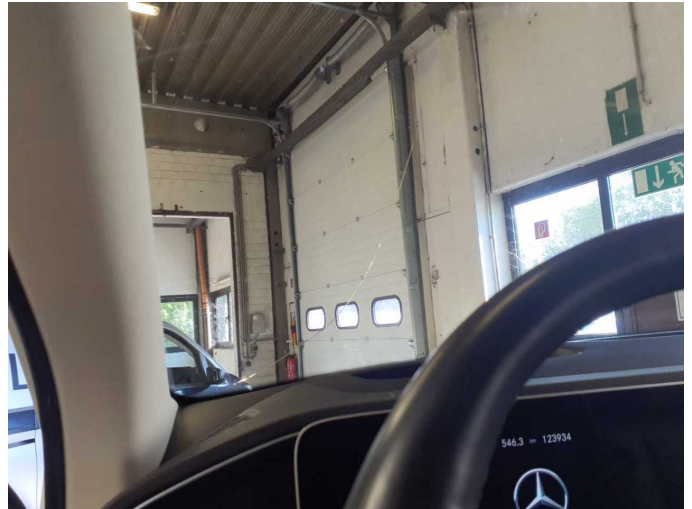
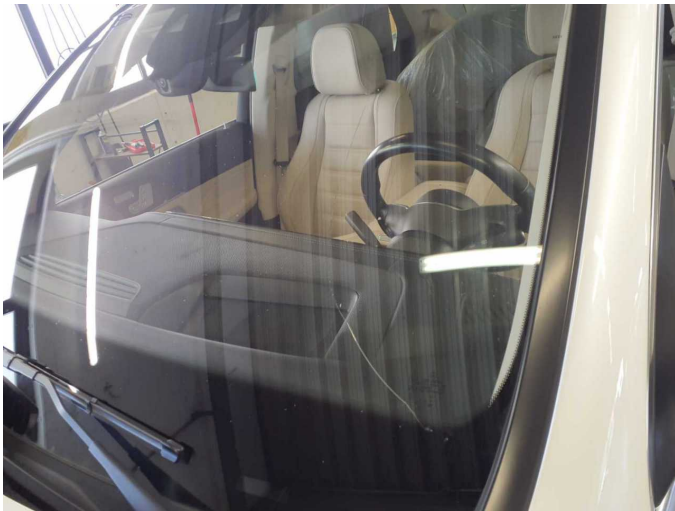
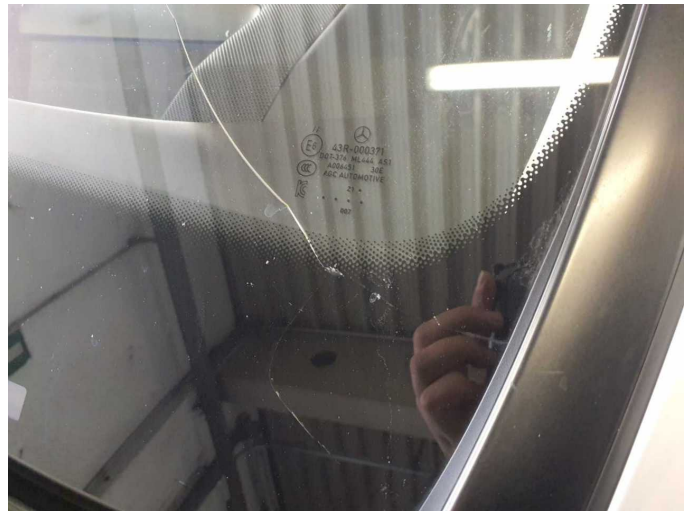
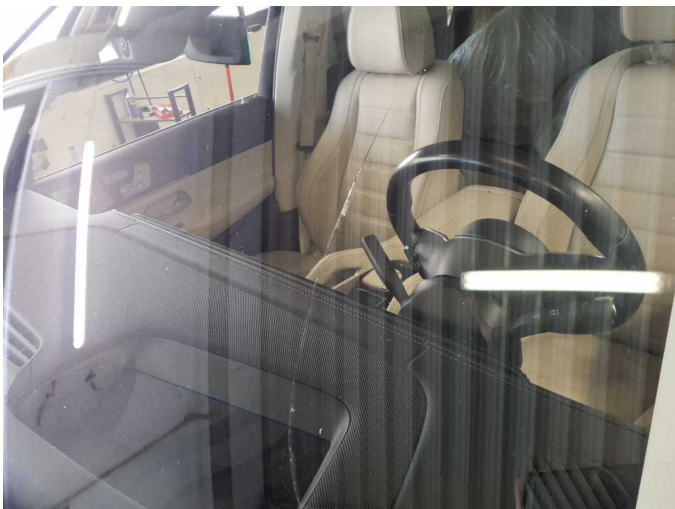
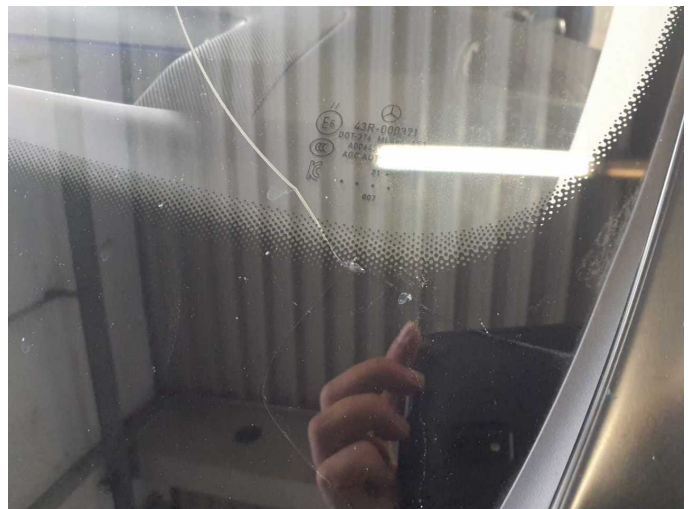
**Damage 3:** Vehicle glazing: Windscreen - Broken / torn - repair according to calculation

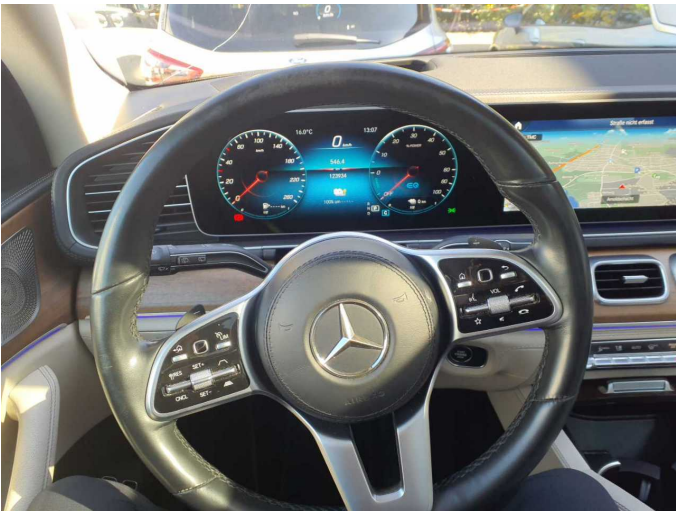
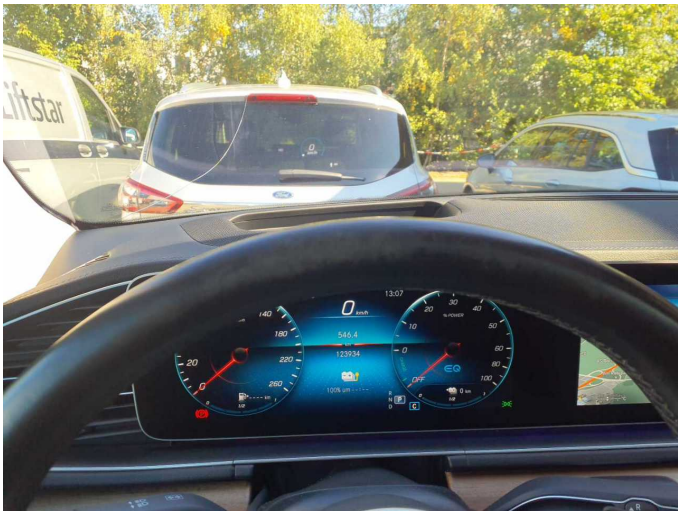
**Wear and tear 3:** Steering system: Steering wheel sheath - Abrasion - No deduction

No.	Component group	Description
1	Front bumper	Front bumper - Scratch(es) - No deduction
2	Rear bumper	Rear bumper - Scratch(es) - No deduction
3	Steering system	Steering wheel sheath - Abrasion - No deduction

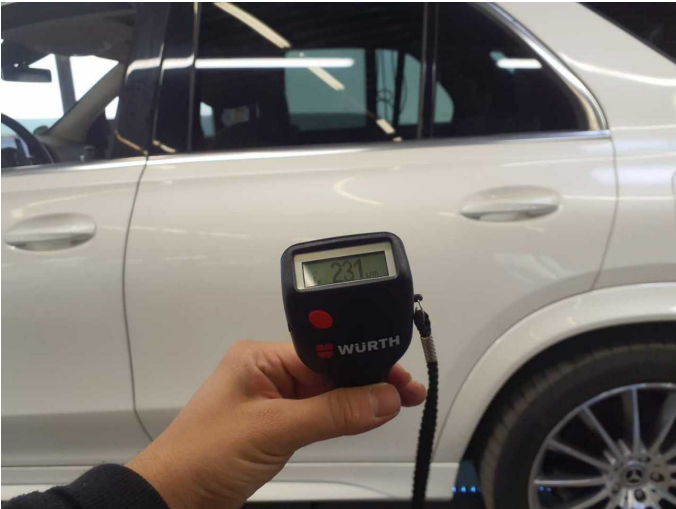
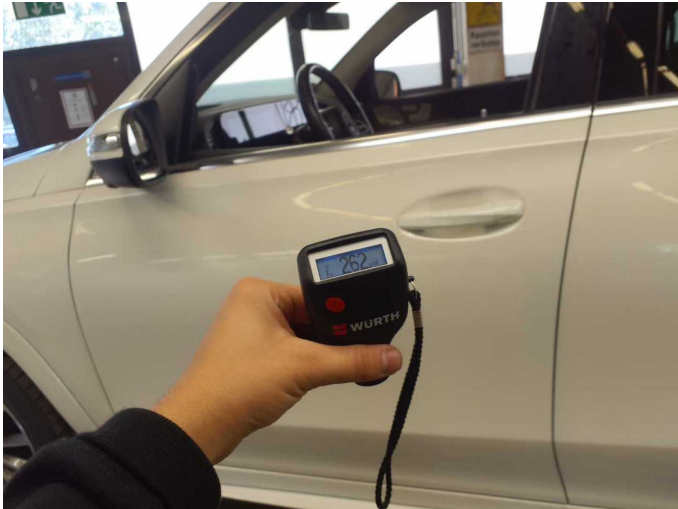
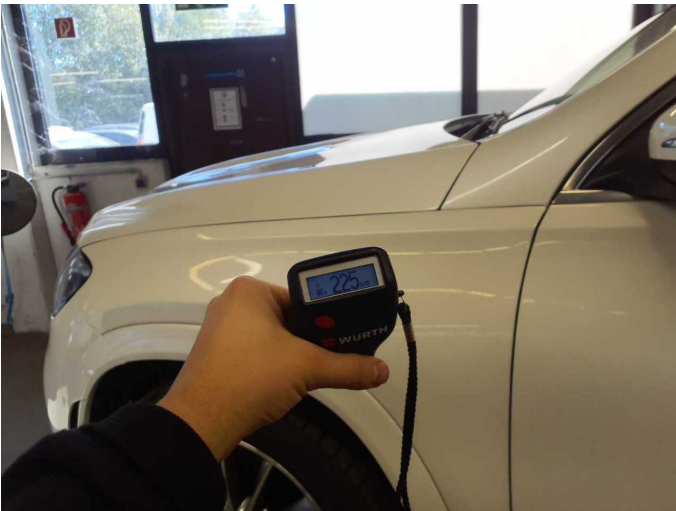
**Repainting 1:** Mudguard - left side, Door - rear left side, Door - front left side

No.	Repainting
1	Mudguard - left side, Door - rear left side, Door - front left side, Professionally carried out, Invoice of repair done Non-existent

Mudguard - left side	225 µm	Door - rear left side	231 µm
Door - front left side	262 µm
