Expertise

Protocol number: 39177877
Order No. / Reference: 24611579
Inspection date: 3 Apr 2025

Manufacturer: Mercedes-Benz	Model: GLA 180 d 8G-DCT
VIN: W1N2477101J376341

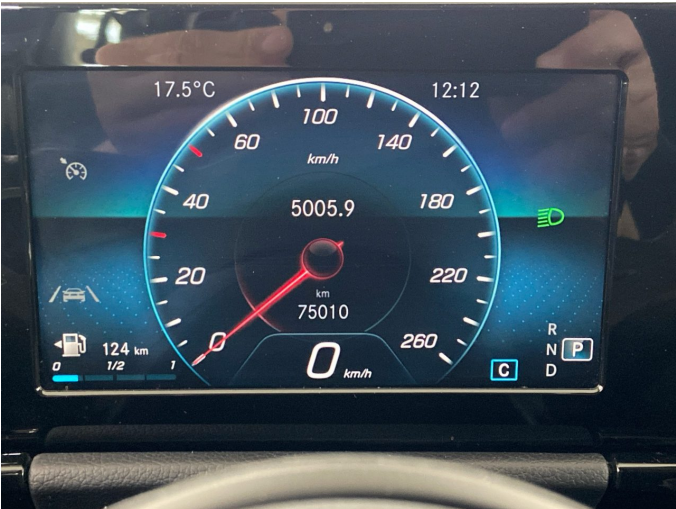
Figure 7: Instrument cluster

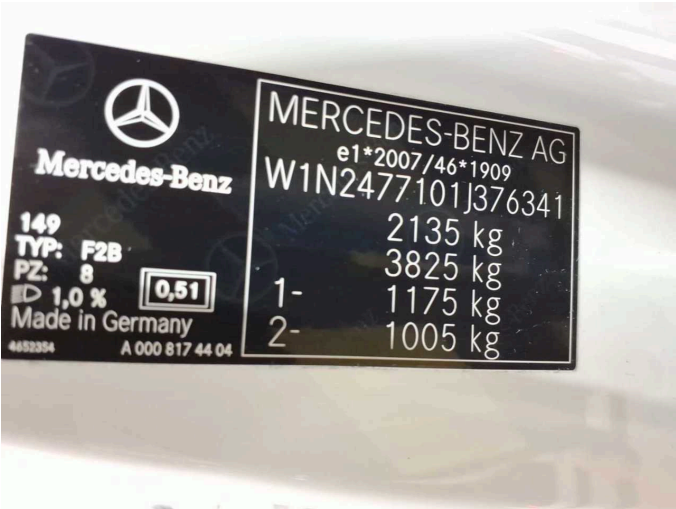
Figure 11: VIN

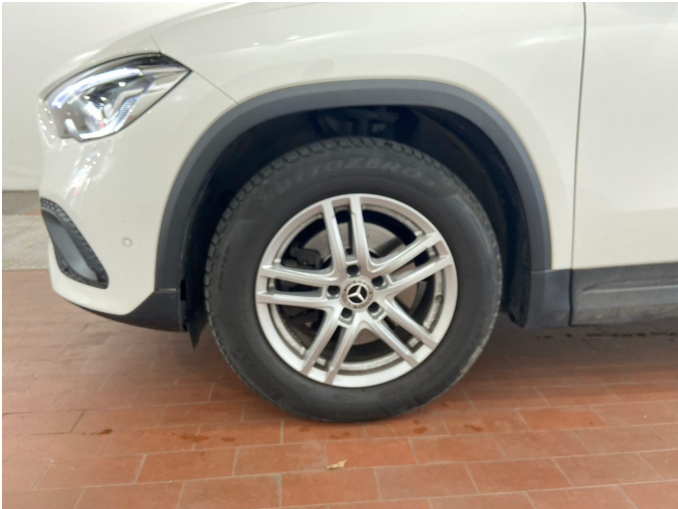
#	Tyre size	Type of tyre	Manufacturer	Tread depth
1)	215/65 R17 99H	Winter tyres on Light alloy	Pirelli	3mm / 3mm
2)	215/65 R17 99H	Winter tyres on Light alloy	Pirelli	6mm / 6mm

Figure 12: Mounted tyres

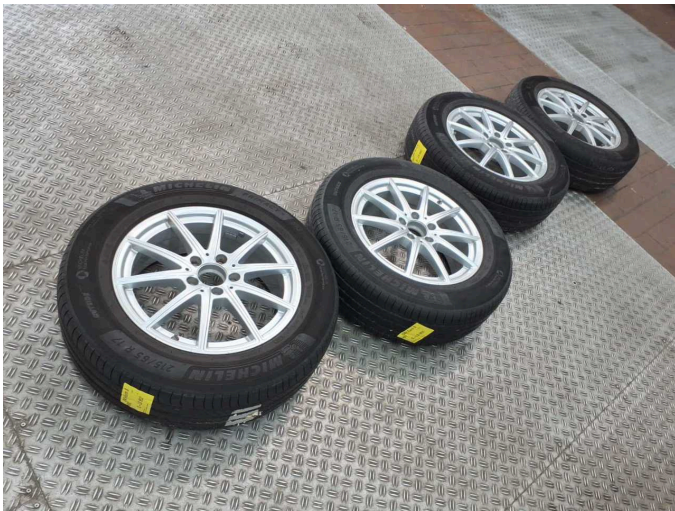
#	Tyre size	Type of tyre	Manufacturer	Tread depth
1)	215/65 R17 99V	Summer tyres on Light alloy	Michelin	3mm / 3mm
2)	215/65 R17 99V	Summer tyres on Light alloy	Michelin	5mm / 5mm

Figure 15: Additional tyres

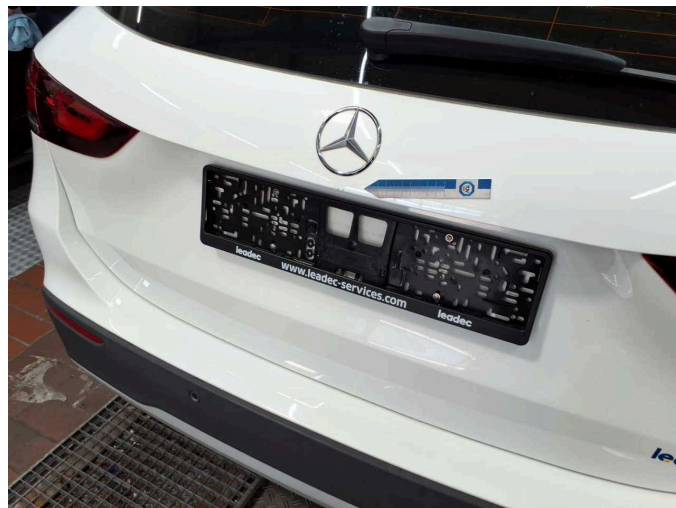
No.	Component group	Description
1	Boot lid / rear door	Boot lid - Scratch(es) - Smart repair

Damage 1: Boot lid / rear door: Boot lid - Scratch(es) - Smart repair

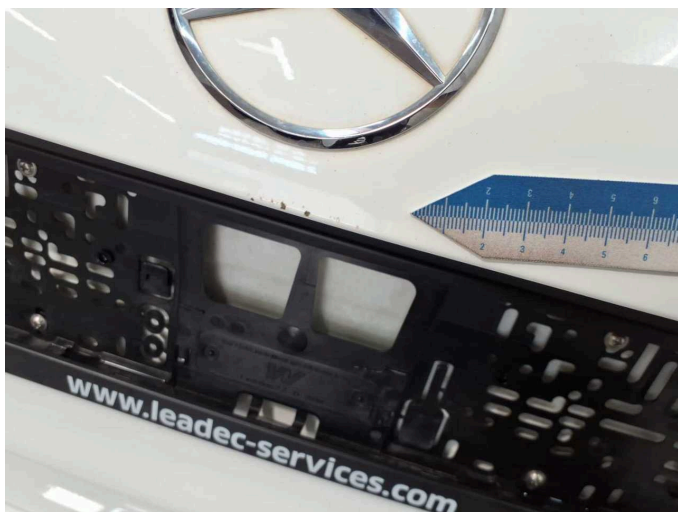
Damage 1: Boot lid / rear door: Boot lid - Scratch(es) - Smart repair
