Expertise

Protocol number: 41500627
Order No. / Reference: 25111924
Inspection date: 11 Sept 2025

Manufacturer: Mercedes-Benz
VIN: W1N2533111G105746

Model: GLC-Coupe 300 de 4Matic 9G-TRONIC Exclusive

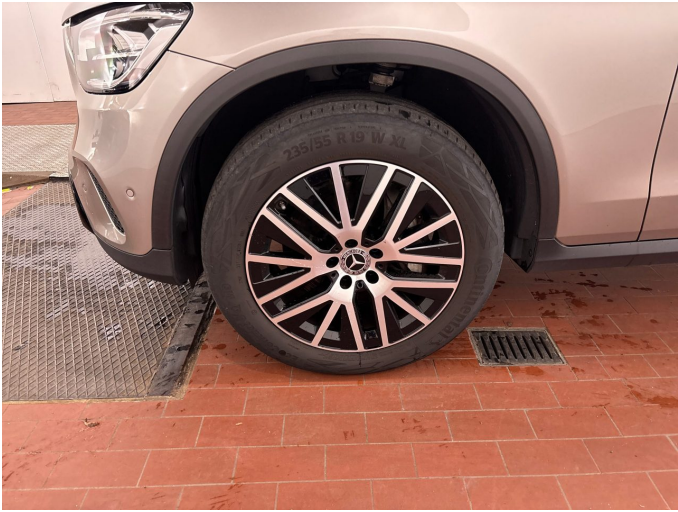
Figure 12: Mounted tyres

#	Tyre size	Type of tyre	Manufacturer	Tread depth
1)	235/55 R19 105W	Summer tyres on Light alloy	Continental	0mm / 0mm
2)	235/55 R19 105W	Summer tyres on Light alloy	Continental	5mm / 5mm

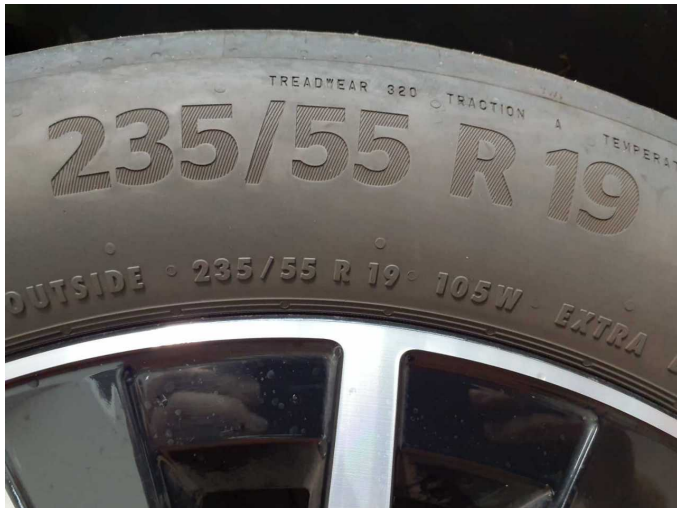
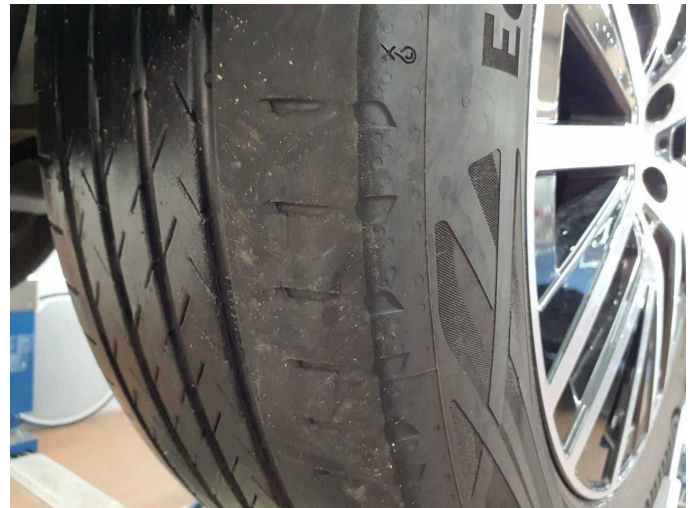
No.	Component group	Description
1	Wheel / tyres	Tyre - front - Worn - Replace

Damage 1: Wheel / tyres: Tyre - front - Worn - Replace

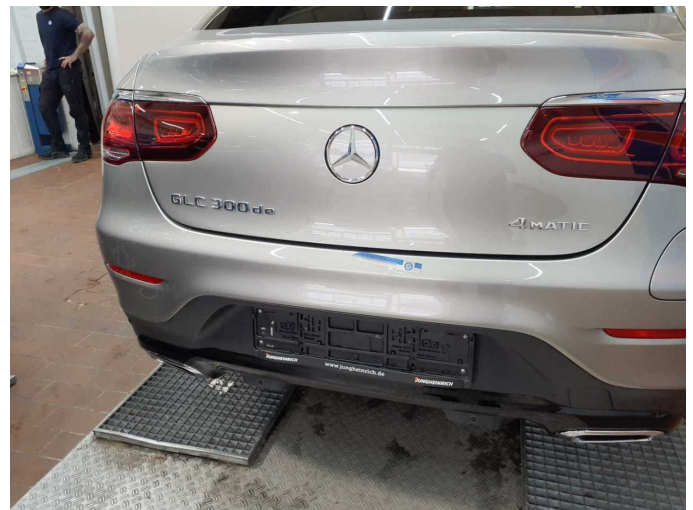
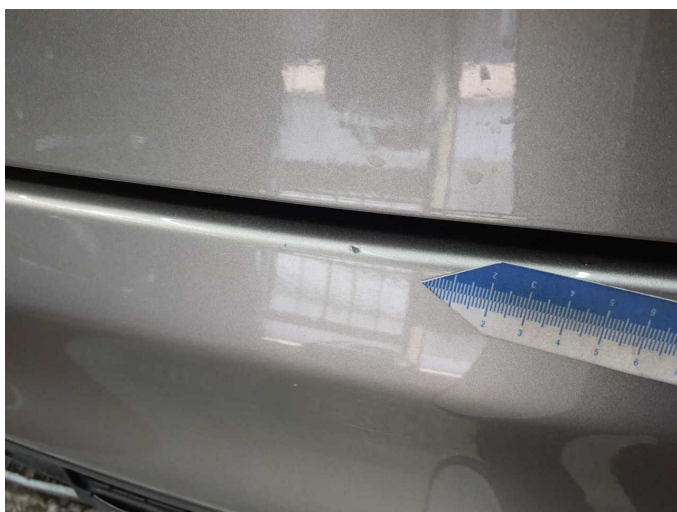
Wear and tear 4: Rear bumper: Rear bumper - Scratch(es) - No deduction

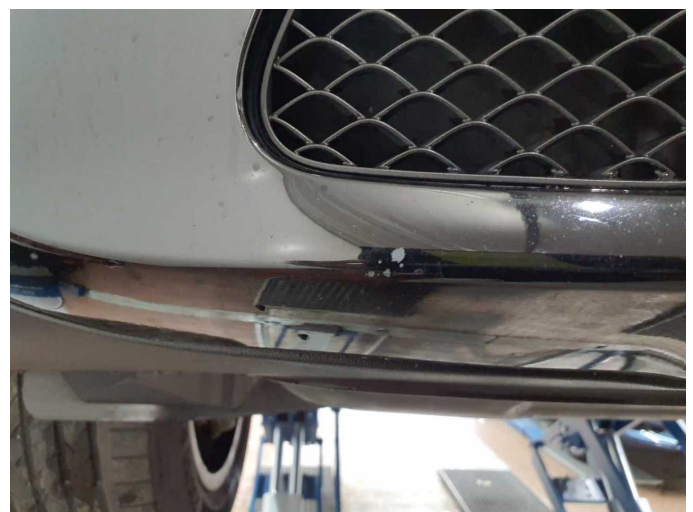
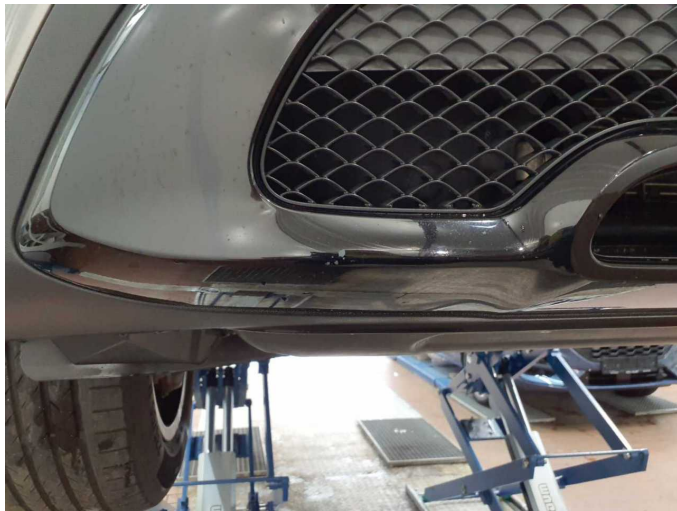
Wear and tear 5: Front bumper: Spoiler - Scratch(es) - No deduction

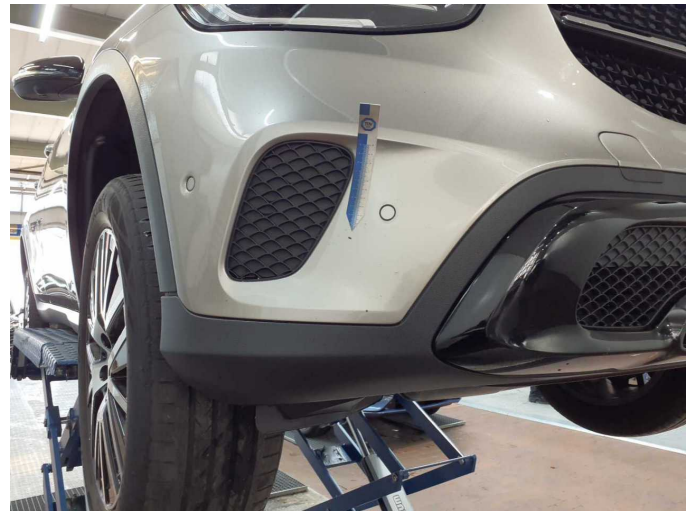
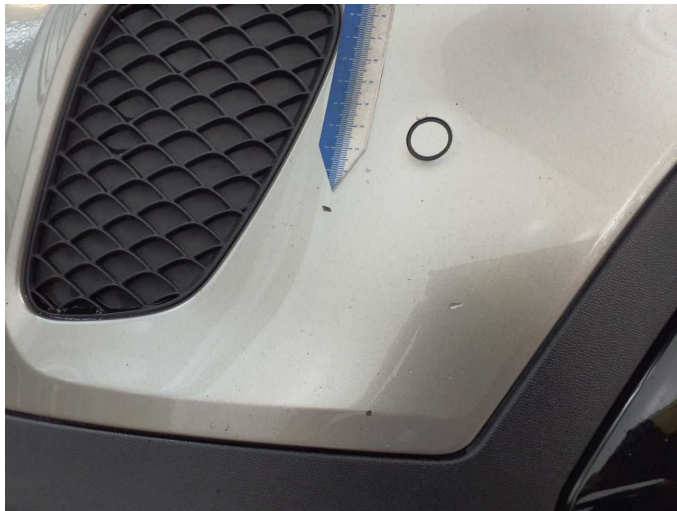
Wear and tear 6: Front bumper: Front bumper - Stone chips - No deduction

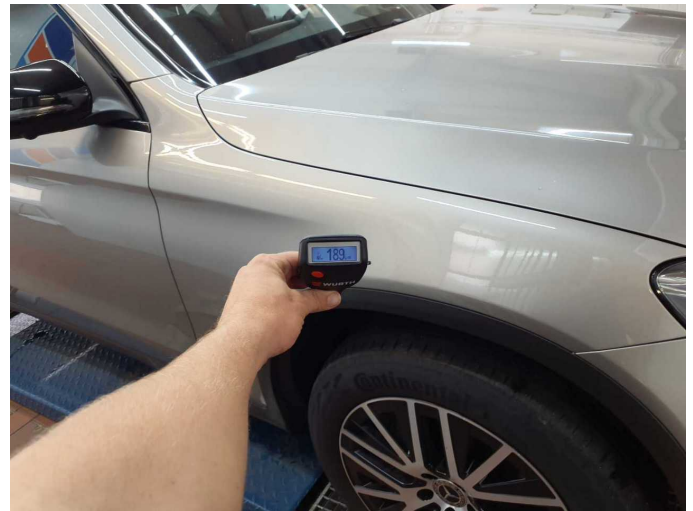
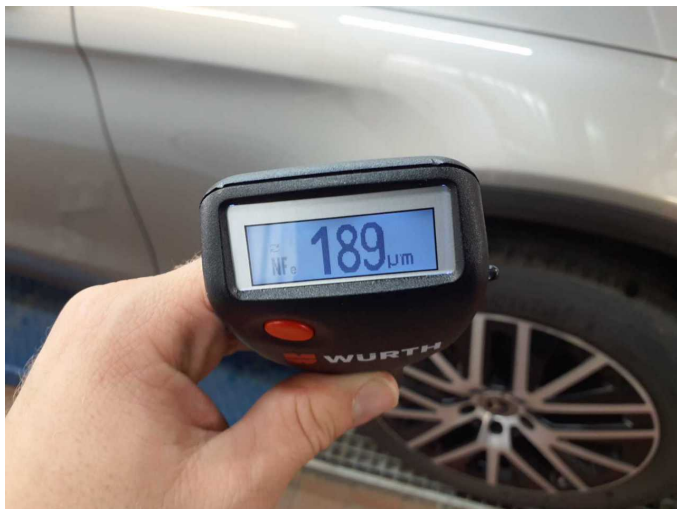
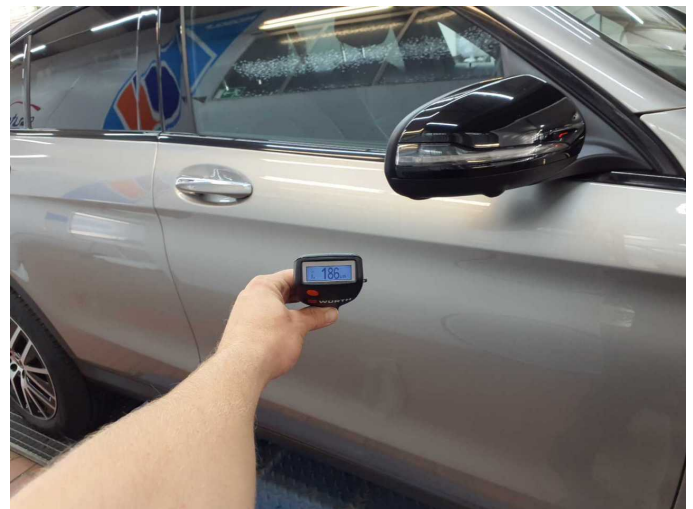
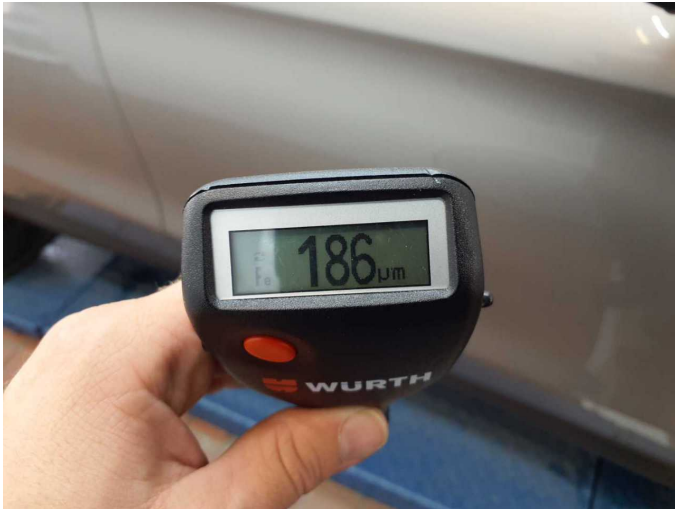
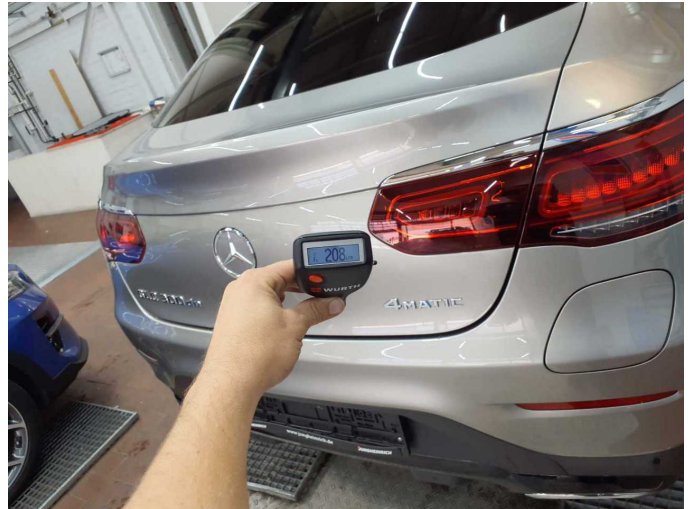
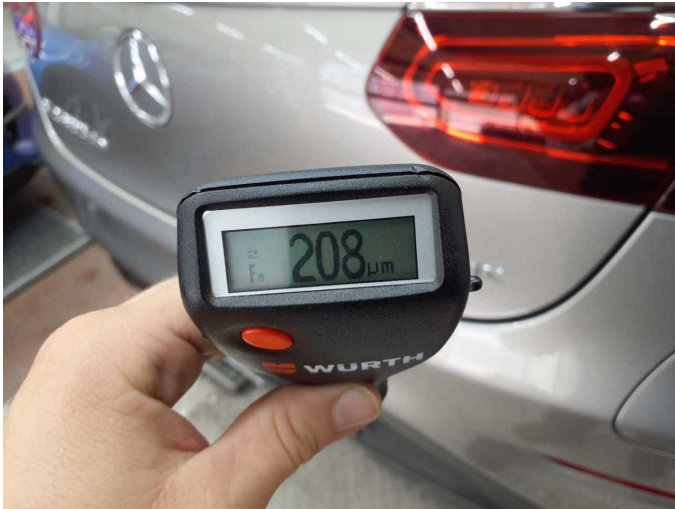
No.	Repainting
1	Boot lid / rear door, Mudguard - right side, Door - front right side, Professionally carried out, Invoice of repair done Non-existent

Boot lid / rear door	208 µm	Mudguard - right side	189 µm
Door - front right side	186 µm

Repainting 1: Boot lid / rear door, Mudguard - right side, Door - front right side
