Expertise

Protocol number: 41450937
Order No. / Reference: 25158958
Inspection date: 9 Sept 2025

Manufacturer: Mercedes-Benz

Model: GLC 300 de 4Matic 9G-TRONIC AMG Line

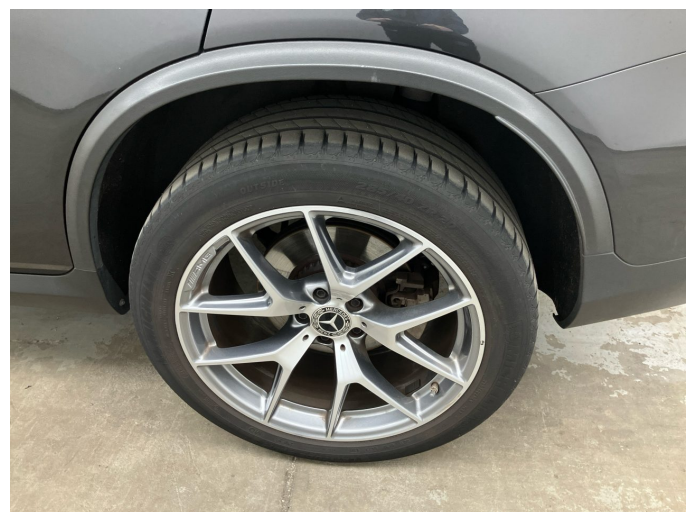
#	Tyre size	Type of tyre	Manufacturer	Tread depth
1)	255/45 R20 105Y	Summer tyres on Light alloy	Michelin	5mm / 5mm
2)	285/40 R20 108Y	Summer tyres on Light alloy	Michelin	5mm / 5mm

Figure 12: Mounted tyres

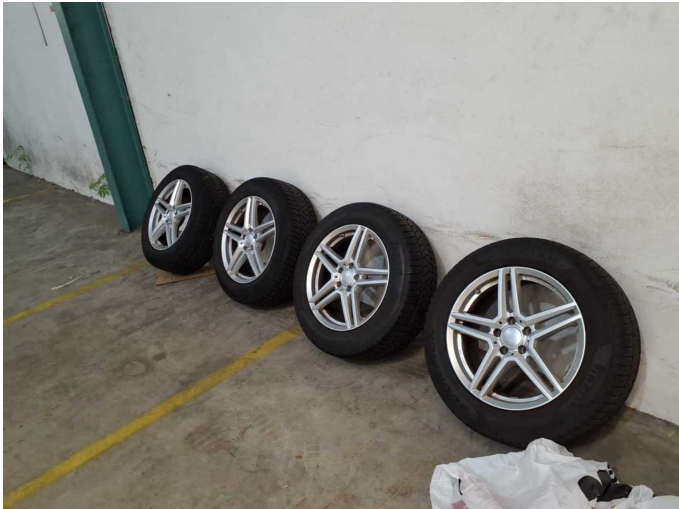
#	Tyre size	Type of tyre	Manufacturer	Tread depth
1)	235/60 R18 107H	Winter tyres on Light alloy	Pirelli	5mm / 5mm
2)	235/60 R18 107H	Winter tyres on Light alloy	Pirelli	6mm / 6mm

Figure 16: Additional tyres

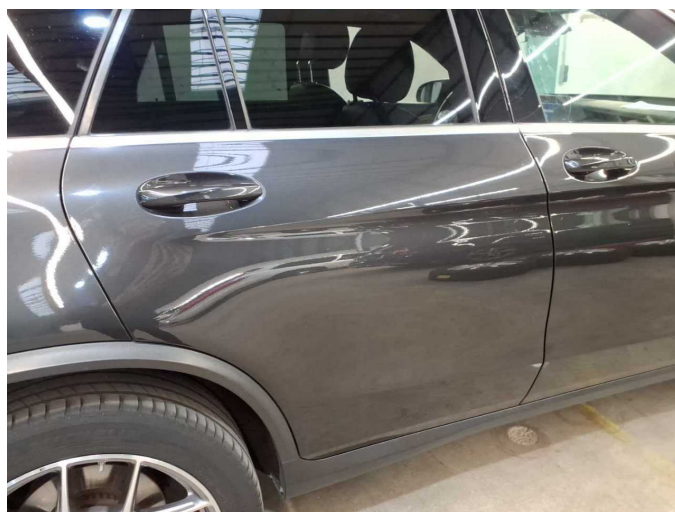
Damage 1: Door - rear right side: Door - Scratch(es) - Smart repair

No.	Component group	Description
1	Door - rear right side	Door - Scratch(es) - Smart repair
2	Wheel / tyres	Alloy rim - front right side - Scratch(es) - Loss in value
3	Boot lid / rear door	Boot lid - Scratch(es) - Paint

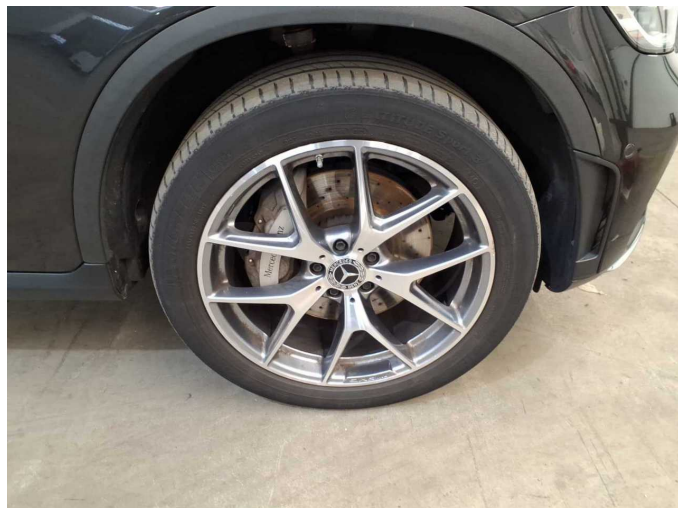
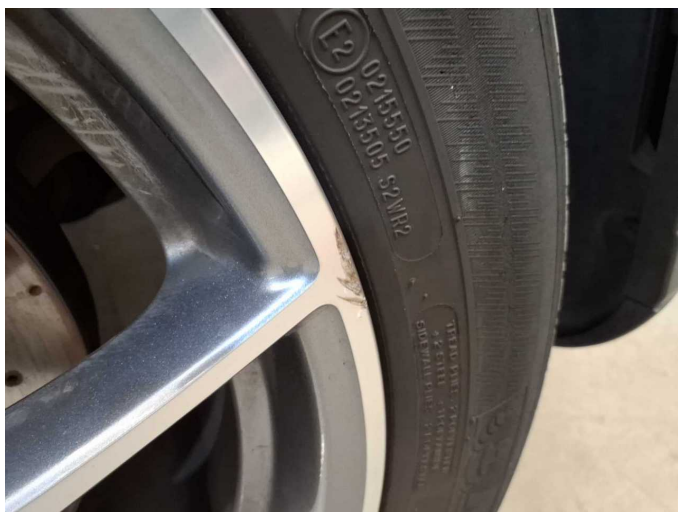
Damage 2: Wheel / tyres: Alloy rim - front right side - Scratch(es) - Loss in value

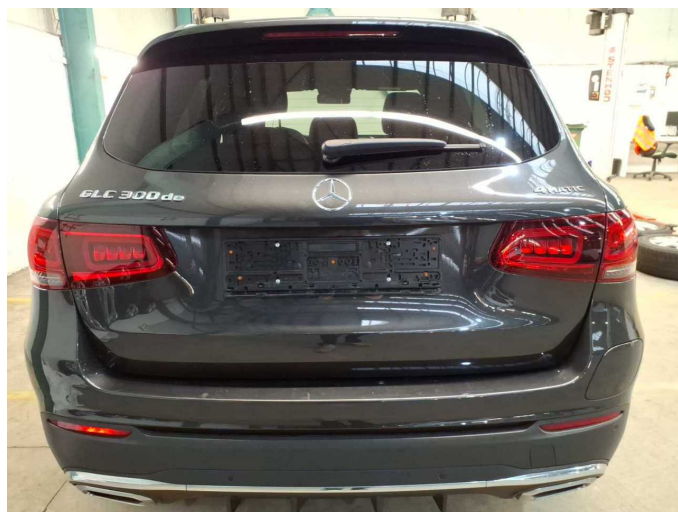
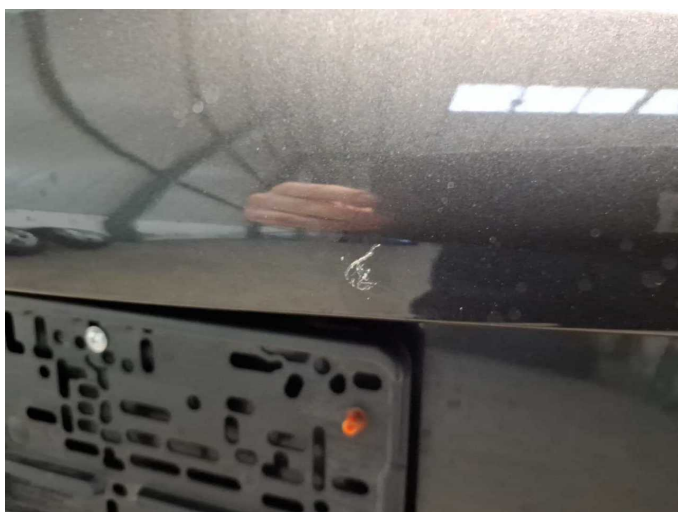
Damage 3: Boot lid / rear door: Boot lid - Scratch(es) - Paint
