Expertise

Protocol number: 41684834
Order No. / Reference: 25145741
Inspection date: 24 Sept 2025

Manufacturer: Mercedes-Benz

Model: GLC 300 de 4Matic 9G-TRONIC

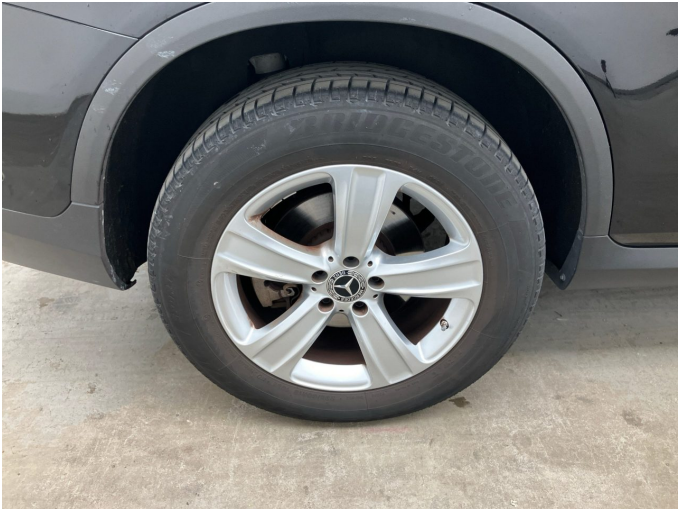
Figure 12: Mounted tyres

#	Tyre size	Type of tyre	Manufacturer	Tread depth
1)	235/60 R18 103V	Summer tyres on Light alloy	Bridgestone	5mm / 5mm
2)	235/60 R18 103V	Summer tyres on Light alloy	Bridgestone	5mm / 5mm

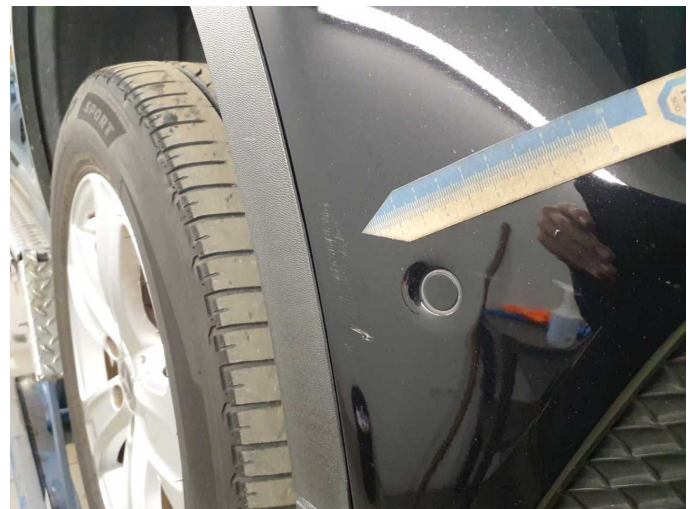
Damage 1: Front bumper: Front bumper - Scratch(es) - Smart repair

No.	Component group	Description
1	Front bumper	Front bumper - Scratch(es) - Smart repair
2	Door - front left side	Door - Scratch(es) - Repair and paint

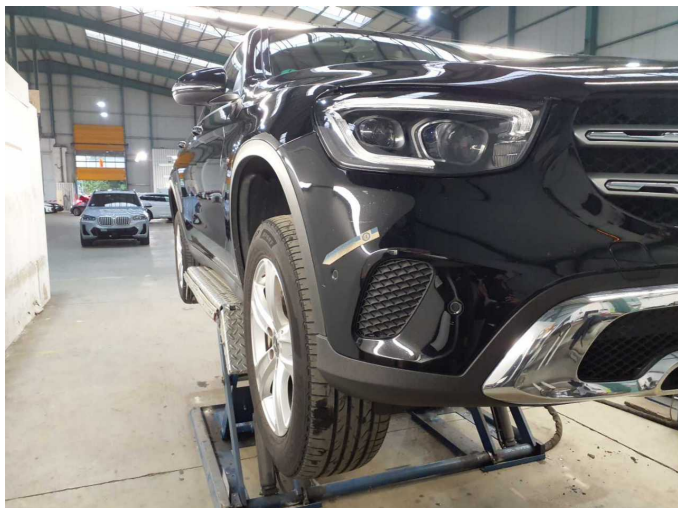
Damage 1: Front bumper: Front bumper - Scratch(es) - Smart repair

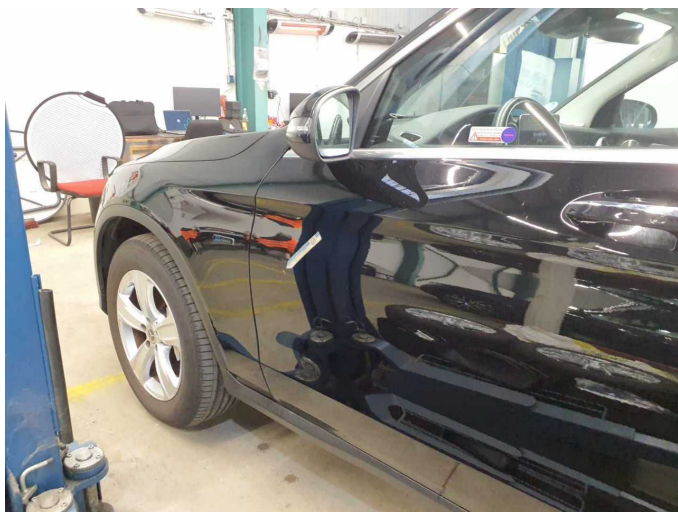
Damage 2: Door - front left side: Door - Scratch(es) - Repair and paint
