Expertise

Protocol number: 41202389
Order No. / Reference: 25082791
Inspection date: 26 Aug 2025

Model: GLC 220 d 4Matic 9G-TRONIC AMG Line

VIN: W1N2539151V304629

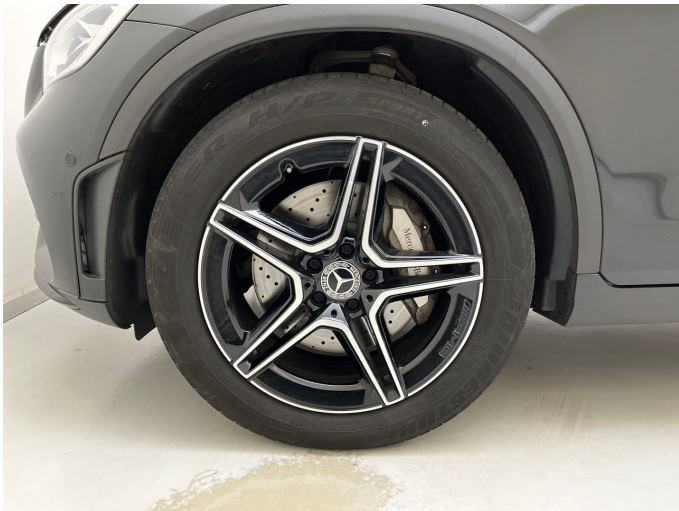
Figure 12: Mounted tyres

#	Tyre size	Type of tyre	Manufacturer	Tread depth
1)	235/55 R19 101V	Summer tyres on Light alloy	Bridgestone	4mm / 4mm
2)	235/55 R19 101V	Summer tyres on Light alloy	Bridgestone	5mm / 5mm

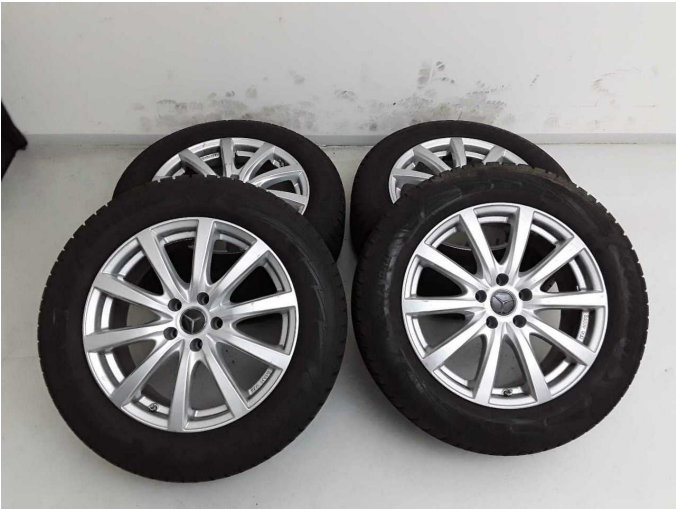
Figure 17: Additional tyres

#	Tyre size	Type of tyre	Manufacturer	Tread depth
1)	235/60 R18 107H	Winter tyres on Light alloy	Goodyear	7mm / 7mm
2)	235/60 R18 107H	Winter tyres on Light alloy	Goodyear	7mm / 7mm

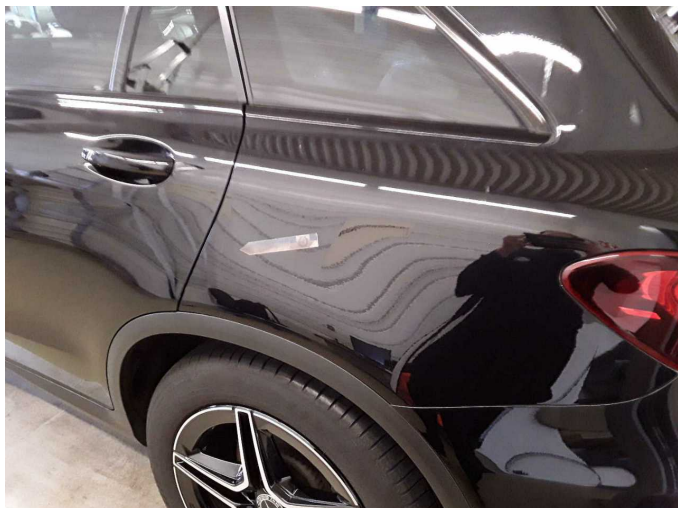
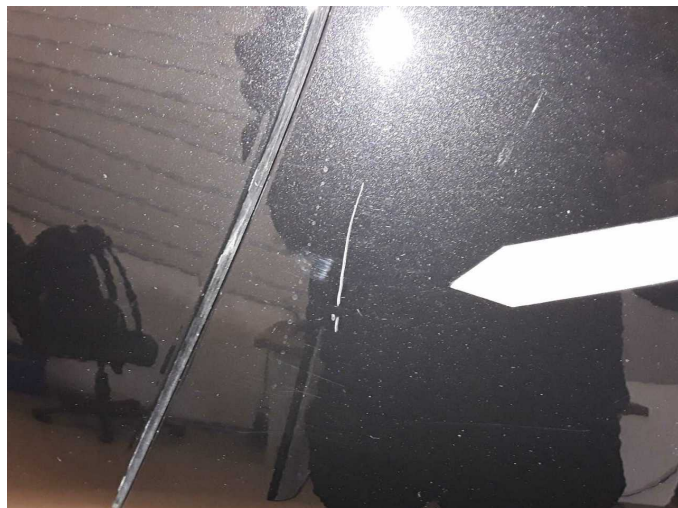
Damage 1: Side panel - rear left side: Side panel - Scratch(es) - Smart repair

No.	Component group	Description
1	Side panel - rear left side	Side panel - Scratch(es) - Smart repair
2	Door - rear right side	Door - Scratch(es) - Smart repair
3	Side panel - rear right side	Side panel - dent(s) - Smart repair

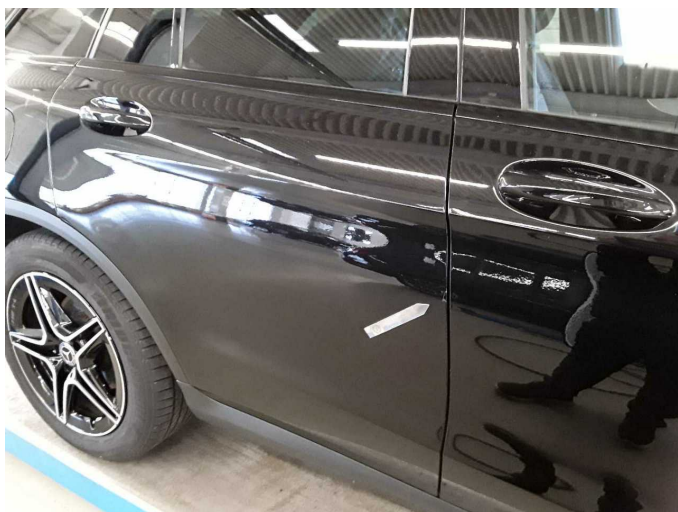
Damage 2: Door - rear right side: Door - Scratch(es) - Smart repair

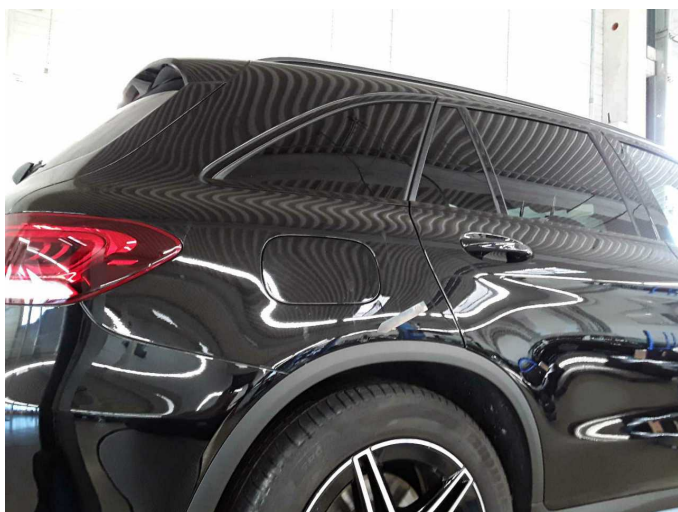
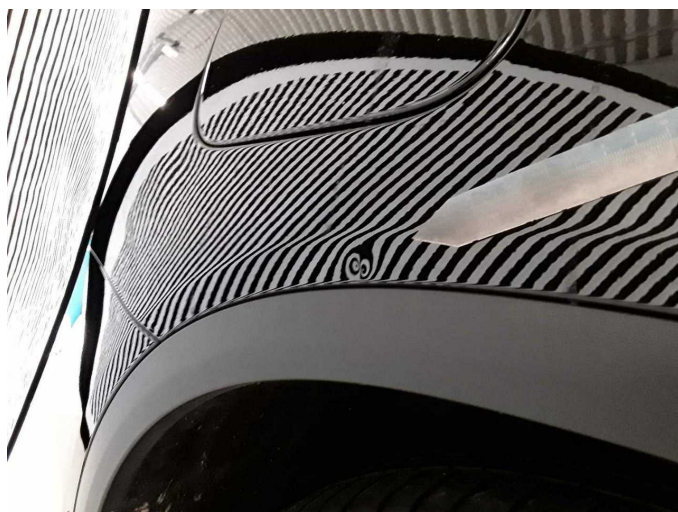
Damage 3: Side panel - rear right side: Side panel - dent(s) - Smart repair
