Expertise

Protocol number: 41164758  
Order No. / Reference: 25103147  
Inspection date: 20 Aug 2025

Manufacturer: Audi  
VIN: WAUZZZF2XNN018927

Model: A6 55 TFSI e quattro S tronic sport

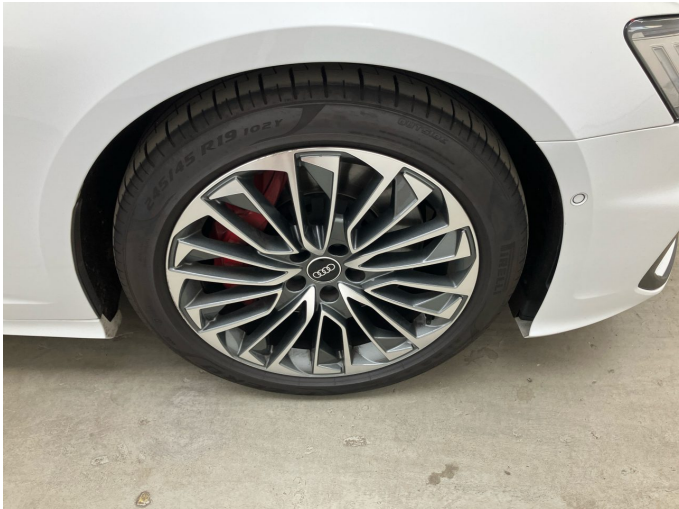
Figure 12: Mounted tyres

#	Tyre size	Type of tyre	Manufacturer	Tread depth
1)	245/45 R19 102Y	Summer tyres on Light alloy	Pirelli	6mm / 6mm
2)	245/45 R19 102Y	Summer tyres on Light alloy	Pirelli	6mm / 6mm

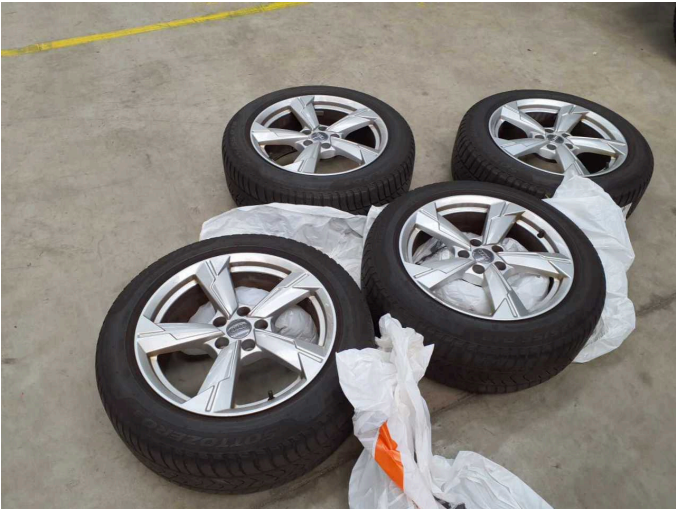
Figure 15: Additional tyres

#	Tyre size	Type of tyre	Manufacturer	Tread depth
1)	225/55 R18 102V	Winter tyres on Light alloy	Pirelli	0mm / 0mm
2)	225/55 R18 102V	Winter tyres on Light alloy	Pirelli	5mm / 5mm

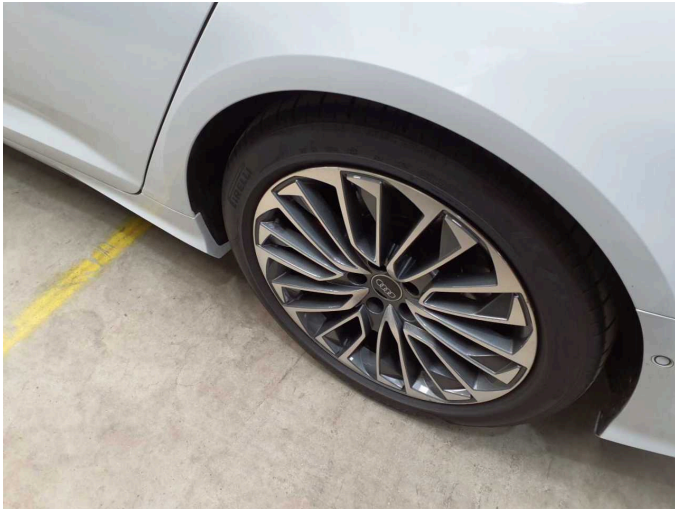
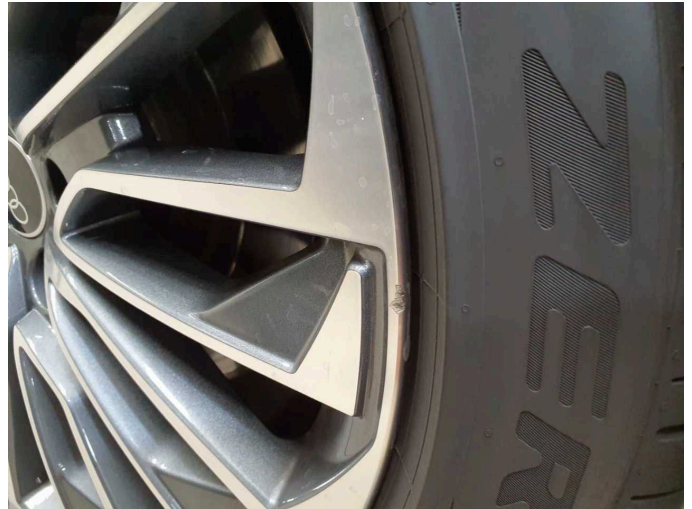
No.	Component group	Description
1	Wheel / tyres	Alloy rim - rear left side - Scratched - Loss in value
2	Wheel / tyres	Alloy rim - front right side - Scratched - Loss in value
3	Rear bumper	Rear bumper - Scratch(es) - Paint

**Damage 1:** Wheel / tyres: Alloy rim - rear left side - Scratched - Loss in value

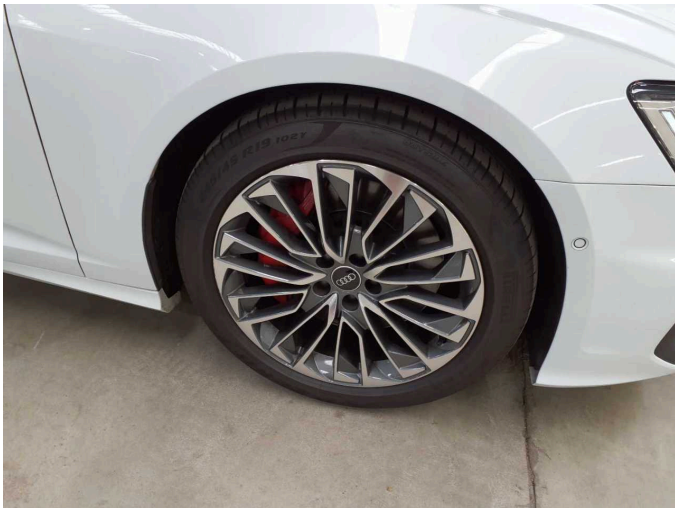
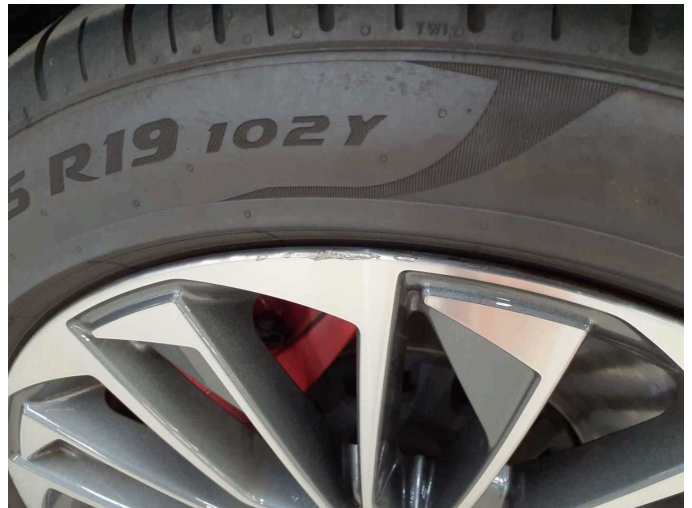
**Damage 2:** Wheel / tyres: Alloy rim - front right side - Scratched - Loss in value

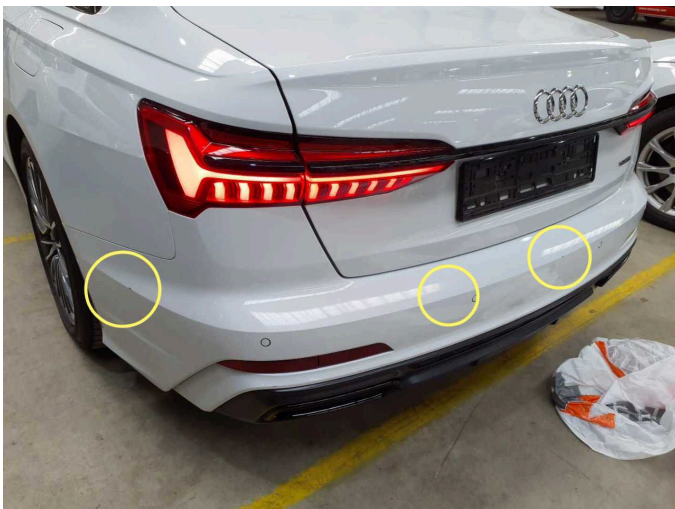
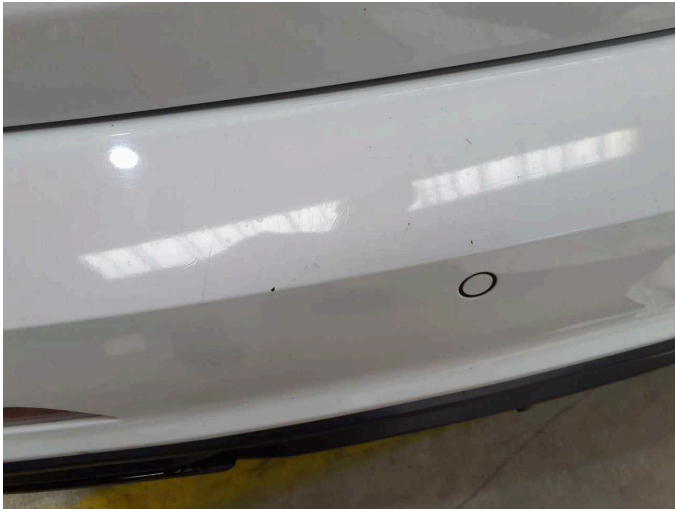
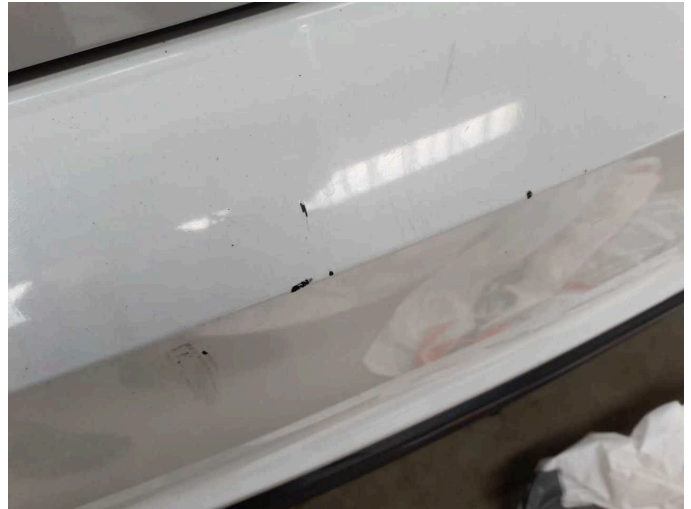
**Damage 3:** Rear bumper: Rear bumper - Scratch(es) - Paint

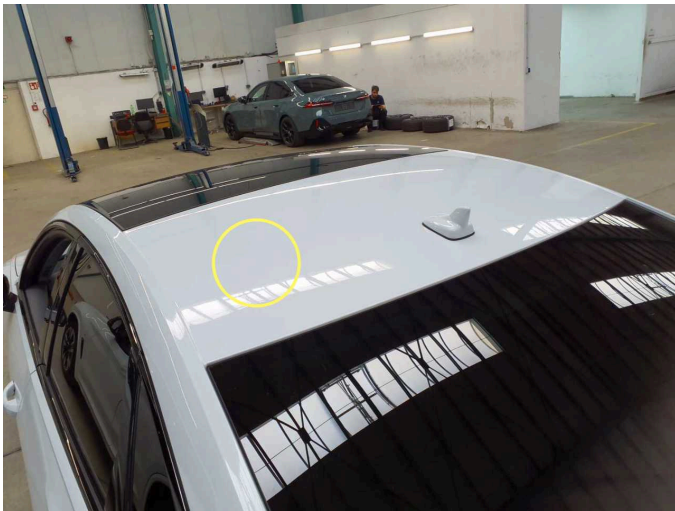
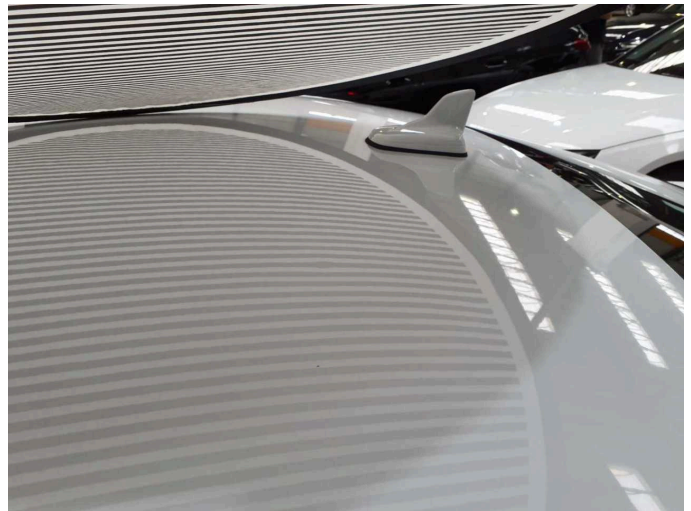
No.	Component group	Description
3	Bonnet	Bonnet - Stone chips - No deduction
4	Vehicle glazing	Windscreen - Stone chips - No deduction
5	Roof	Roof - dent(s) - No deduction

**Wear and tear 5:** Roof: Roof - dent(s) - No deduction

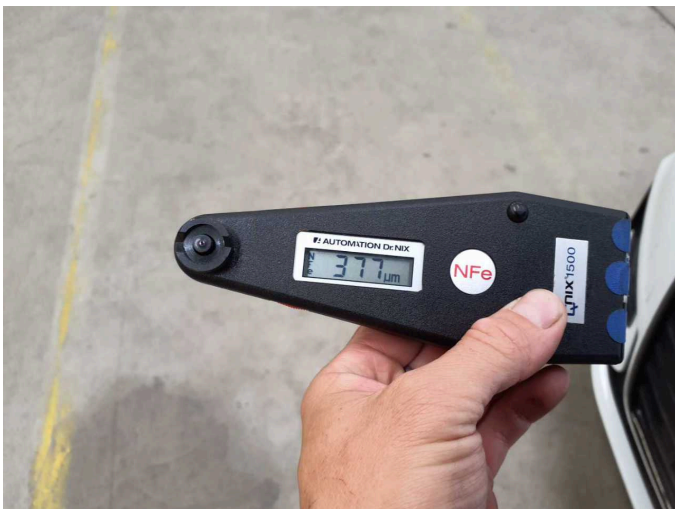
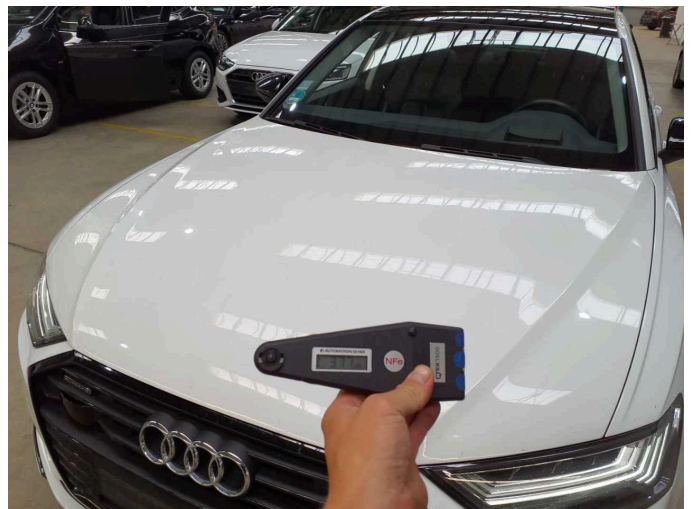
1 Bonnet, Professionally carried out, Invoice of repair done Non-existent

Bonnet 377 µm |

**Repainting 1:** Bonnet
