Expertise

Protocol number: 41301466
Order No. / Reference: 25118546
Inspection date: 29 Aug 2025

Manufacturer: Audi

Model: Q3 45 TFSIe S tronic S line

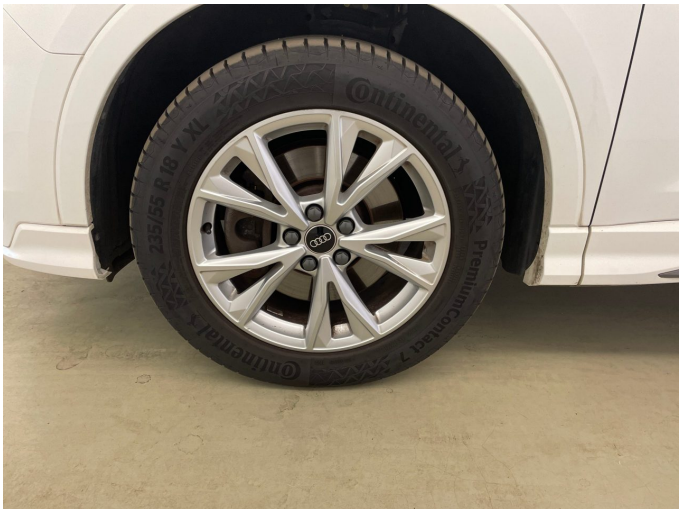
Figure 12: Mounted tyres

#	Tyre size	Type of tyre	Manufacturer	Tread depth
1)	235/55 R18 104Y	Summer tyres on Light alloy	Continental	5mm / 5mm
2)	235/55 R18 100V	Summer tyres on Light alloy	Bridgestone	5mm / 5mm

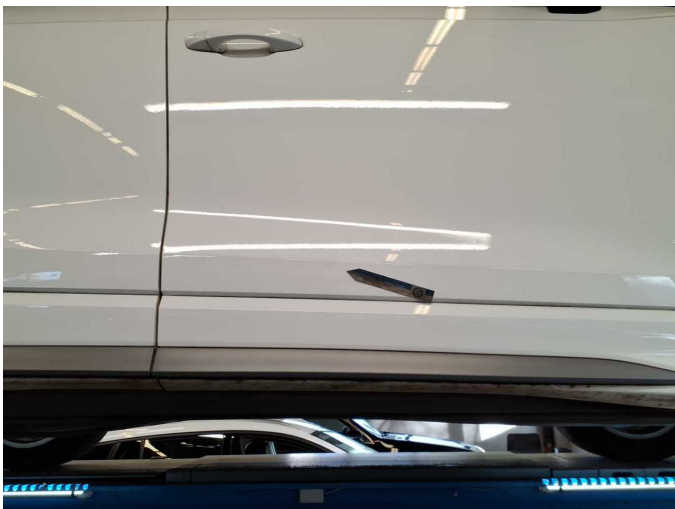
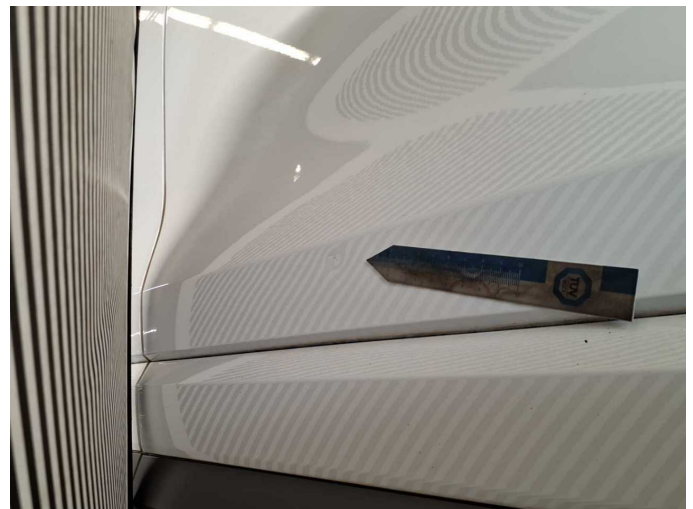
Damage 1: Door - front right side: Door - dent(s) - Smooth repair work

No.	Component group	Description
1	Door - front right side	Door - dent(s) - Smooth repair work
2	Rear bumper	Spoiler - Scratch(es) - Smart repair
3	Door - rear left side	Door - Dent / paintcoat damage - Repair and paint

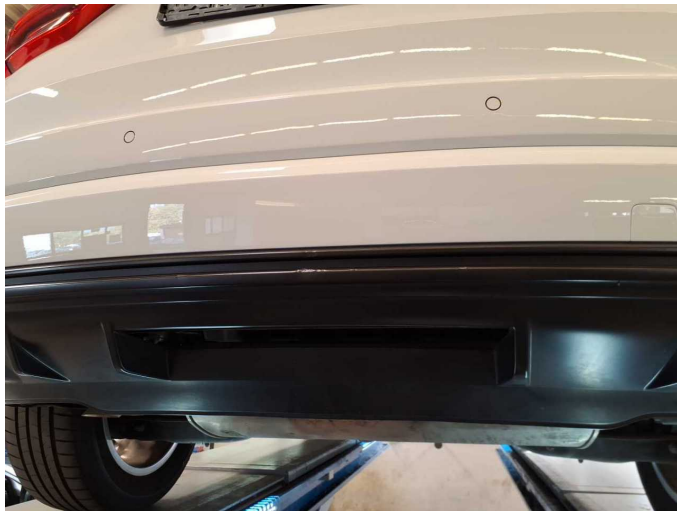
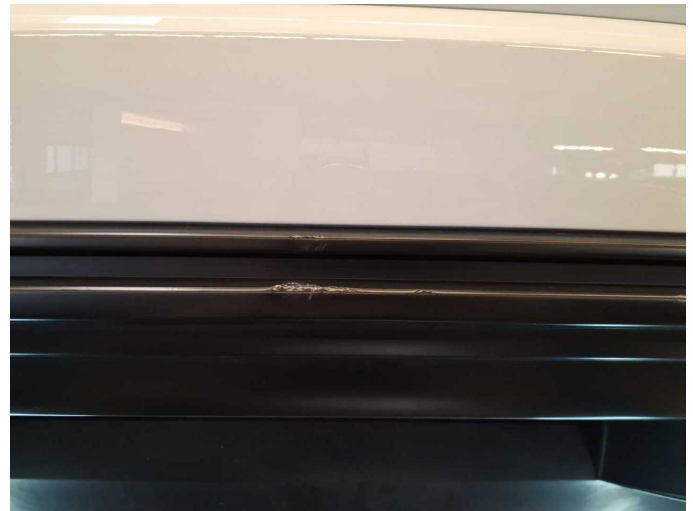
Damage 2: Rear bumper: Spoiler - Scratch(es) - Smart repair

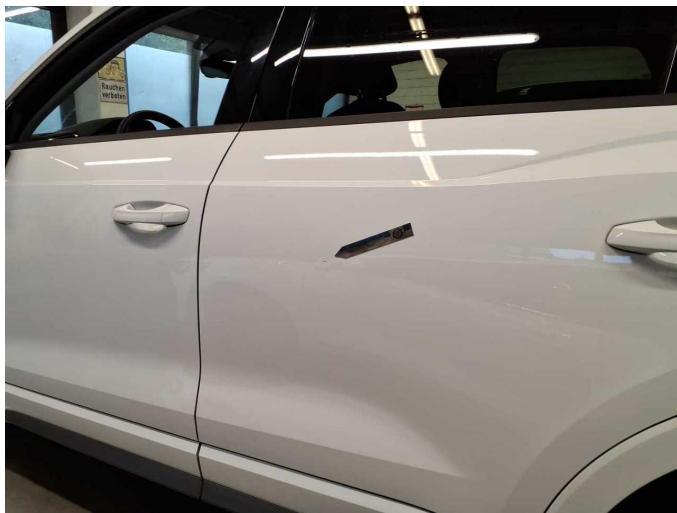
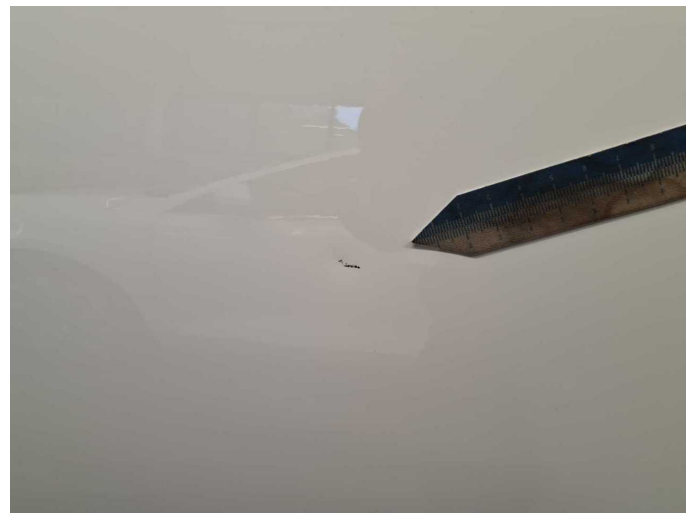
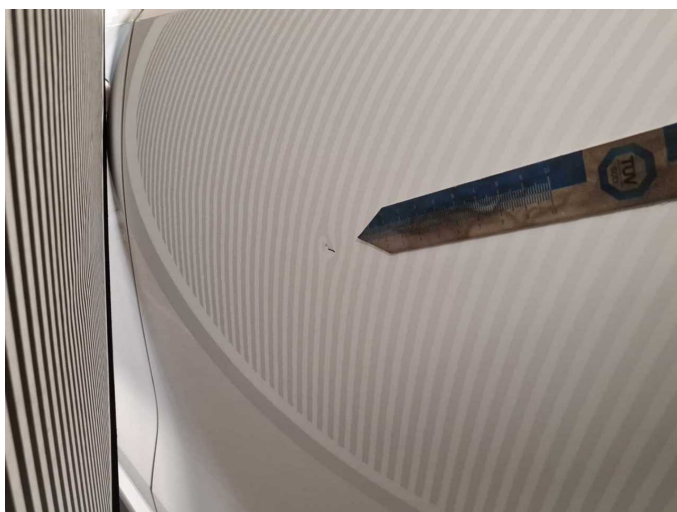
Damage 3: Door - rear left side: Door - Dent / paintcoat damage - Repair and paint

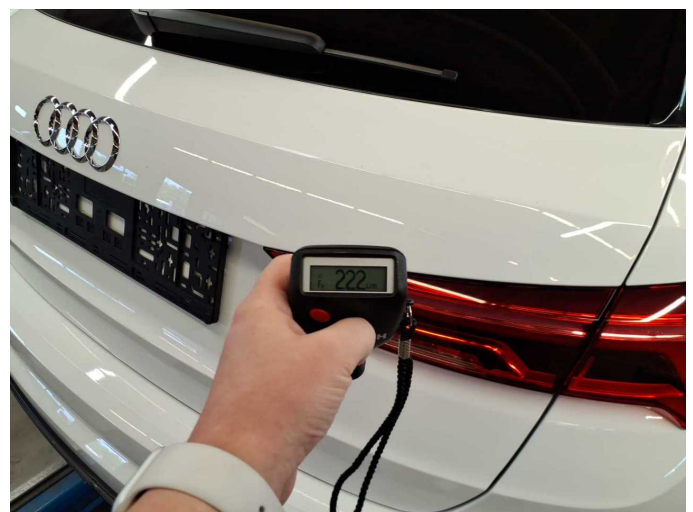
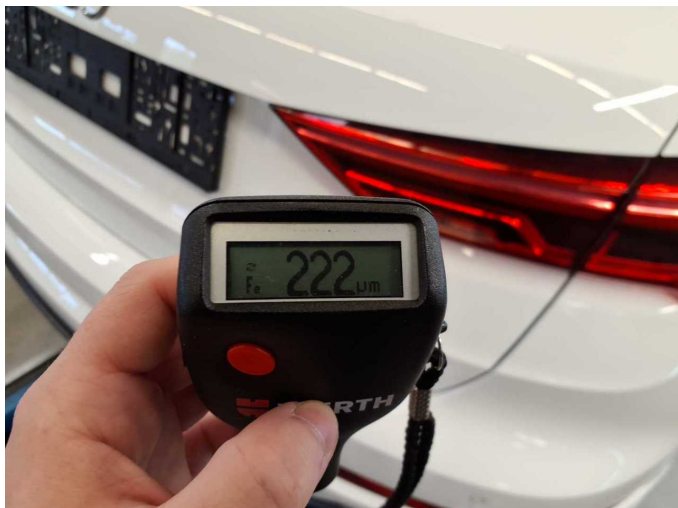
No.	Repainting
1	Boot lid / rear door, Professionally carried out, Invoice of repair done Non-existent

Boot lid / rear door	222 µm
----------------------	--------

Repainting 1: Boot lid / rear door
