Expertise

Protocol number: 41325200  
Order No. / Reference: 25110394  
Inspection date: 2 Sept 2025

Model: A4 Avant 35 TDI S tronic advanced

VIN: WAUZZZF43MA002382

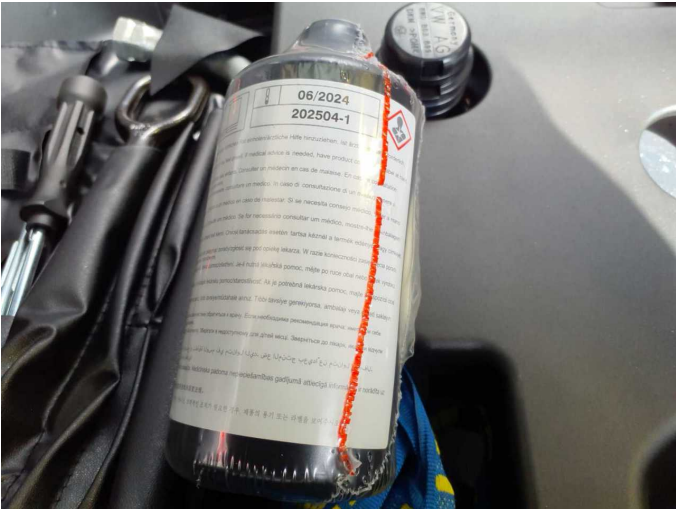
Damage 1: Equipment: Tirefit filler - Expired - Replace

| No. | Component group | Description |
|---|---|---|
| 1 | Equipment | Tirefit filler - Expired - Replace |

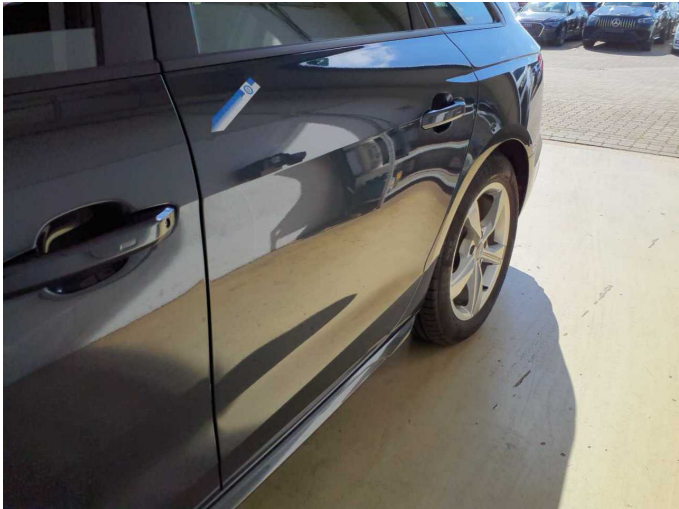
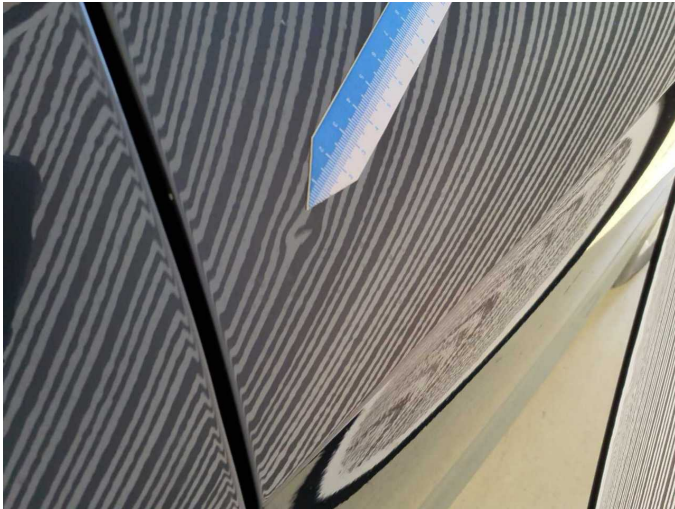
Damage 2: Door - rear left side: Door - dent(s) - Smooth repair work

**Damage 2:** Door - rear left side: Door - dent(s) - Smooth repair work

| No. | Component group | Description |
|---|---|---|
| 2 | Door - rear left side | Door - dent(s) - Smooth repair work |

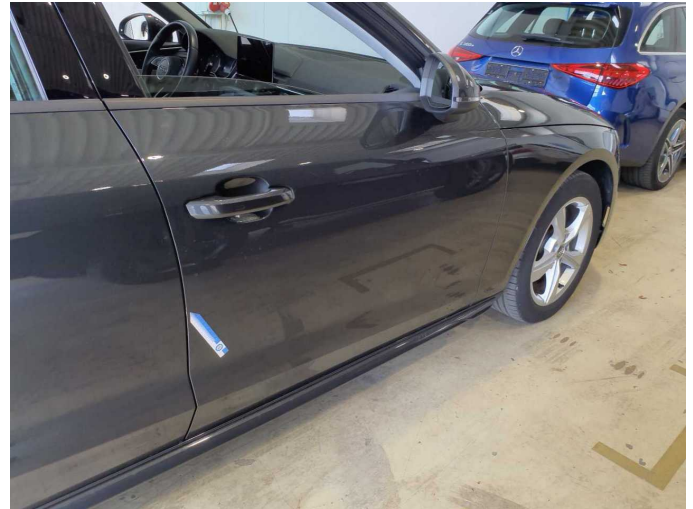
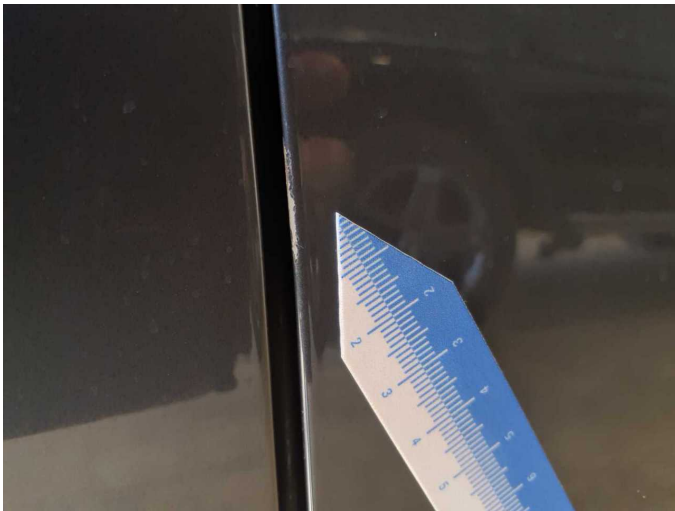
**Damage 3:** Door - front right side: Door edge - Scratch(es) - Smart repair

| No. | Component group | Description |
|---|---|---|
| 3 | Door - front right side | Door edge - Scratch(es) - Smart repair |

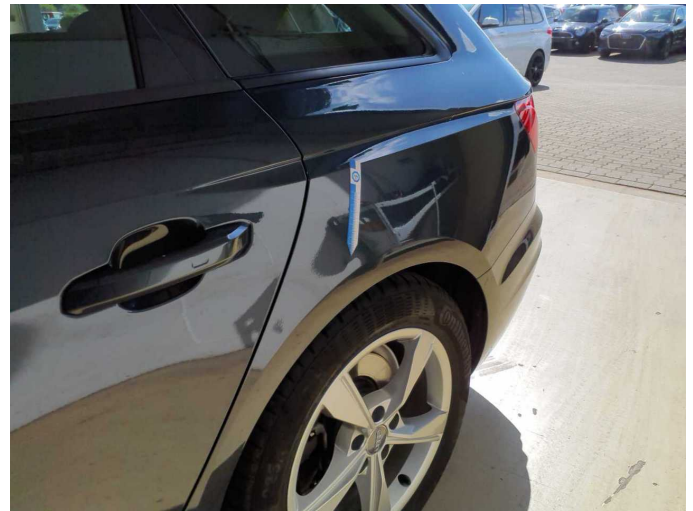
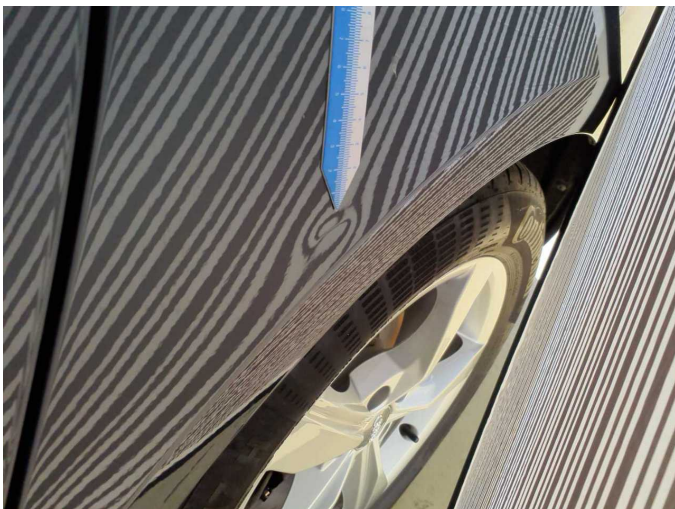
**Damage 4:** Side panel - rear left side: Side panel - dent(s) - Smart repair

| No. | Component group | Description |
|---|---|---|
| 4 | Side panel - rear left side | Side panel - dent(s) - Smart repair |

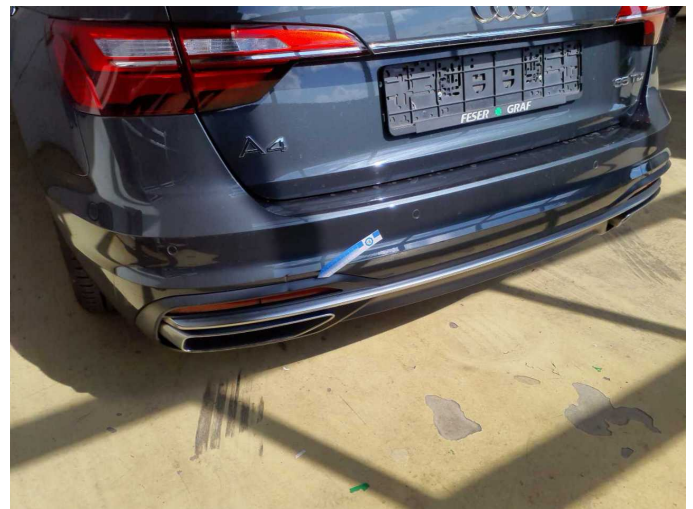
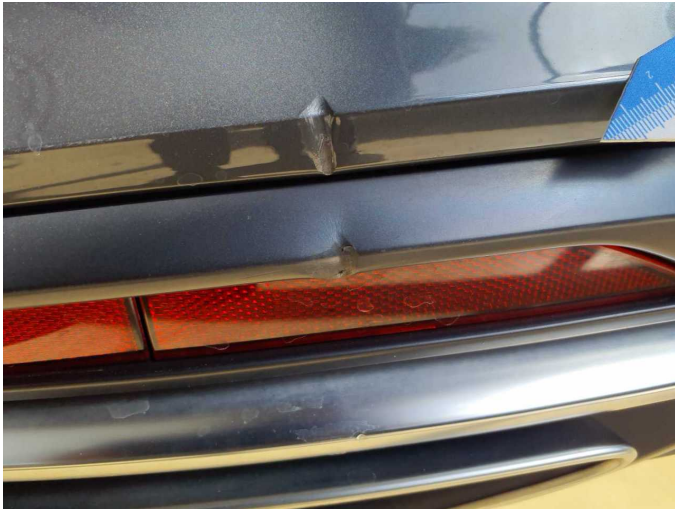
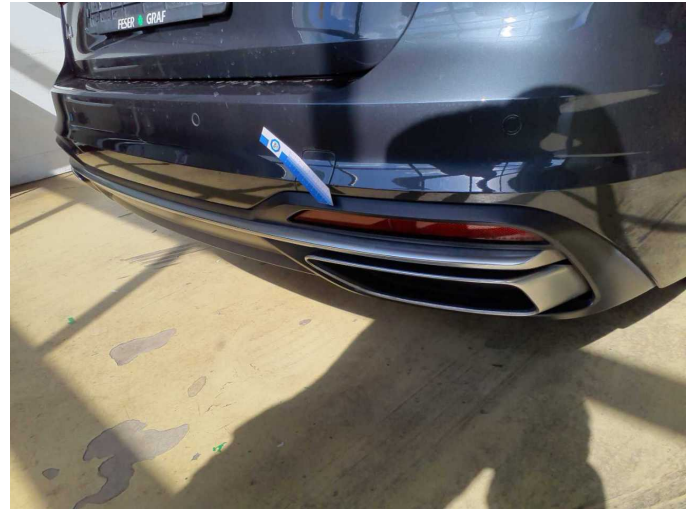
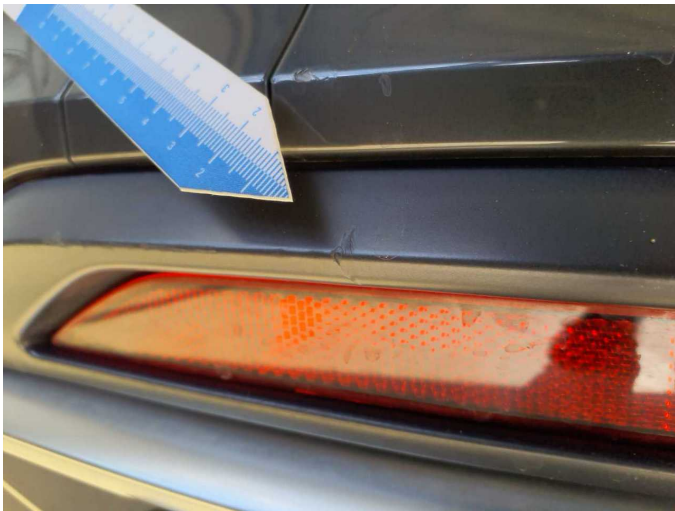
**Damage 5:** Rear bumper: Spoiler - Scratch(es) - Replace

| No. | Component group | Description |
|---|---|---|
| 5 | Rear bumper | Spoiler - Scratch(es) - Replace |

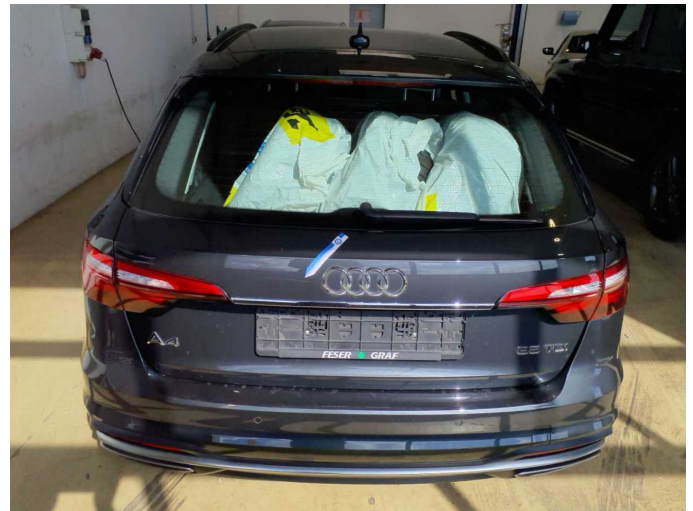
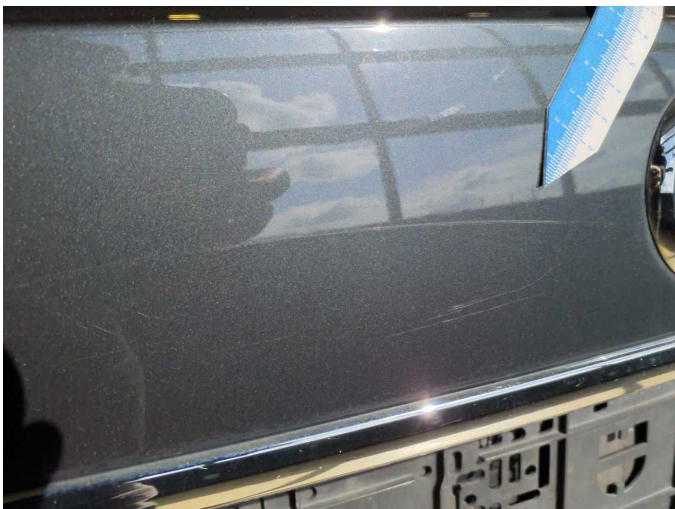
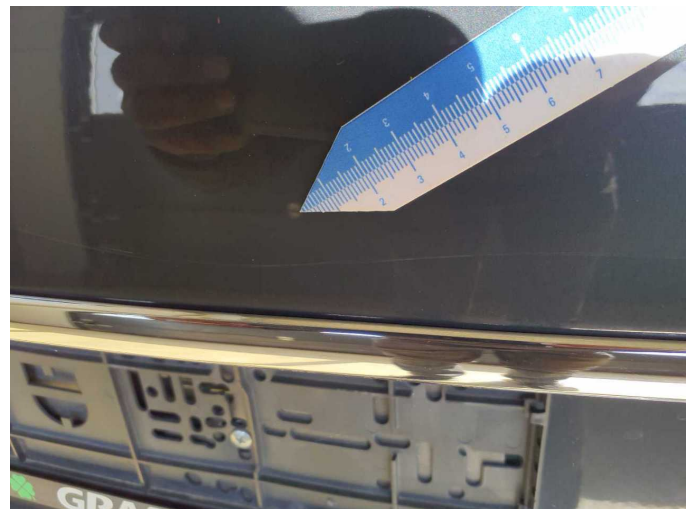
**Damage 6:** Boot lid / rear door: Boot lid - Scratch(es) - Paint

| No. | Component group | Description |
|---|---|---|
| 6 | Boot lid / rear door | Boot lid - Scratch(es) - Paint |

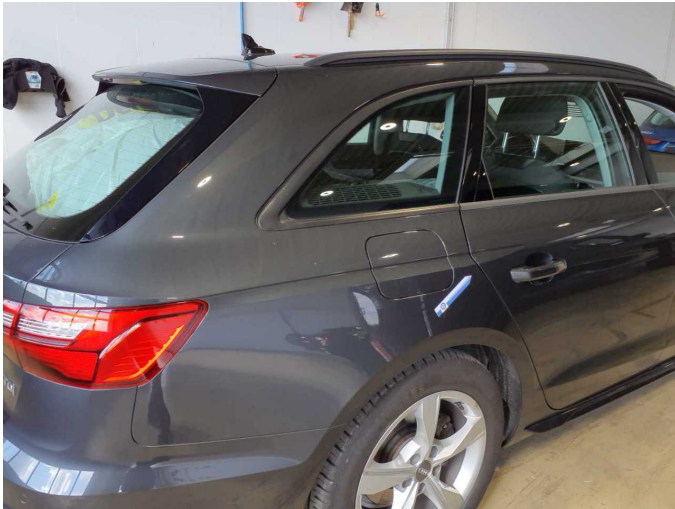
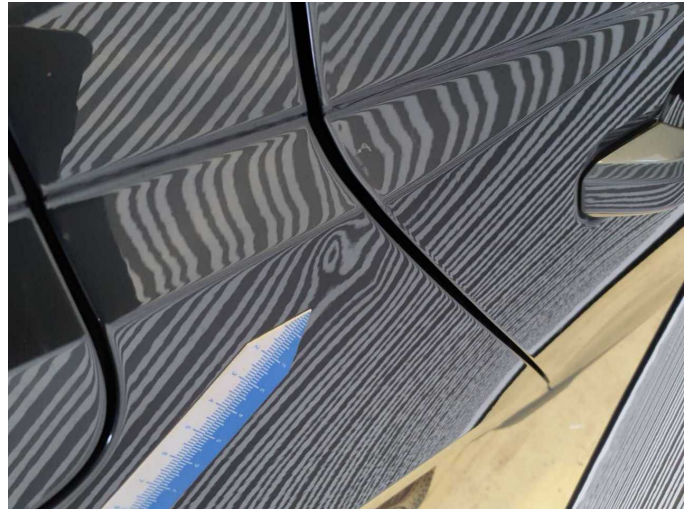
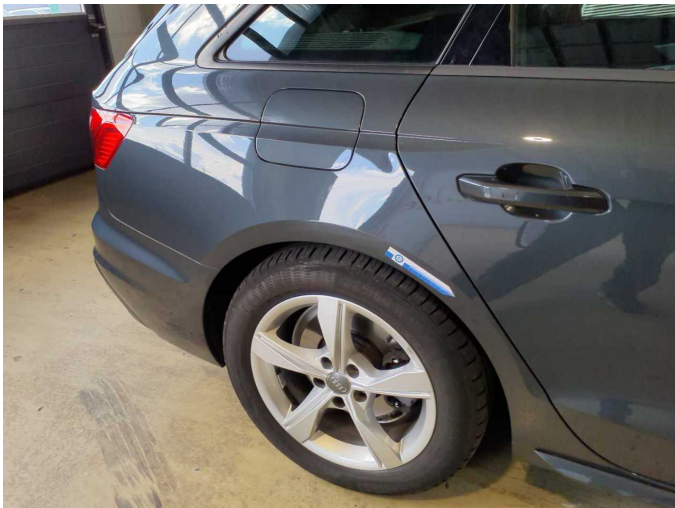
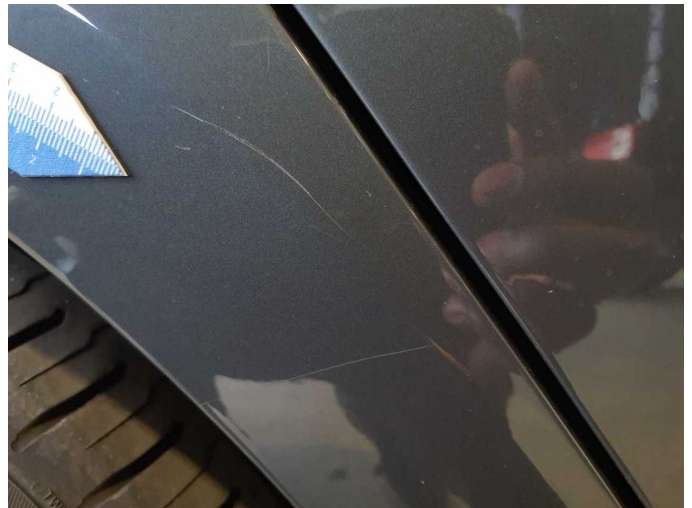
**Damage 7:** Side panel - rear right side: Side panel (+ Kratzer) - dent(s) - Repair and paint

| No. | Component group | Description |
|---|---|---|
| 7 | Side panel - rear right side | Side panel (+ Kratzer) - dent(s) - Repair and paint |

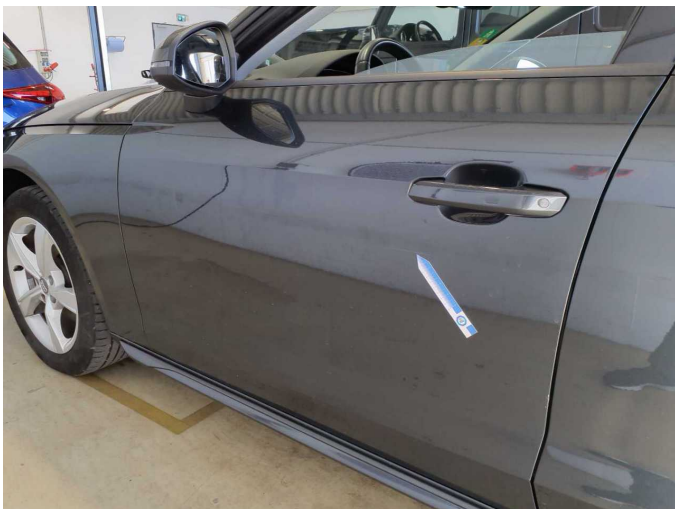
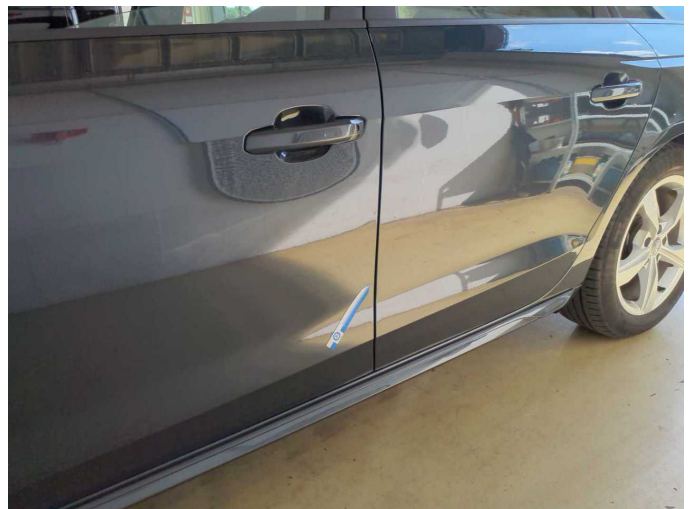
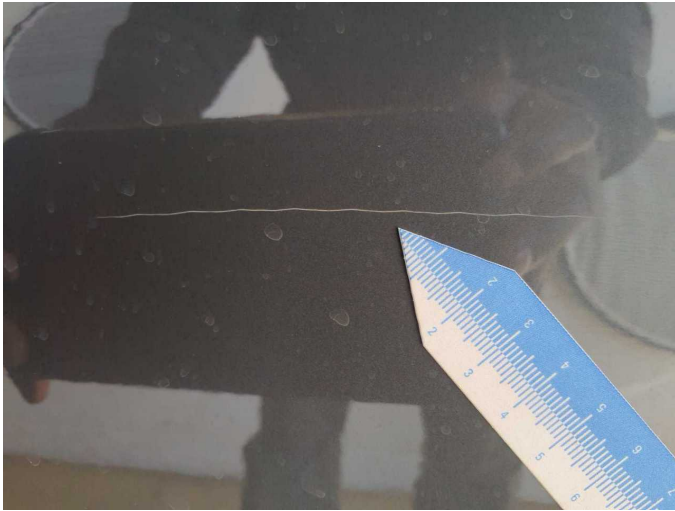
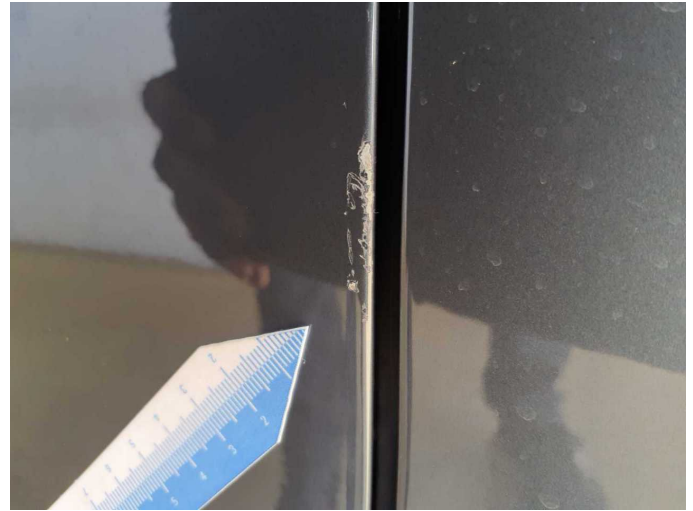
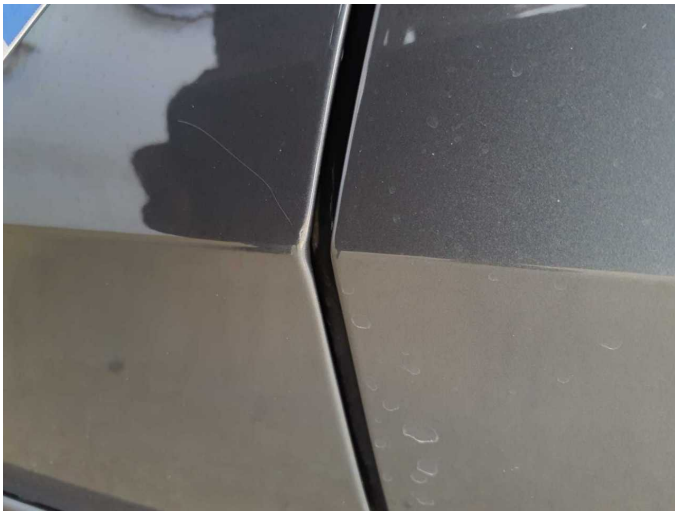
**Damage 8:** Door - front left side: Door - Scratch(es) - Paint

| No. | Component group | Description |
|---|---|---|
| 8 | Door - front left side | Door - Scratch(es) - Paint |

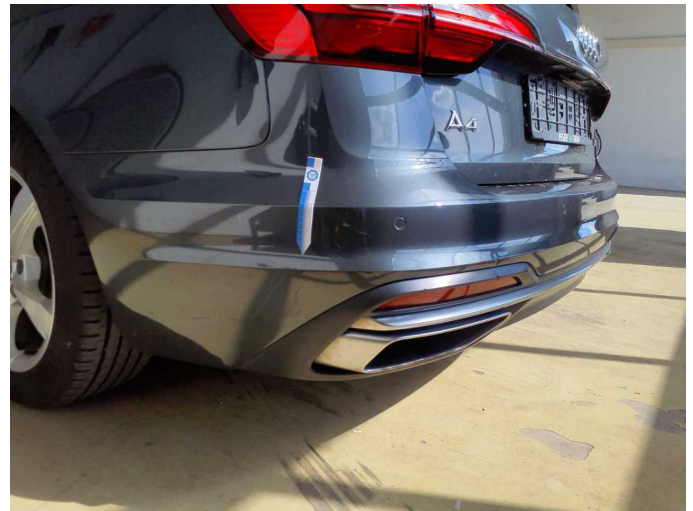
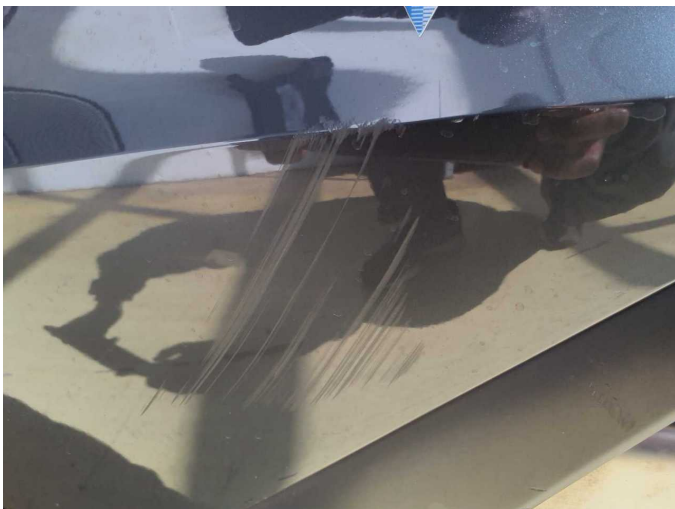
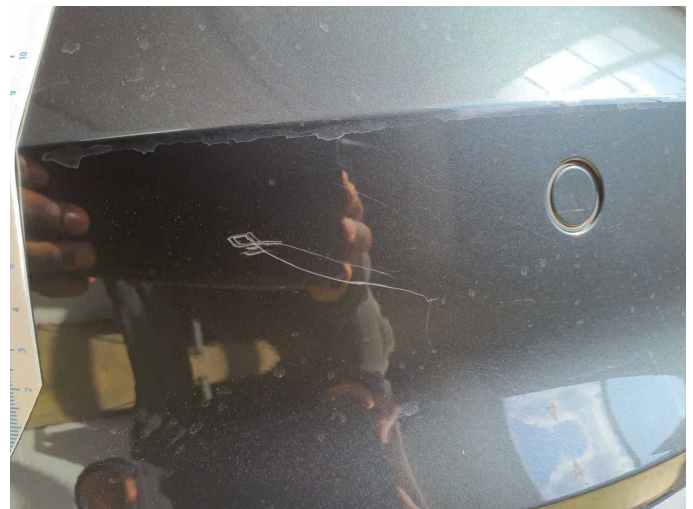
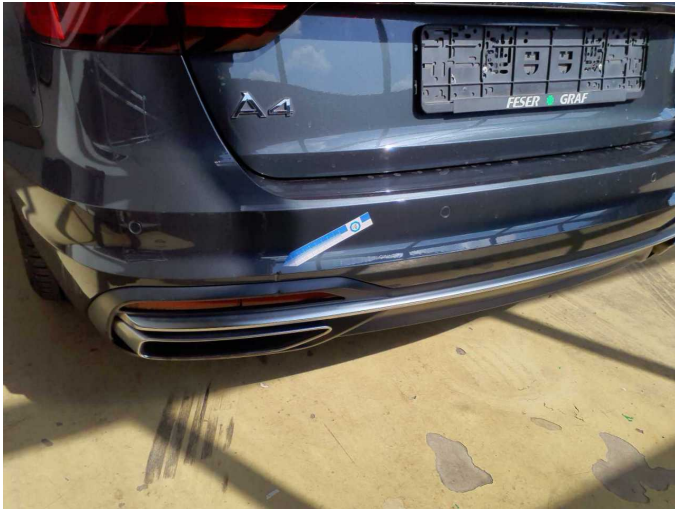
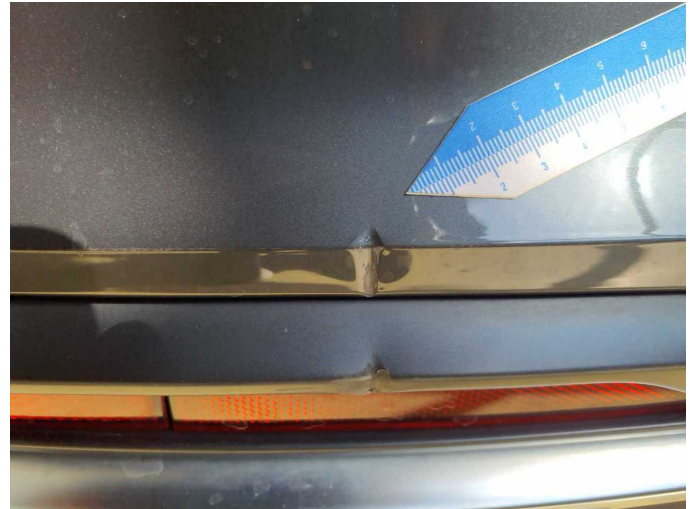
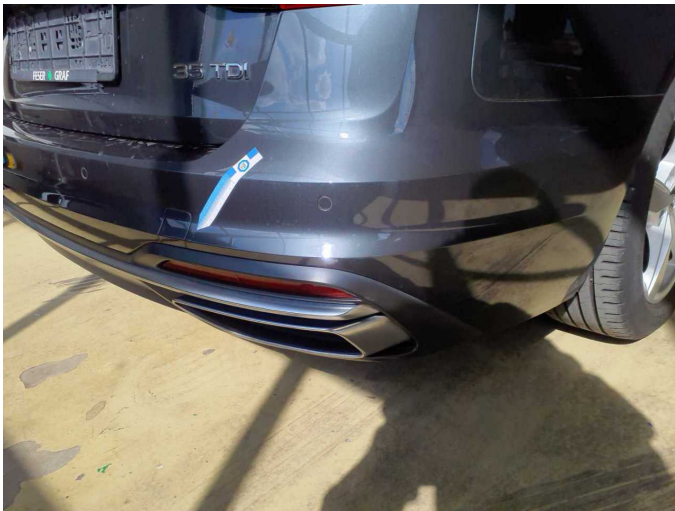
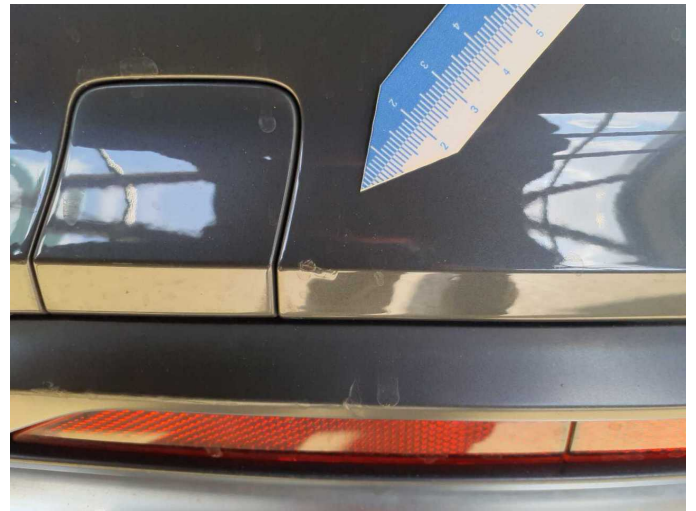
**Damage 9:** Rear bumper: Rear bumper - Scratch(es) - Repair and paint

| No. | Component group | Description |
|---|---|---|
| 9 | Rear bumper | Rear bumper - Scratch(es) - Repair and paint |

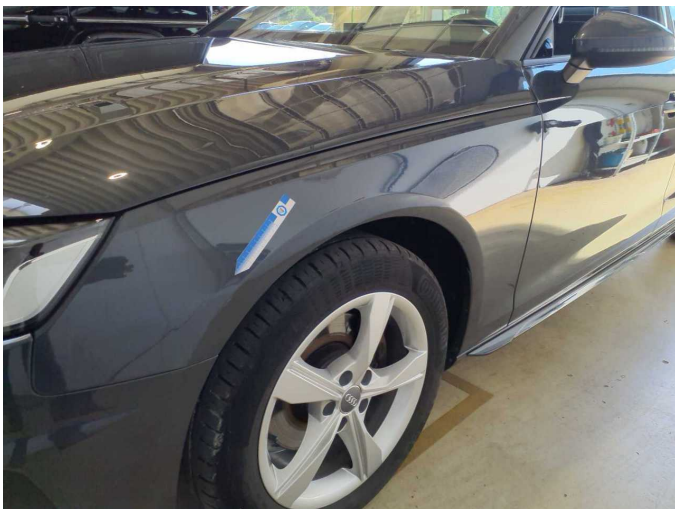
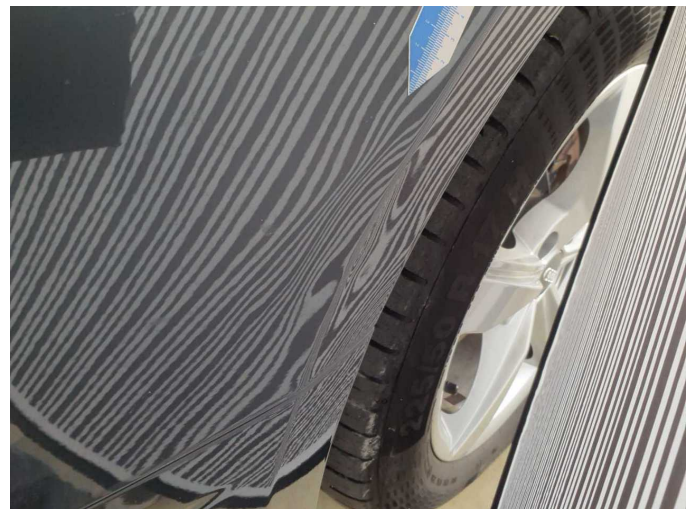
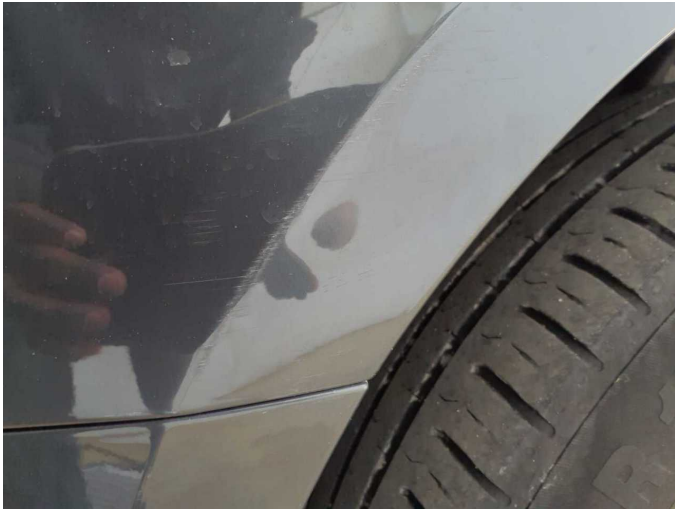
**Damage 10:** Mudguard - left side: Mudguard - left side - Dent / paintcoat damage - Repair and paint

| No. | Component group | Description |
|---|---|---|
| 10 | Mudguard - left side | Mudguard - left side - Dent / paintcoat damage - Repair and paint |

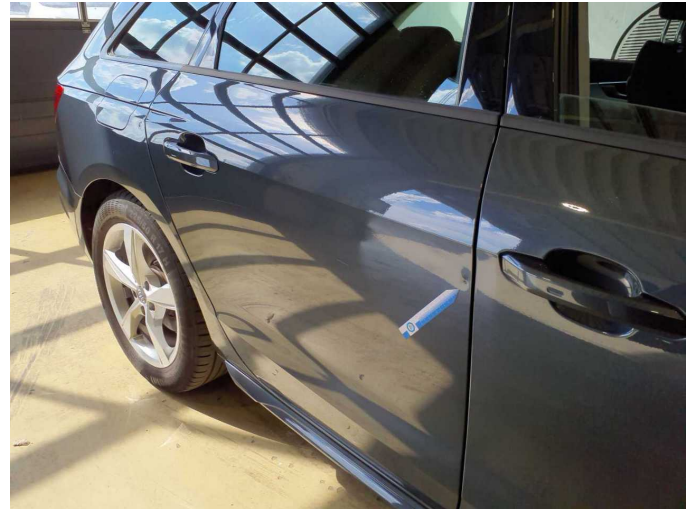
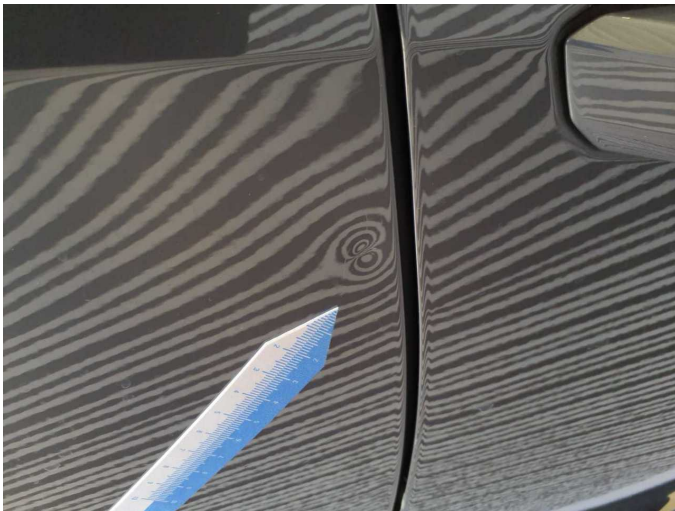
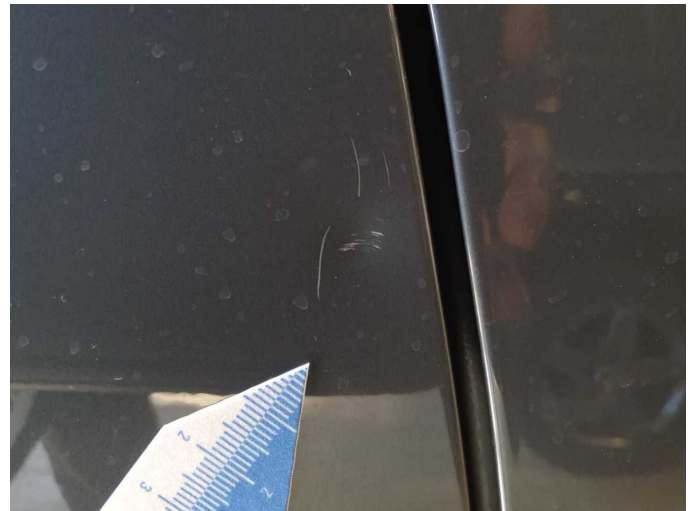
**Damage 11:** Door - rear right side: Door - Dent / paintcoat damage - Repair and paint

| No. | Component group | Description |
|---|---|---|
| 11 | Door - rear right side | Door - Dent / paintcoat damage - Repair and paint |

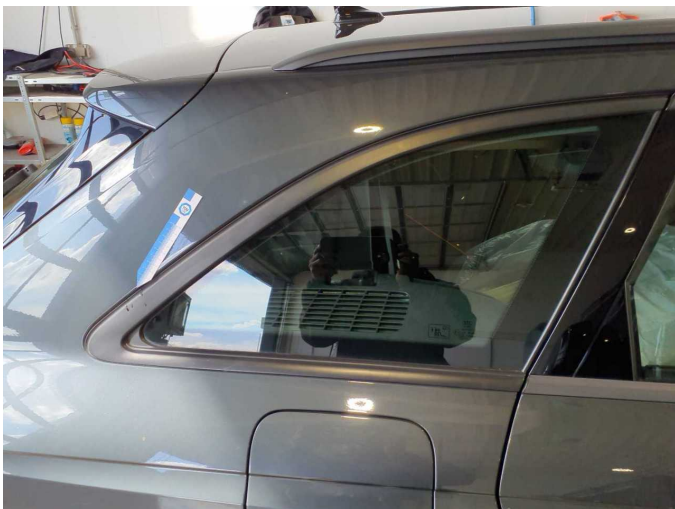
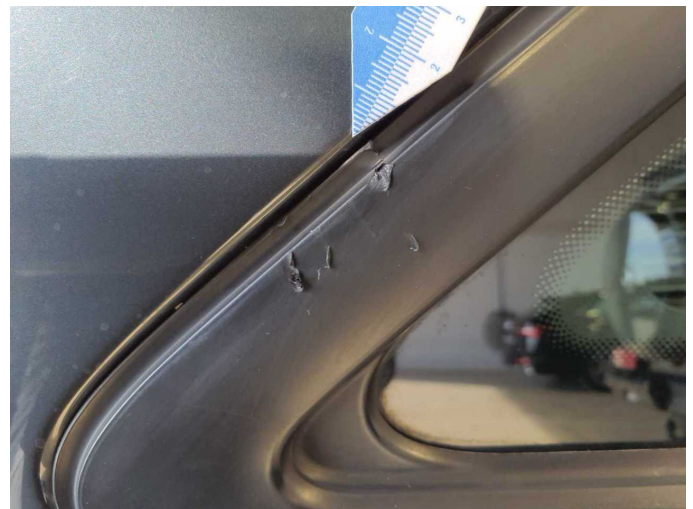
**Damage 12:** Door - rear right side: Window guide - Damaged - Replace

| No. | Component group | Description |
|---|---|---|
| 12 | Door - rear right side | Window guide - Damaged - Replace |

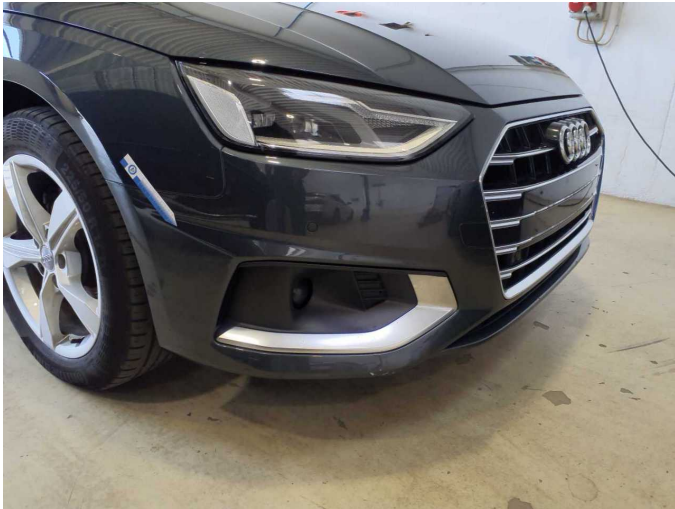
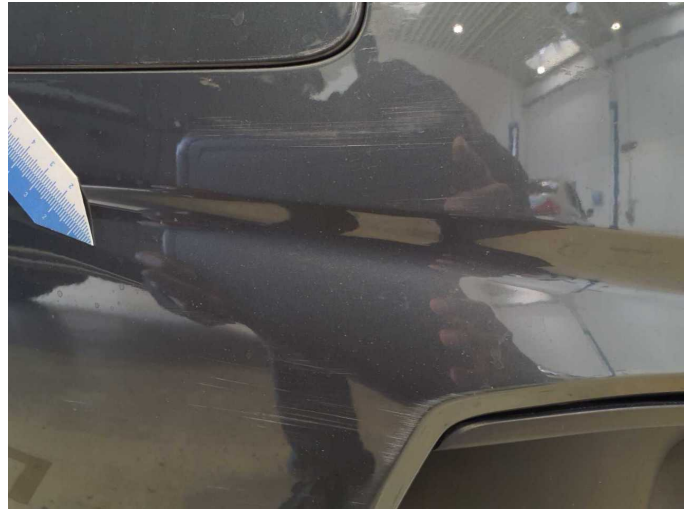
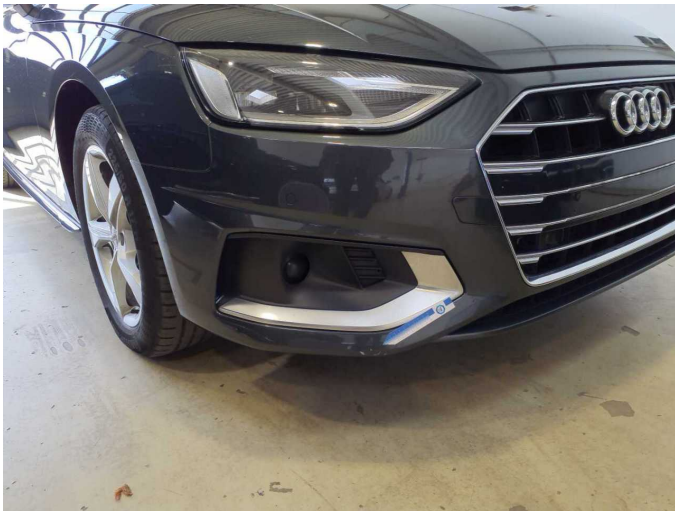
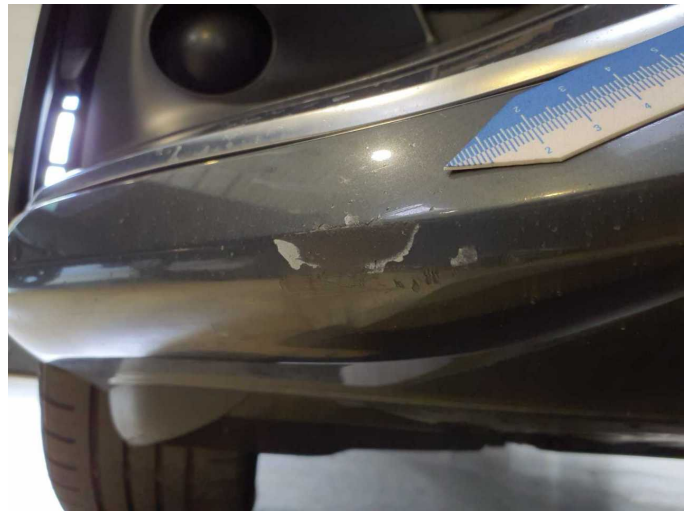
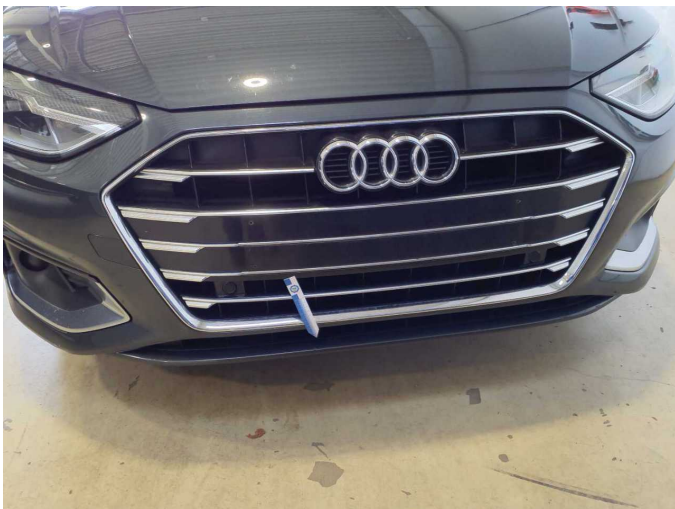
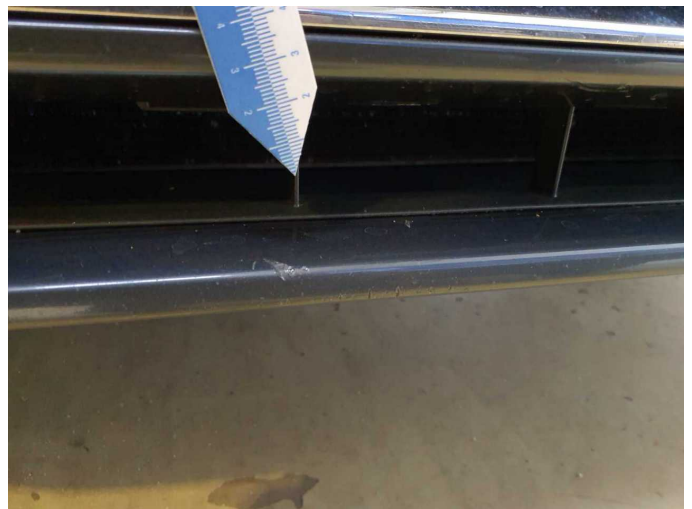
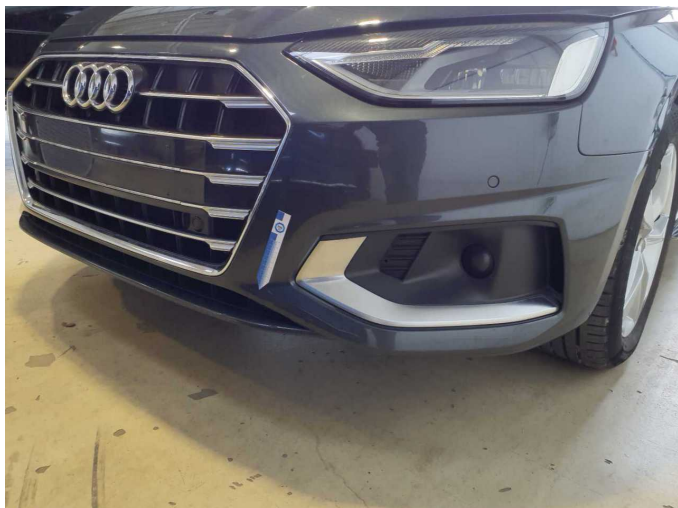
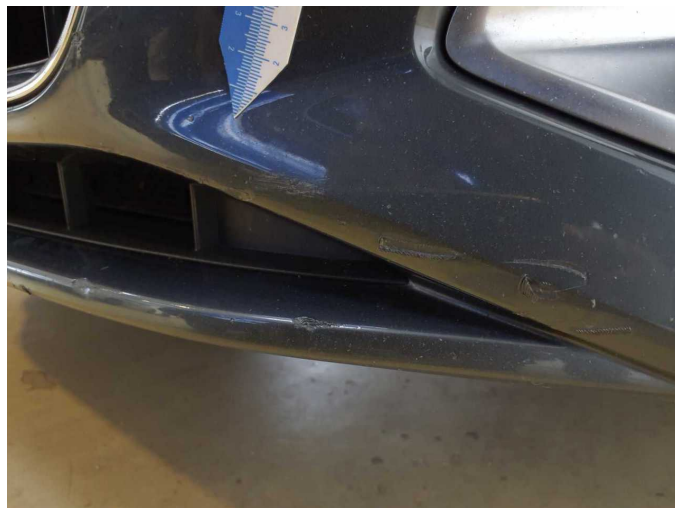
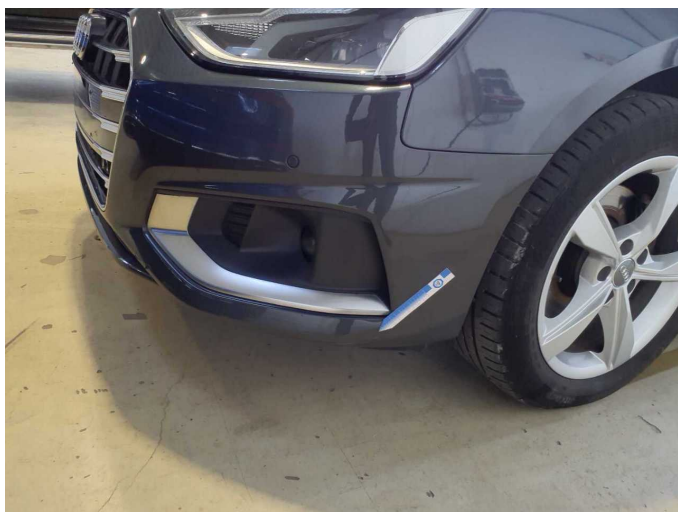
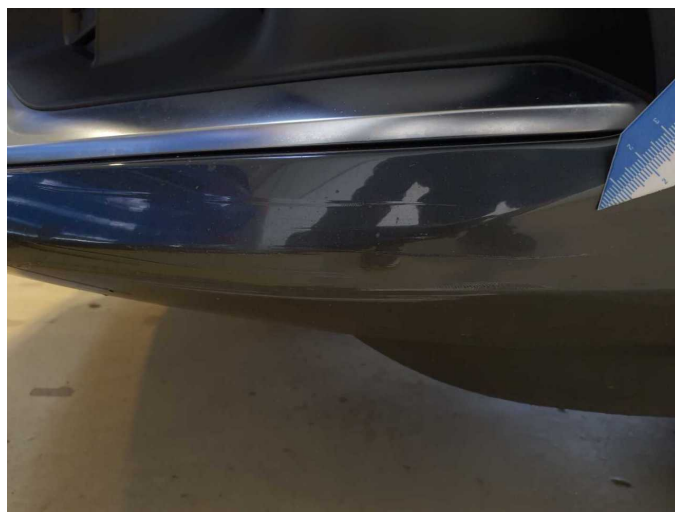
**Damage 13:** Front bumper: Front bumper - Scratch(es) - Paint

| No. | Component group | Description |
|---|---|---|
| 13 | Front bumper | Front bumper - Scratch(es) - Paint |

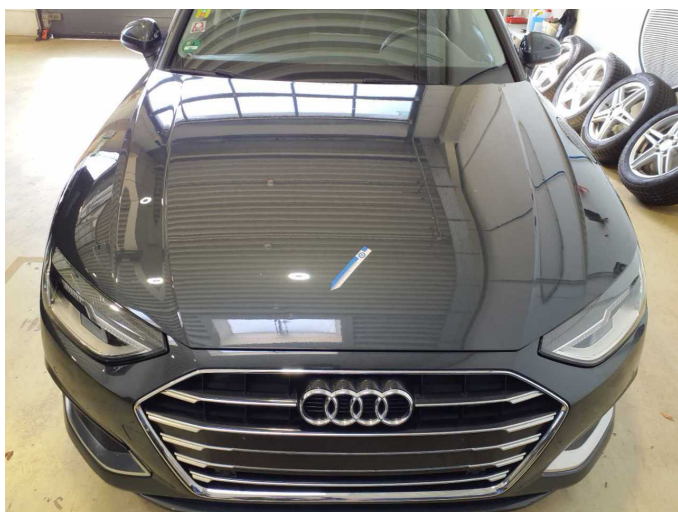
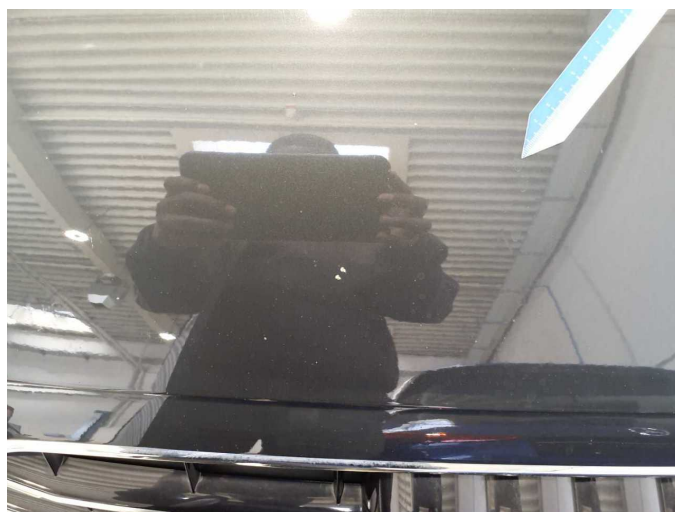
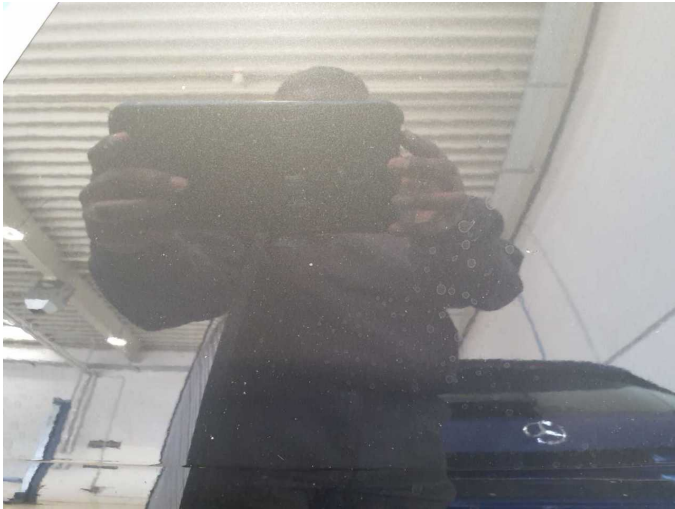
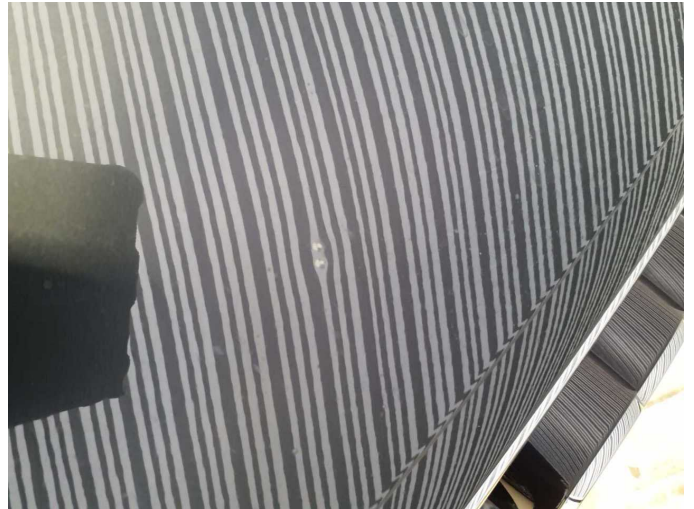
**Damage 14:** Bonnet: Bonnet (+ Steinschläge) - Dent / paintcoat damage - Repair and paint

**Damage 14:** Bonnet: Bonnet (+ Steinschläge) - Dent / paintcoat damage  
- Repair and paint

| No. | Component group | Description |
|---|---|---|
| 14 | Bonnet | Bonnet (+ Steinschläge) - Dent / paintcoat damage - Repair and paint |

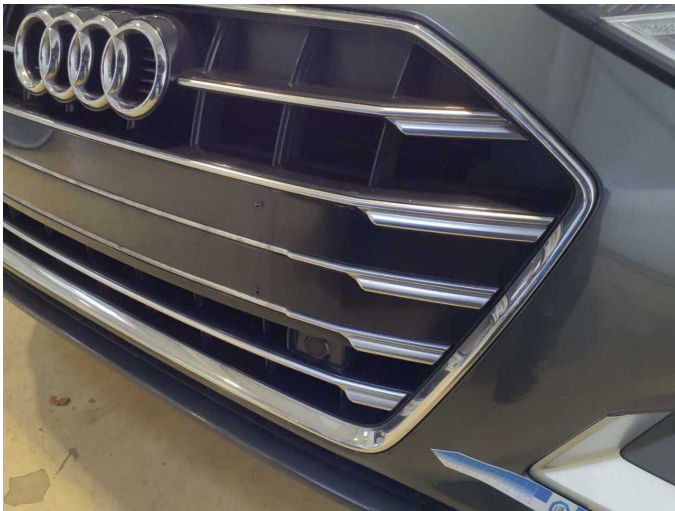
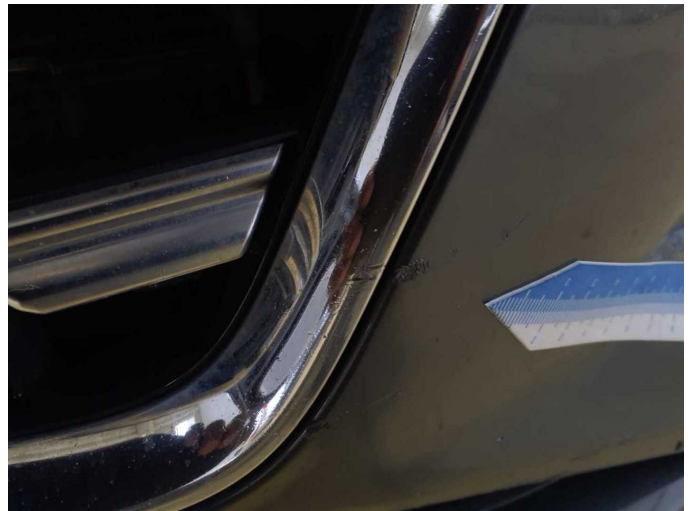
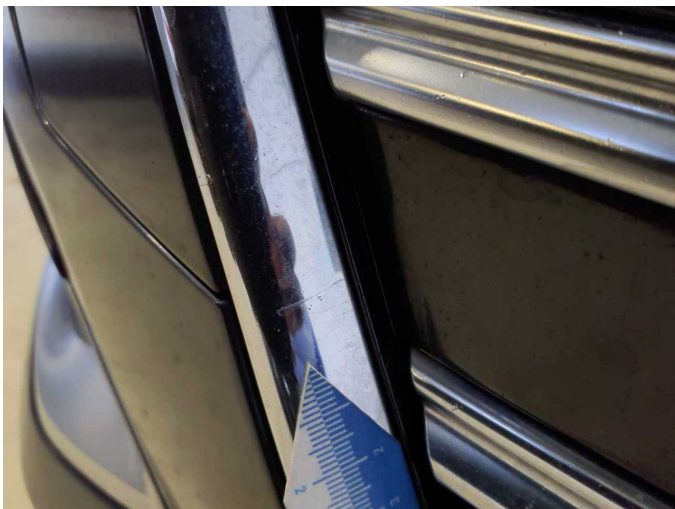
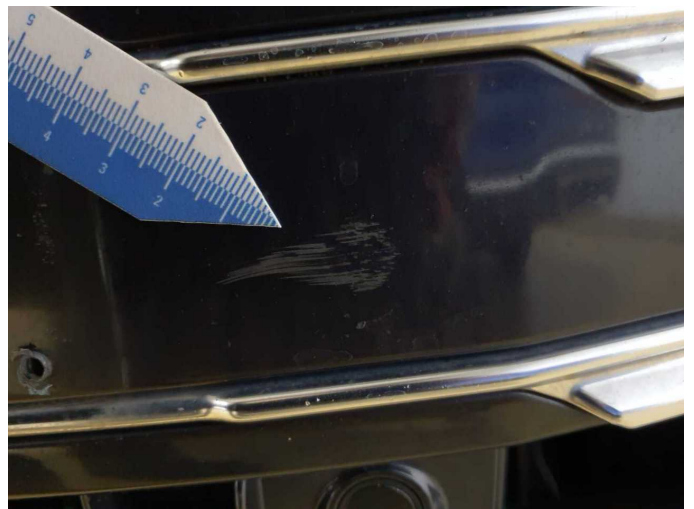
**Wear and tear 1:** Front bumper: Grille - Scratch(es) - No deduction

| No. | Component group | Description |
|---|---|---|
| 1 | Front bumper | Grille - Scratch(es) - No deduction |
