# AUDI A4

## A4 Avant 40 TDI S tronic

VIN NO WAUZZZF46NA036530  
Registration Number 46NA036530

### Inspection Report Summary

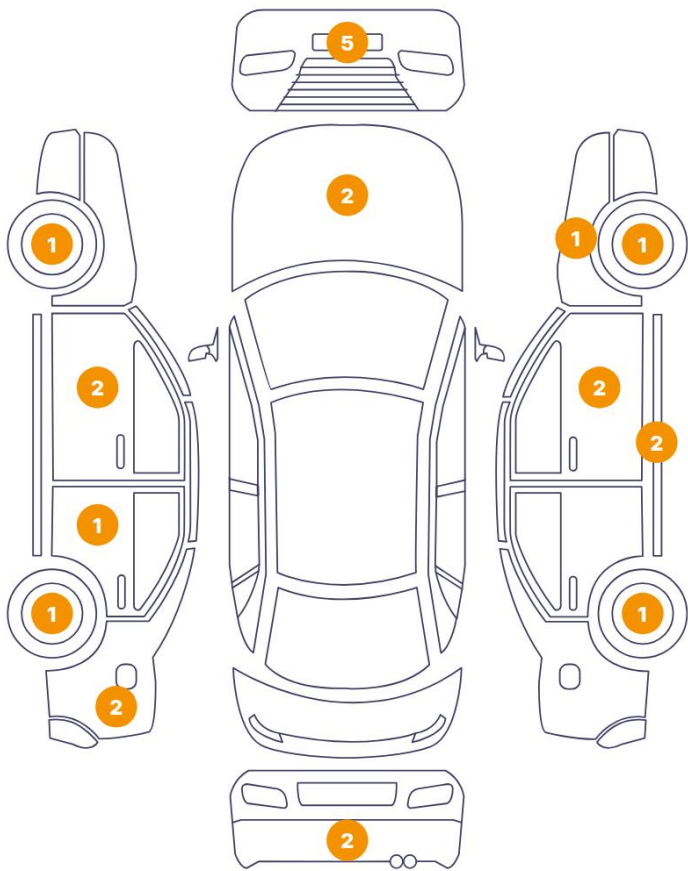
23 Schäden

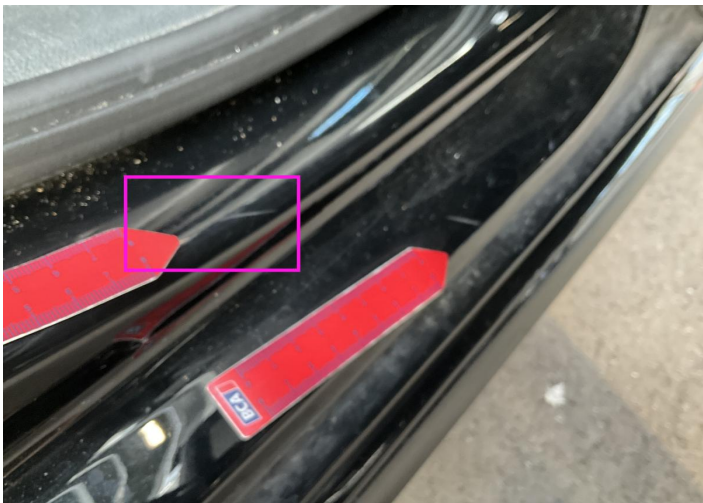
| Component | | Damage | Comments |
|---|---|---|---|
| 1 | Rocker Panel / Center Right | Paint / Scratch / Scuff | |

1. Rocker Panel / Center Right  
Paint / Scratch / Scuff -

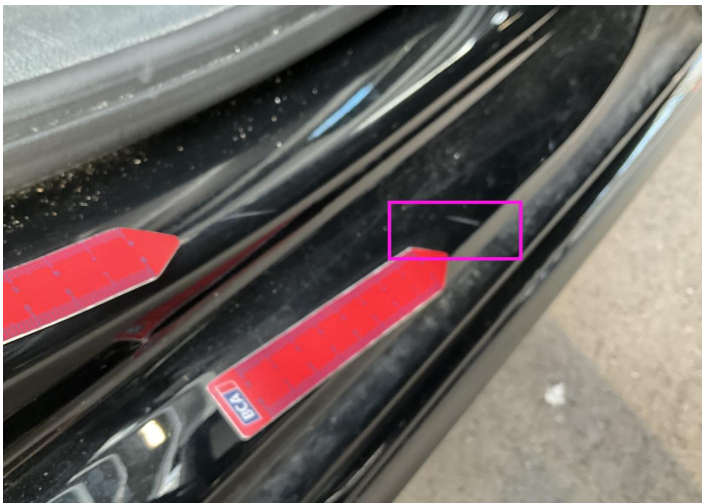
| Component | | Damage | Comments |
|---|---|---|---|
| 2 | Rocker Panel / Center Right | Paint / Scratch / Scuff | |

2. Rocker Panel / Center Right  
Paint / Scratch / Scuff -

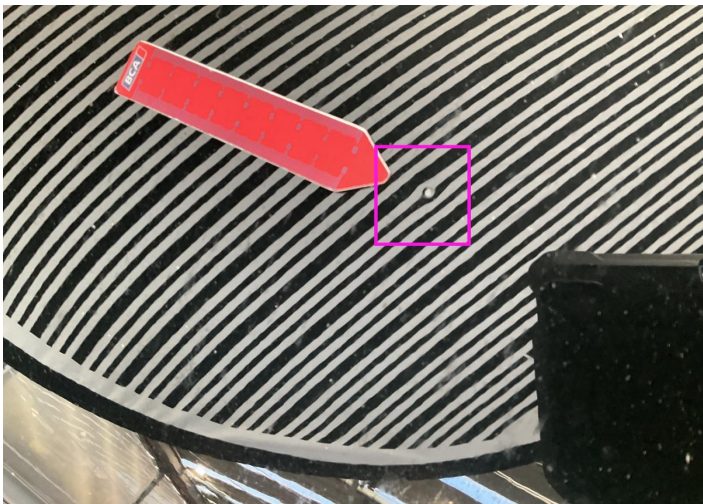
| Component | | Damage | Comments |
|---|---|---|---|
| 3 | Hood | Bodywork / Dent / Dent | |

3. Hood  
Bodywork / Dent / Dent -

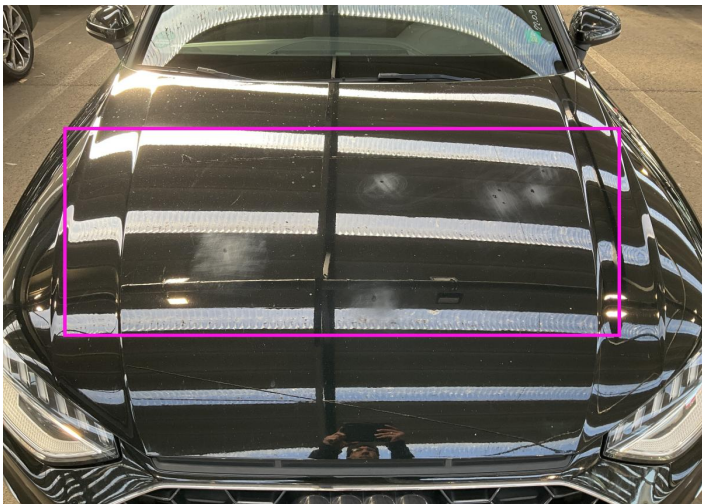
| Component | | Damage | Comments |
|---|---|---|---|
| 4 | Hood | Paint / Poor Previous Repair | |

4. Hood  
Paint / Poor Previous Repair -

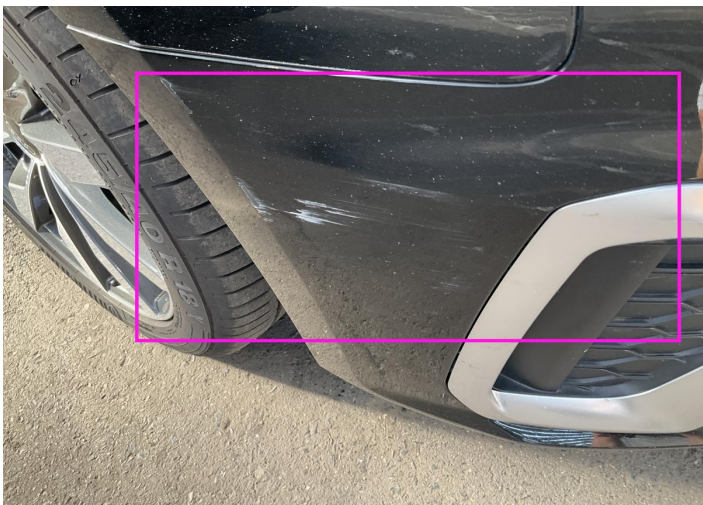
| Component | | Damage | Comments |
|---|---|---|---|
| 5 | Corner Bumper / Front Right | Paint / Scratch / Scuff | |

5. Corner Bumper / Front Right  
Paint / Scratch / Scuff -

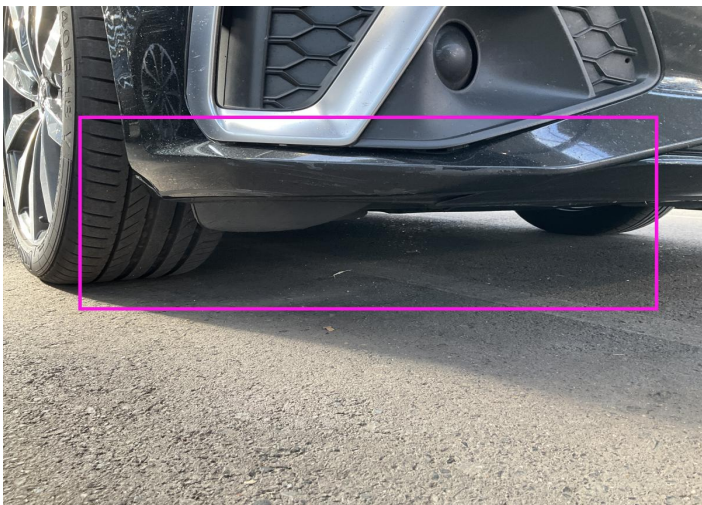
| Component | | Damage | Comments |
|---|---|---|---|
| 6 | Corner Bumper / Front Right | Paint / Scratch / Scuff | |

6. Corner Bumper / Front Right  
Paint / Scratch / Scuff -

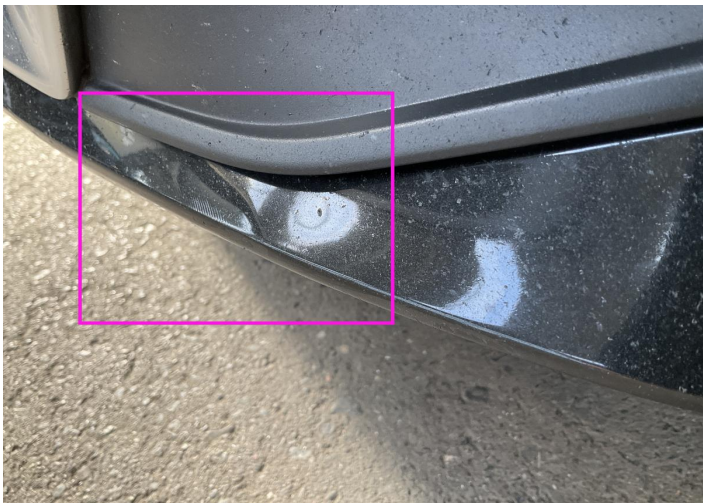
| Component | | Damage | Comments |
|---|---|---|---|
| 7 | Corner Bumper / Front Right | Bodywork / Dent / Dent | |

7. Corner Bumper / Front Right  
Bodywork / Dent / Dent -

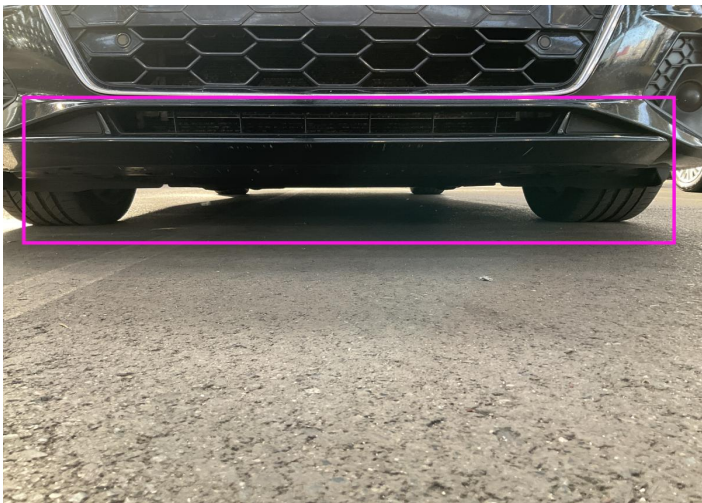
| Component | | Damage | Comments |
|---|---|---|---|
| 8 | Bumper / Front | Paint / Scratch / Scuff | |

8. Bumper / Front  
Paint / Scratch / Scuff -

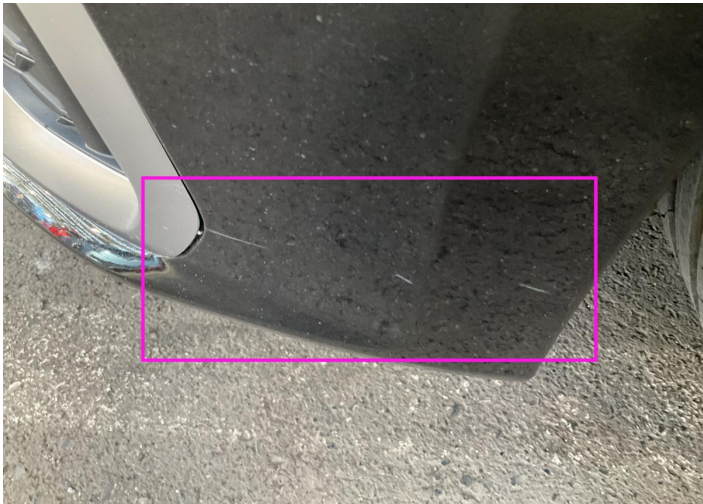
| Component | | Damage | Comments |
|---|---|---|---|
| 9 | Corner Bumper / Front Left | Paint / Scratch / Scuff | |

9. Corner Bumper / Front Left  
Paint / Scratch / Scuff -

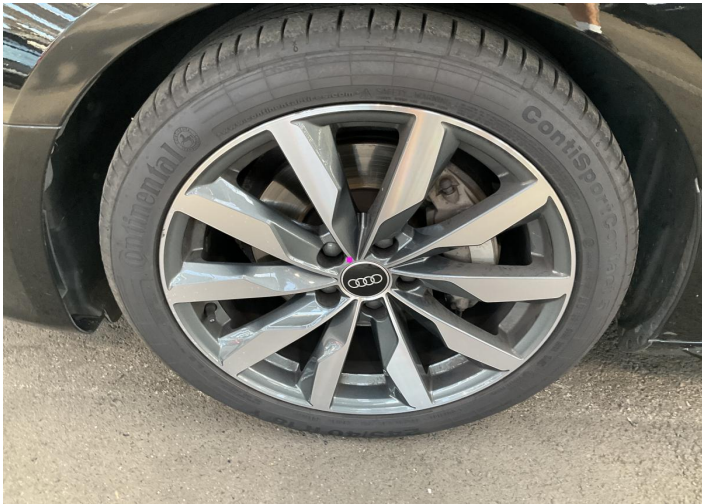
| Component | | Damage | Comments |
|---|---|---|---|
| 10 | Rim / Front Left | Out of Bodywork / Scratch | |

10. Rim / Front Left  
Out of Bodywork / Scratch -

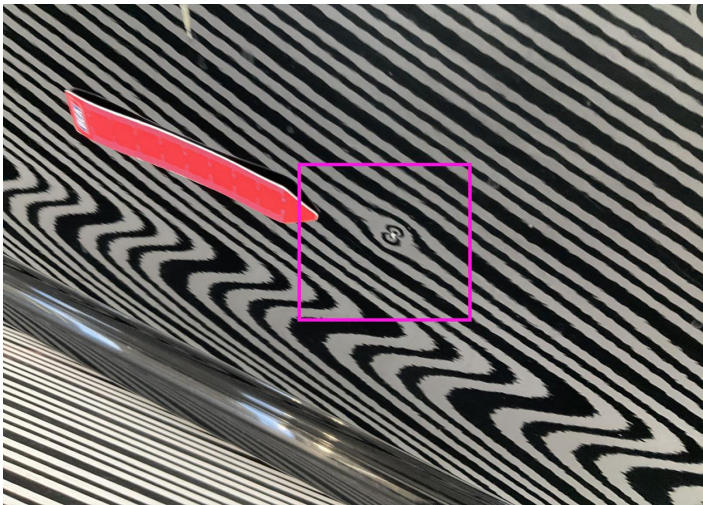
| Component | | Damage | Comments |
|---|---|---|---|
| 11 | Door / Front Left | Bodywork / Dent / Dent | |

11. Door / Front Left  
Bodywork / Dent / Dent -

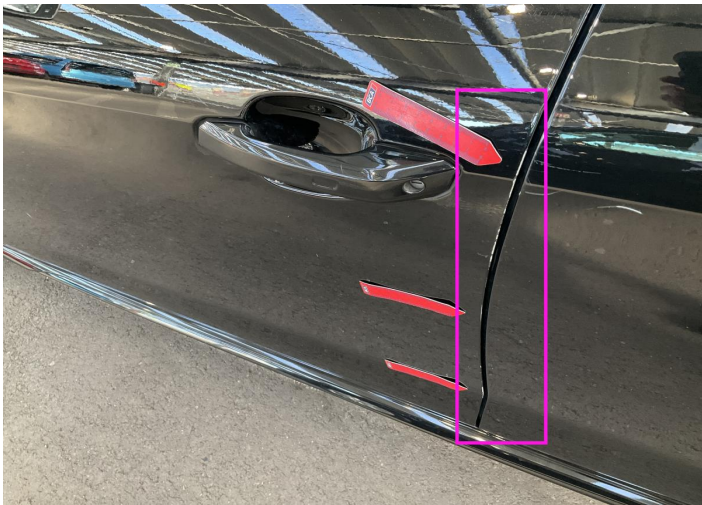
| Component | | Damage | Comments |
|---|---|---|---|
| 12 | Door / Front Left | Paint / Scratch / Scuff | |

12. Door / Front Left  
Paint / Scratch / Scuff -

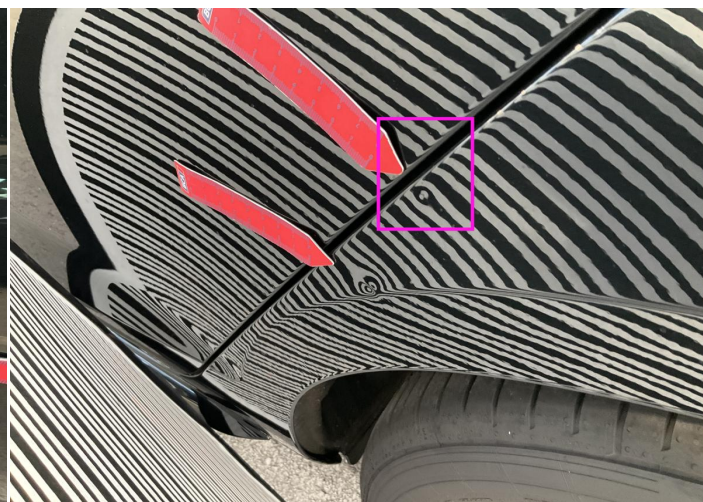
| 14 | Fender / Back Left | Bodywork / Dent / Dent |

14. Fender / Back Left  
Bodywork / Dent / Dent -

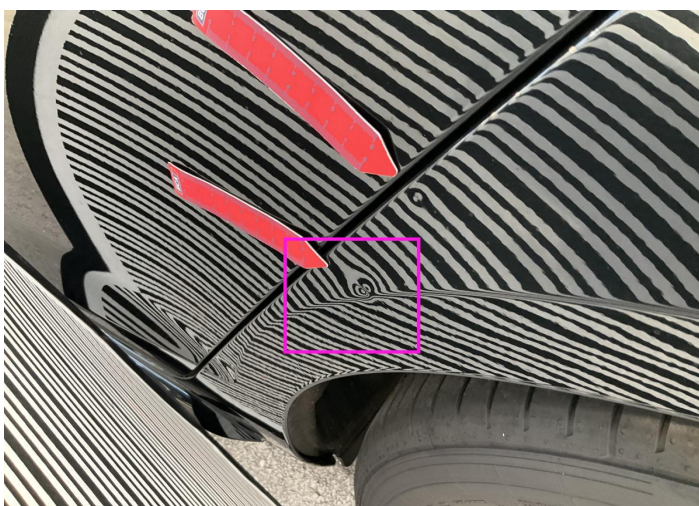
| 15 | Fender / Back Left | Bodywork / Dent / Dent |

15. Fender / Back Left  
Bodywork / Dent / Dent -

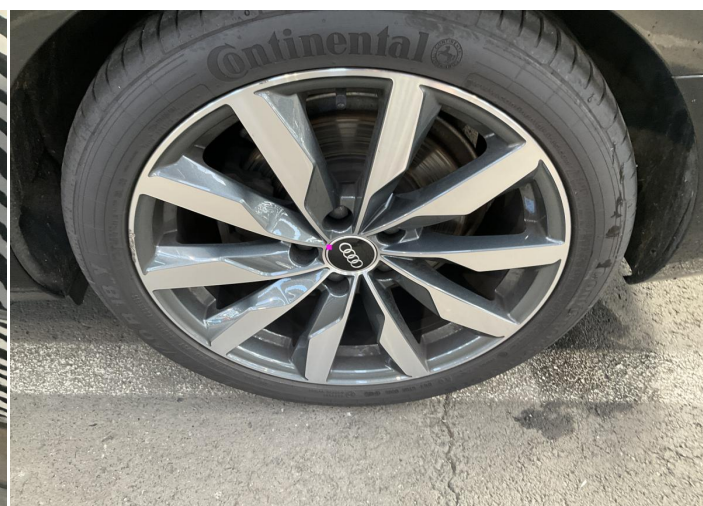
| 16 | Rim / Back Left | Out of Bodywork / Scratch |

16. Rim / Back Left  
Out of Bodywork / Scratch -

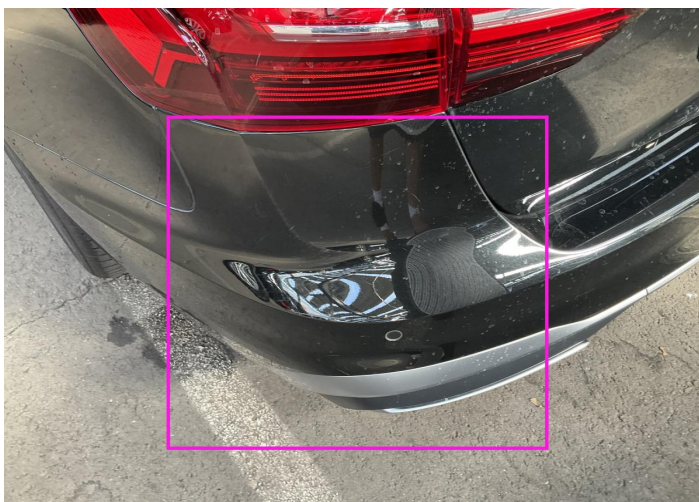
| 17 | Corner Bumper / Back Left | Paint / Scratch / Scuff |

17. Corner Bumper / Back Left  
Paint / Scratch / Scuff -

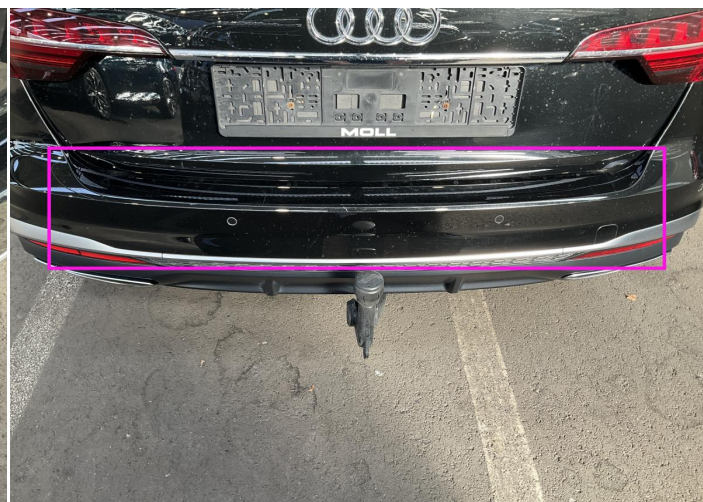
| 18 | Bumper / Back | Paint / Scratch / Scuff |

18. Bumper / Back  
Paint / Scratch / Scuff -

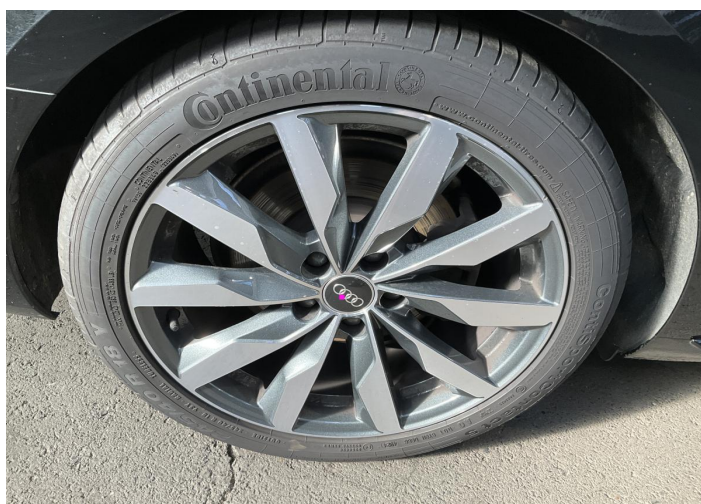
| 19 | Rim / Back Right | Out of Bodywork / Scratch |

19. Rim / Back Right  
Out of Bodywork / Scratch -

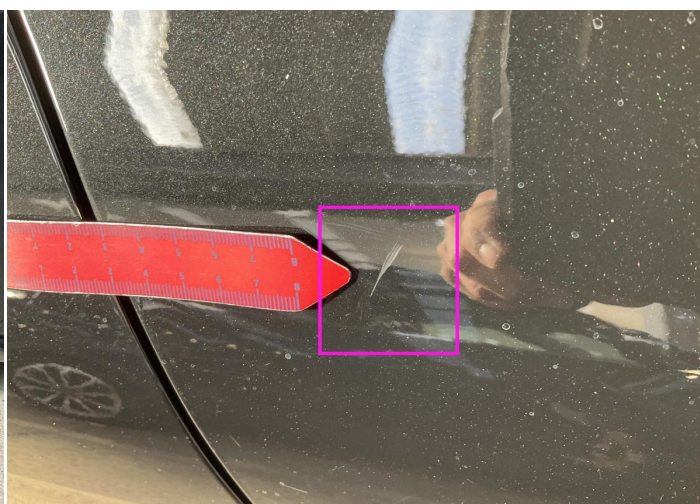
| 20 | Door / Front Right | Paint / Scratch / Scuff |

20. Door / Front Right  
Paint / Scratch / Scuff -

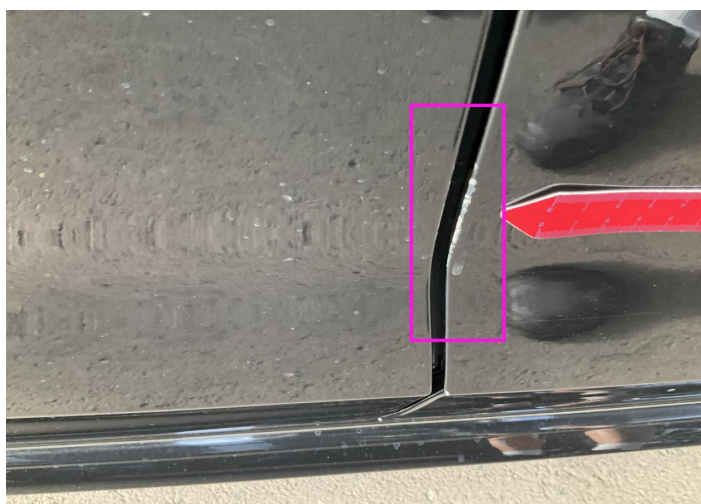
| 21 | Door / Front Right | Paint / Scratch / Scuff |

21. Door / Front Right  
Paint / Scratch / Scuff -

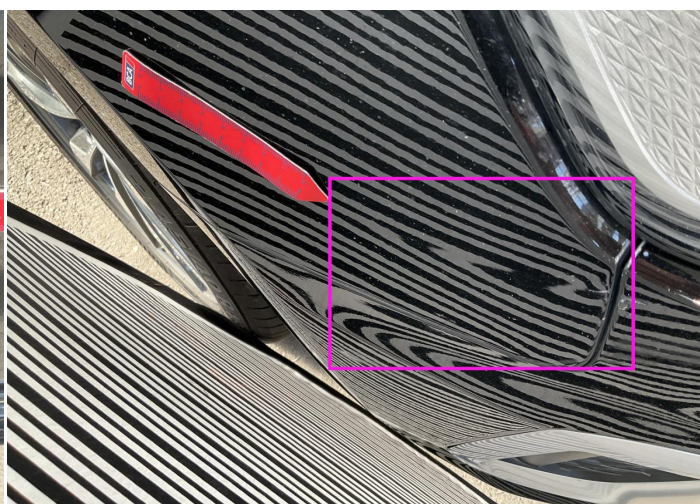
| 22 | Fender / Front Right | Bodywork / Dent / Dent |

22. Fender / Front Right  
Bodywork / Dent / Dent -

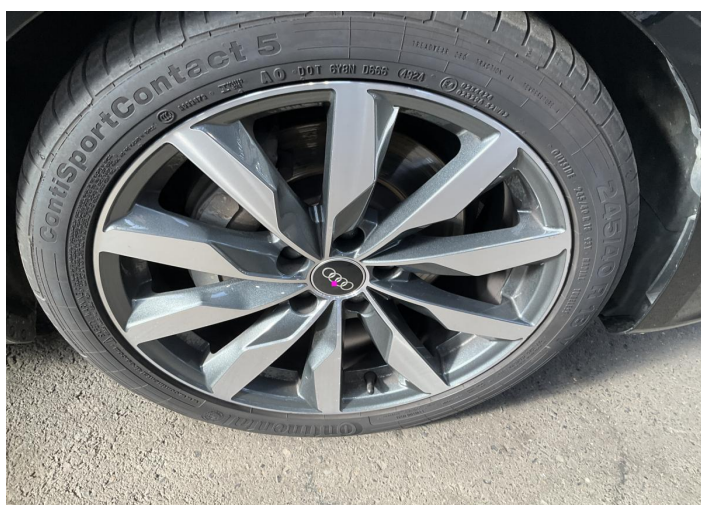
| 23 | Rim / Front Right | Out of Bodywork / Scratch |

23. Rim / Front Right  
Out of Bodywork / Scratch -
