Expertise

Protocol number: 41579437  
Order No. / Reference: 25145359  
Inspection date: 15 Sept 2025

Manufacturer: Audi  
VIN: WAUZZZFY2L2099022

Model: Q5 55 TFSI e quattro S tronic

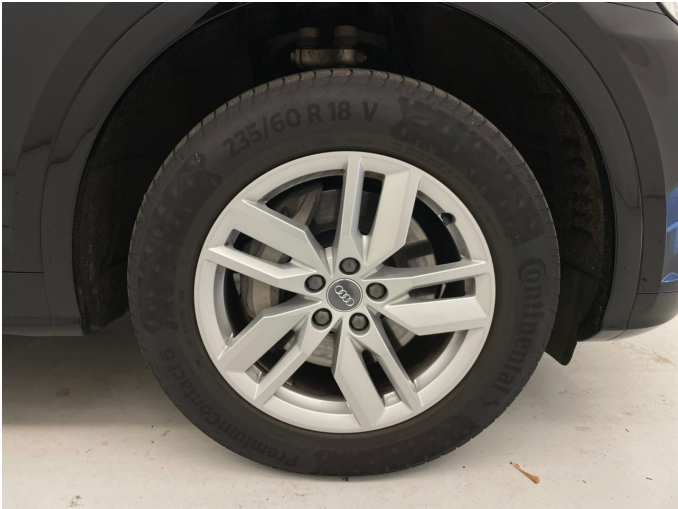
Figure 12: Mounted tyres

| # | Tyre size | Type of tyre | Manufacturer | Tread depth |
|---|---|---|---|---|
| 1) | 235/60 R18 103V | Summer tyres on Light alloy | Continental | 3mm / 3mm |
| 2) | 235/60 R18 103W | Summer tyres on Light alloy | Hankook | 7mm / 7mm |

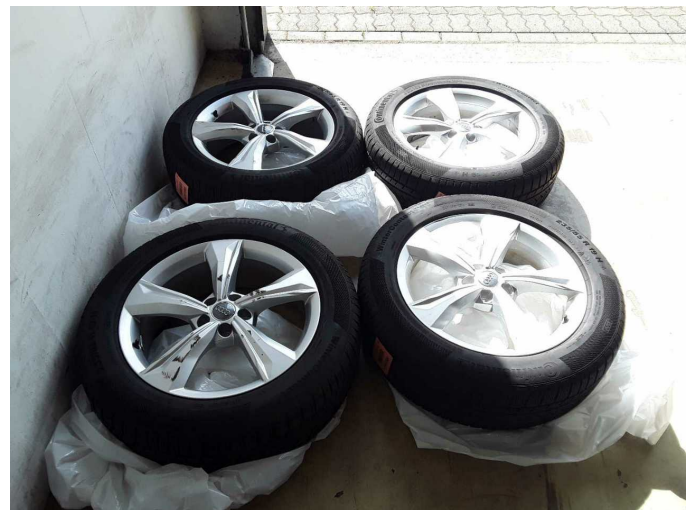
Figure 16: Additional tyres

| # | Tyre size | Type of tyre | Manufacturer | Tread depth |
|---|---|---|---|---|
| 1) | 235/55 R19 101H | Winter tyres on Light alloy | Continental | 6mm / 6mm |
| 2) | 235/55 R19 101H | Winter tyres on Light alloy | Continental | 8mm / 8mm |

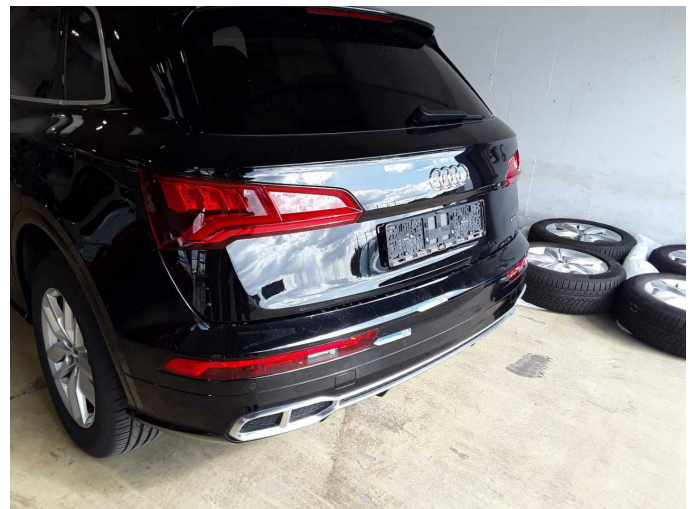
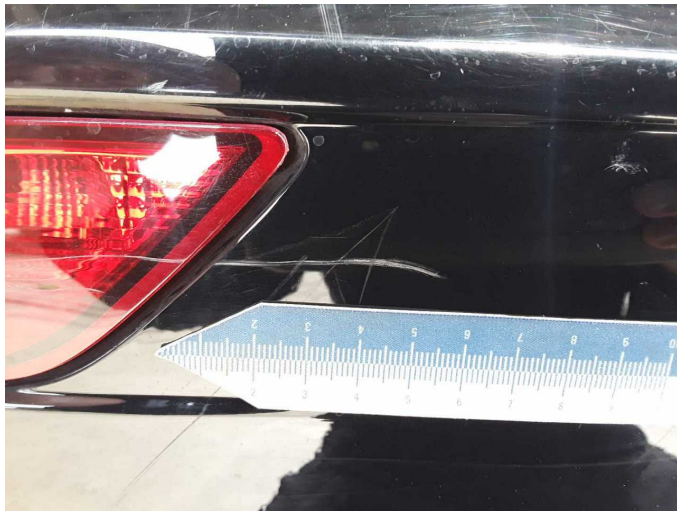
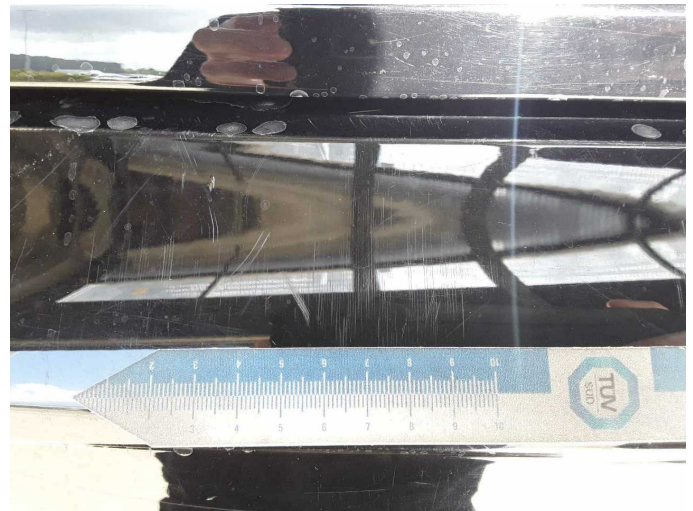
| No. | Component group | Description |
|---|---|---|
| 1 | Rear bumper | Rear bumper (ist bereits im Unfallschaden berücksichtigt) - Scratch(es) - No deduction |

**Damage 1:** Rear bumper: Rear bumper (ist bereits im Unfallschaden berücksichtigt) - Scratch(es) - No deduction

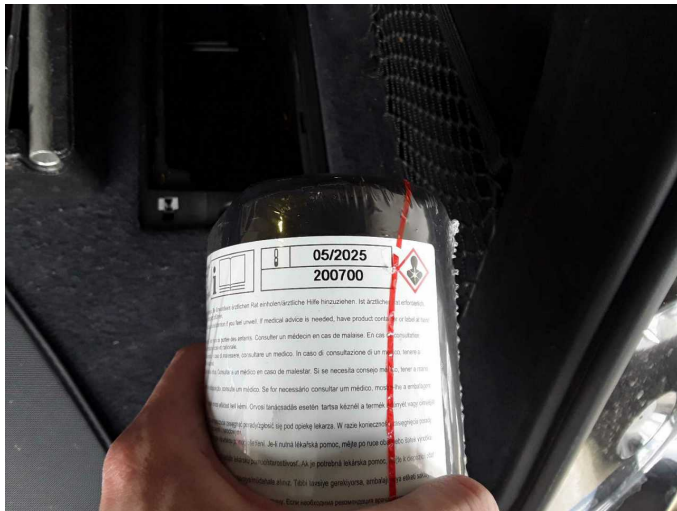
| No. | Component group | Description |
|---|---|---|
| 2 | Equipment | Tirefit filler - Expired - Replace |

**Damage 2:** Equipment: Tirefit filler - Expired - Replace

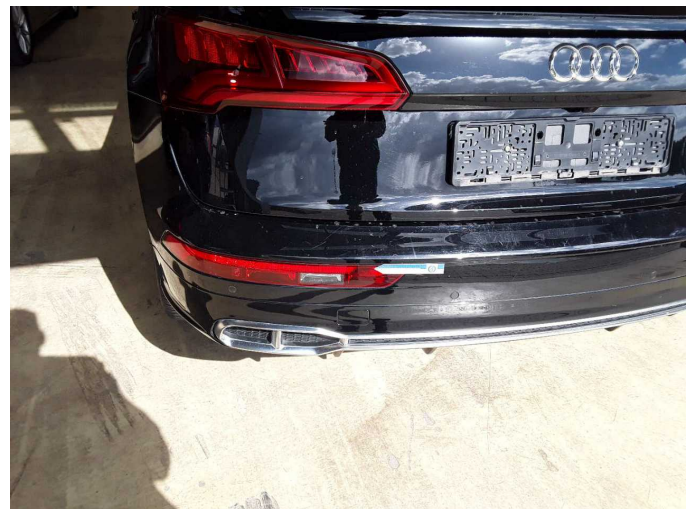
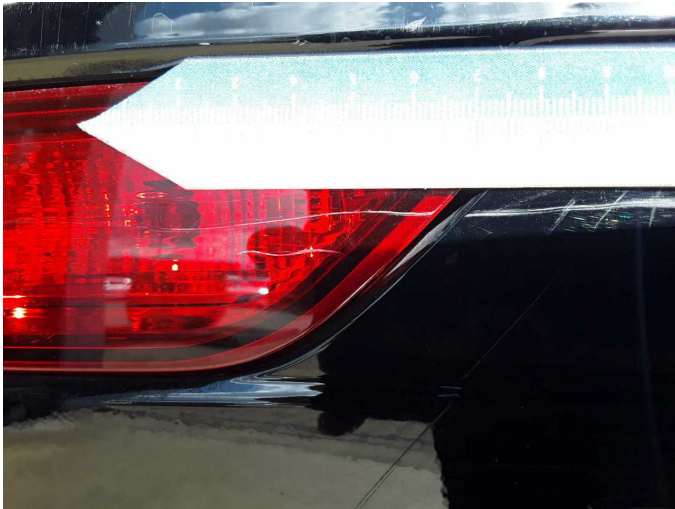
| No. | Component group | Description |
|---|---|---|
| 4 | Rear bumper | Reflector - left side - Scratch(es) - Replace |

**Damage 4:** Rear bumper: Reflector - left side - Scratch(es) - Replace

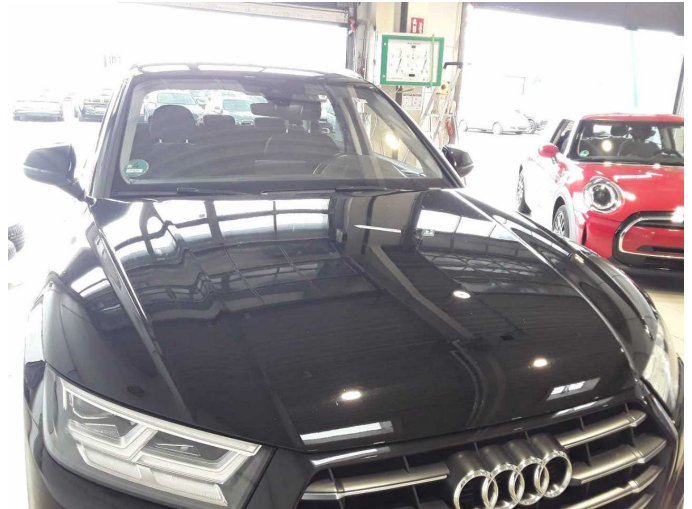
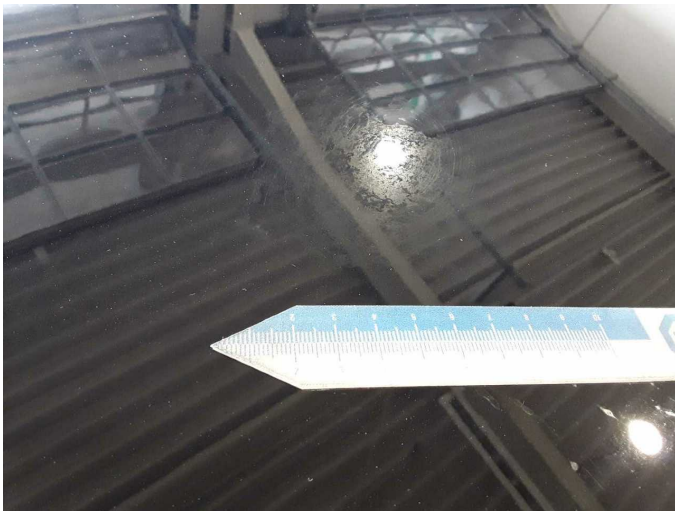
| No. | Component group | Description |
|---|---|---|
| 5 | Bonnet | Bonnet (Verätzungen) - Paint defect - Paint |

**Damage 5:** Bonnet: Bonnet (Verätzungen) - Paint defect - Paint

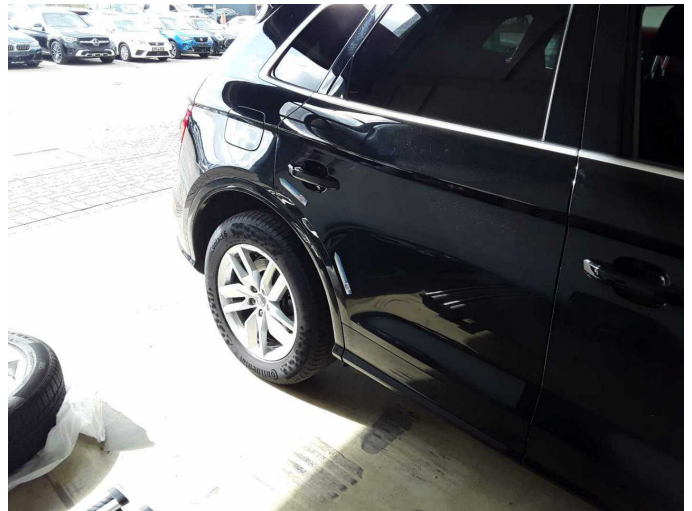
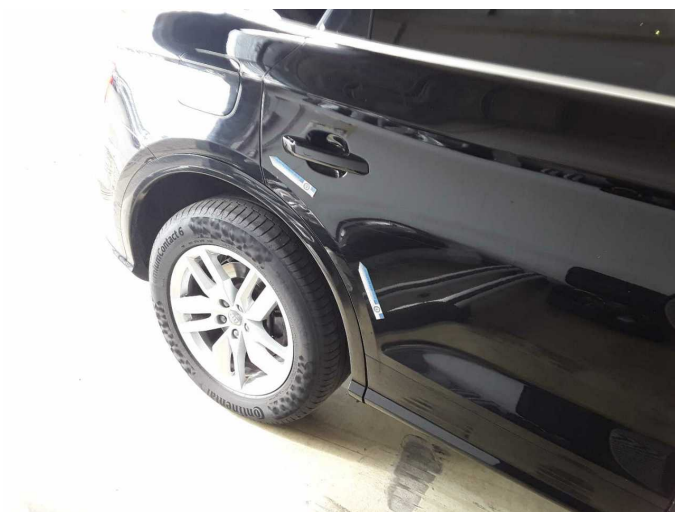
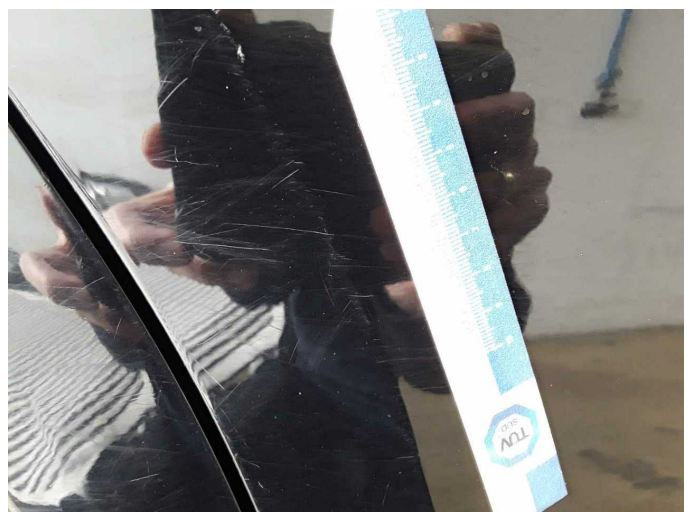
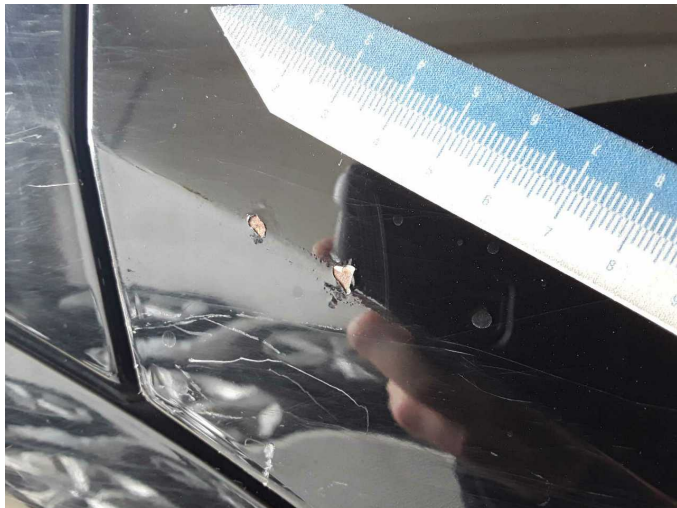
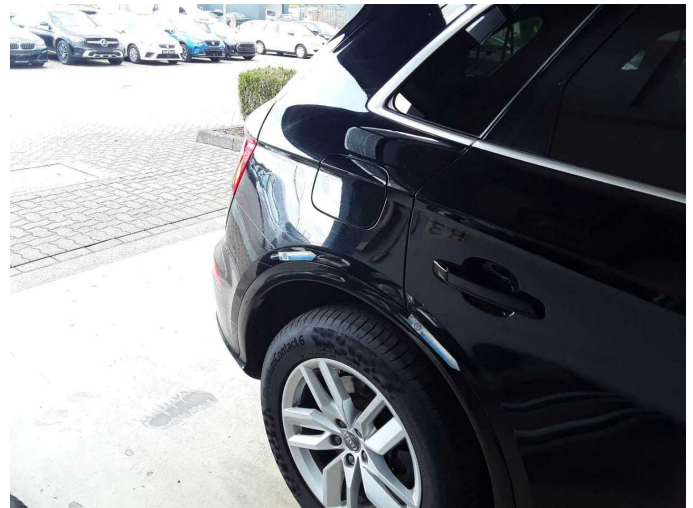
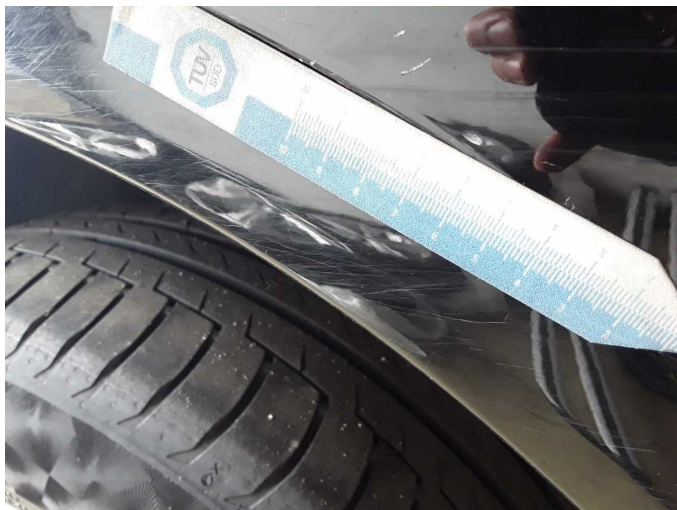
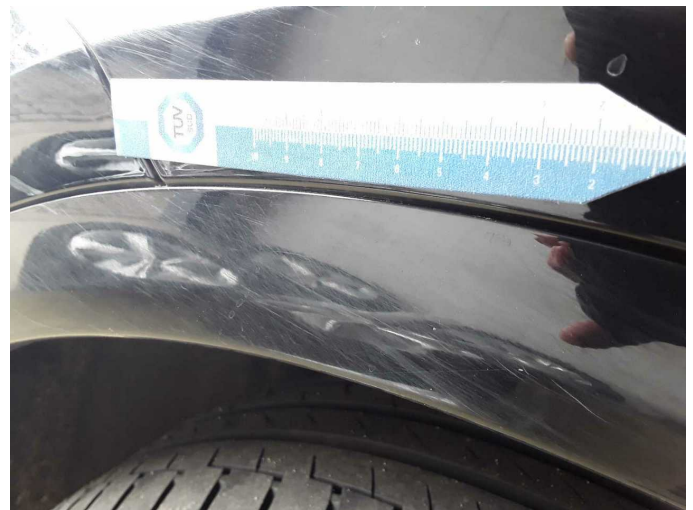
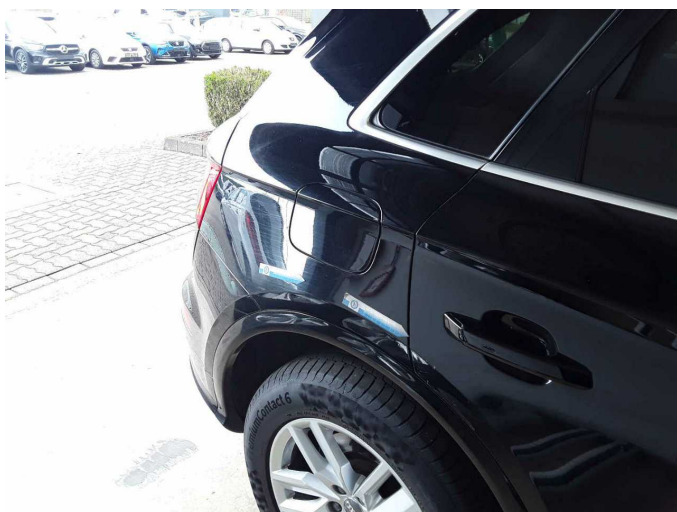
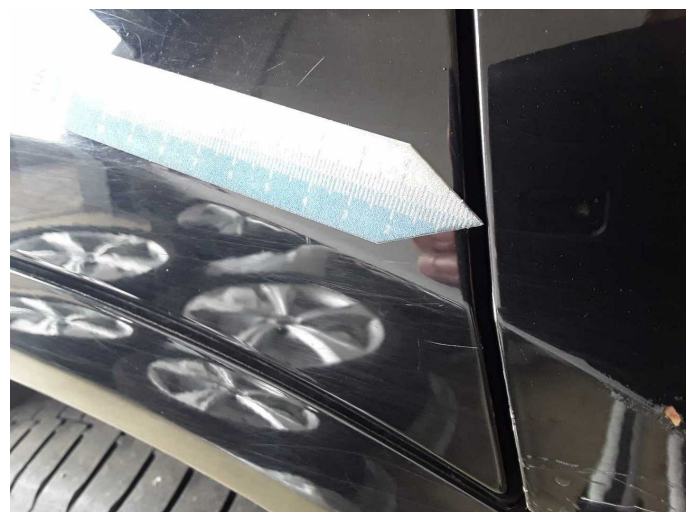
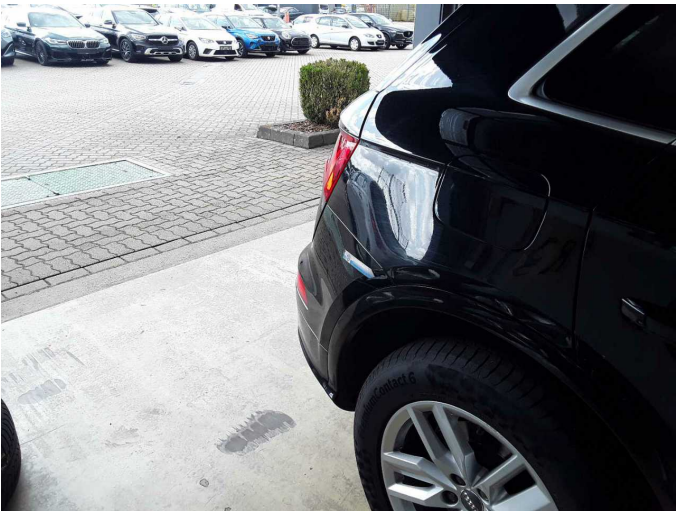
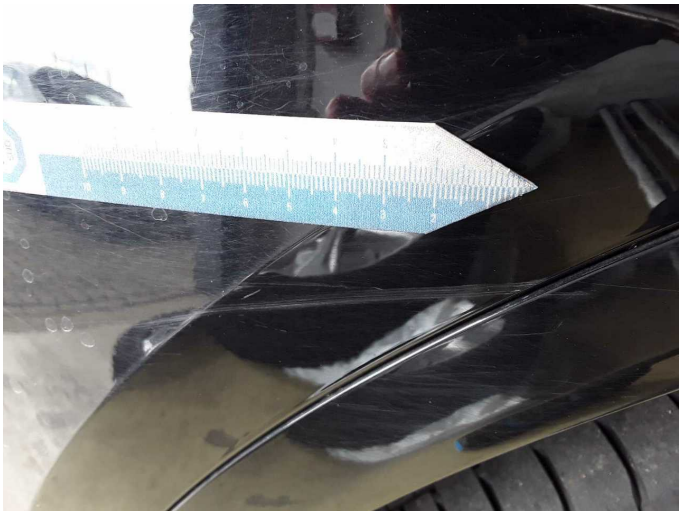
| No. | Accident |
|---|---|
| 1 | Side right |

**Accident 1:** Side right

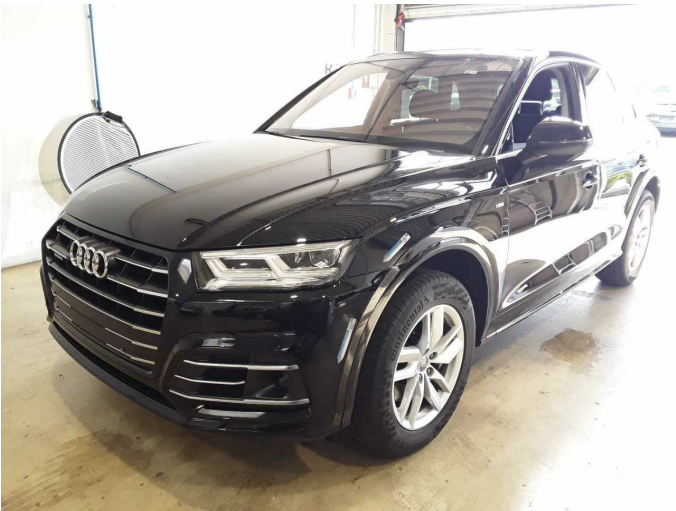
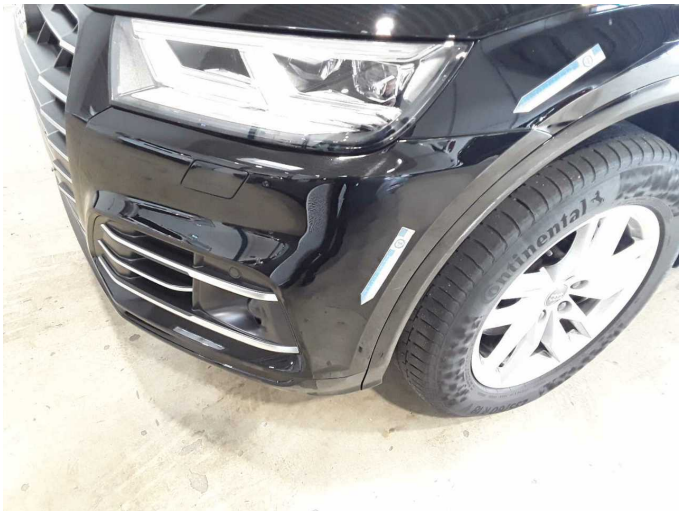
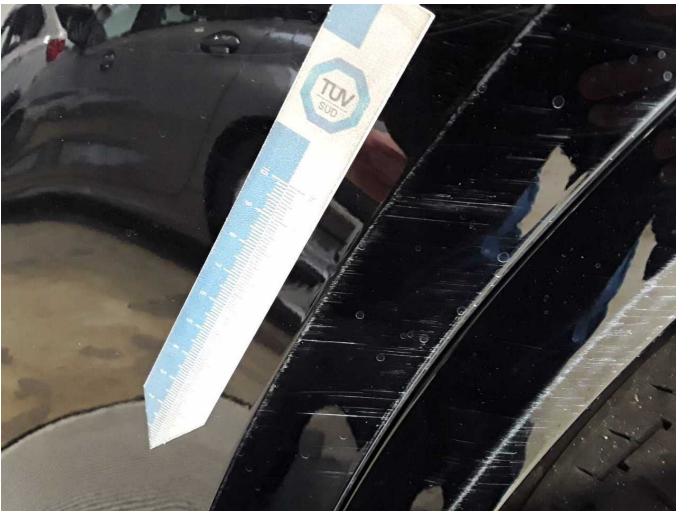
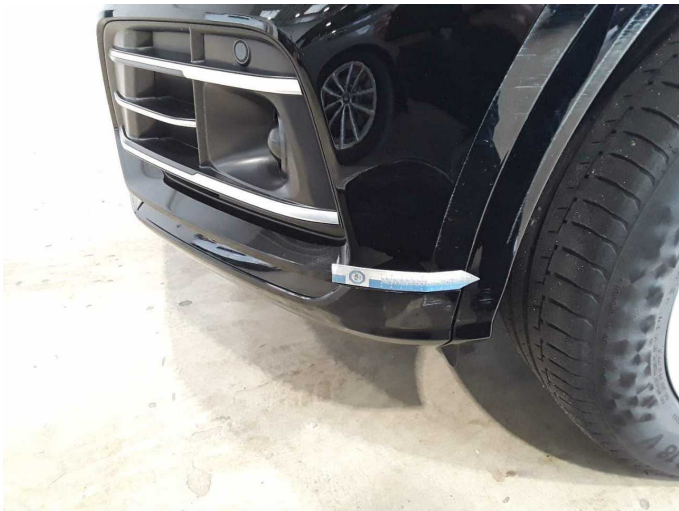
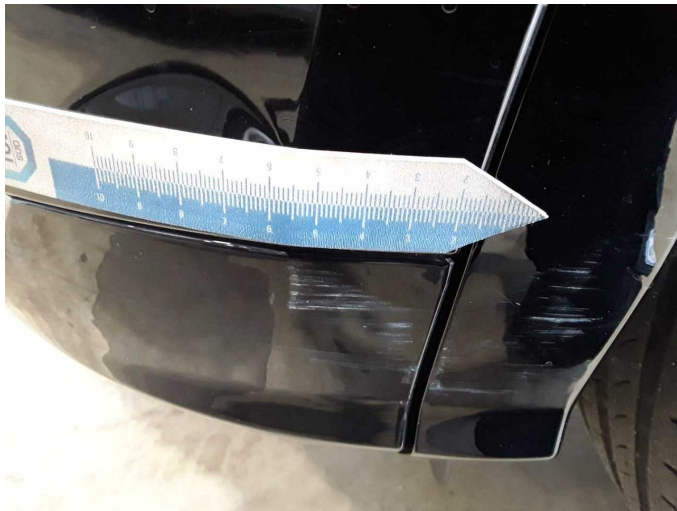
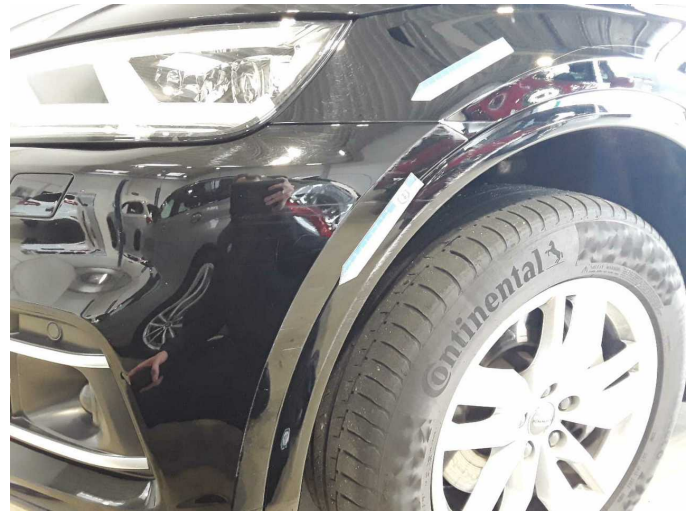
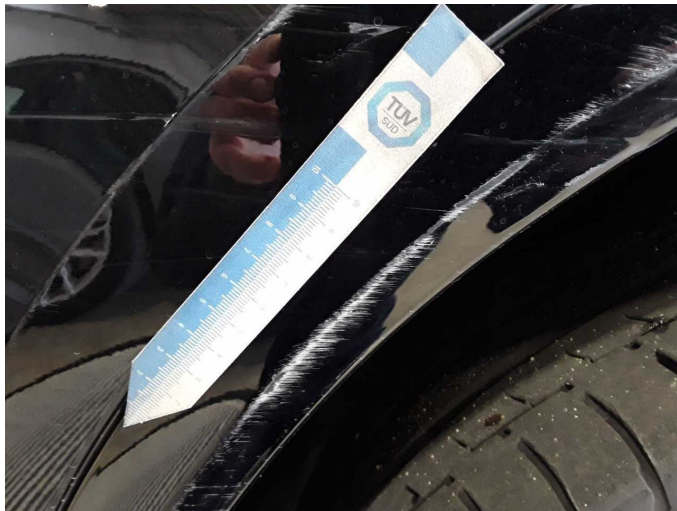
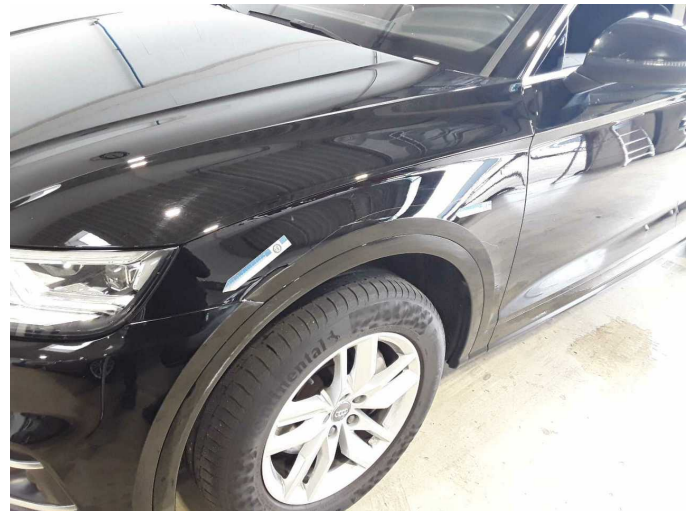
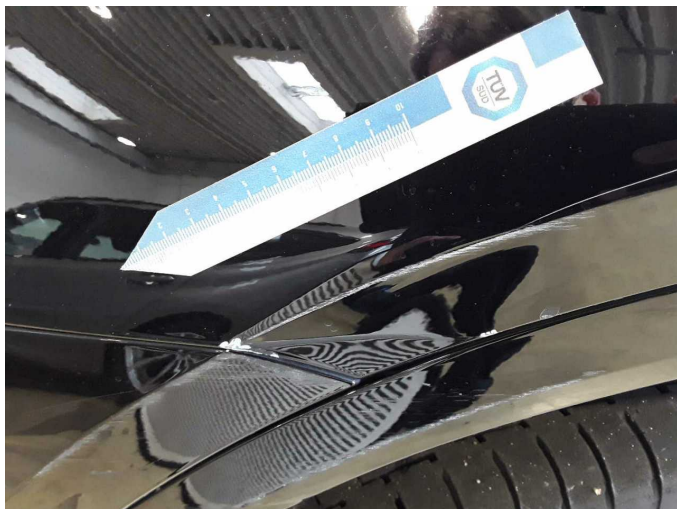
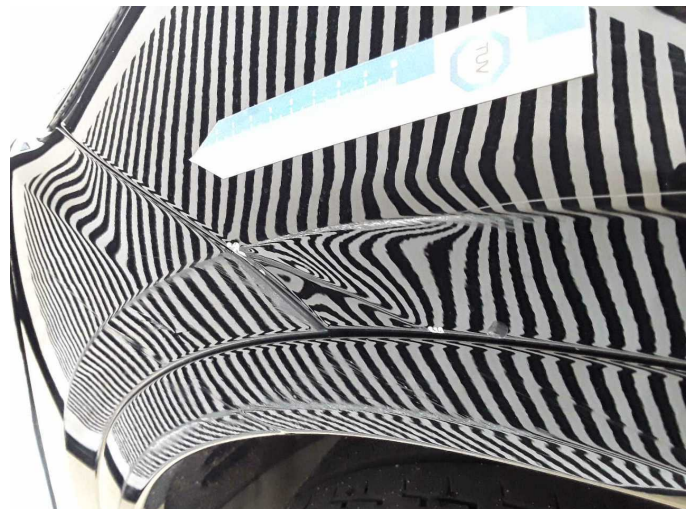
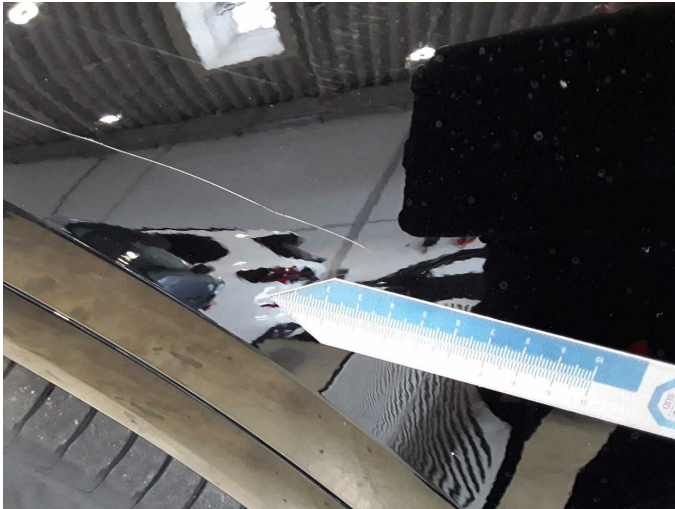
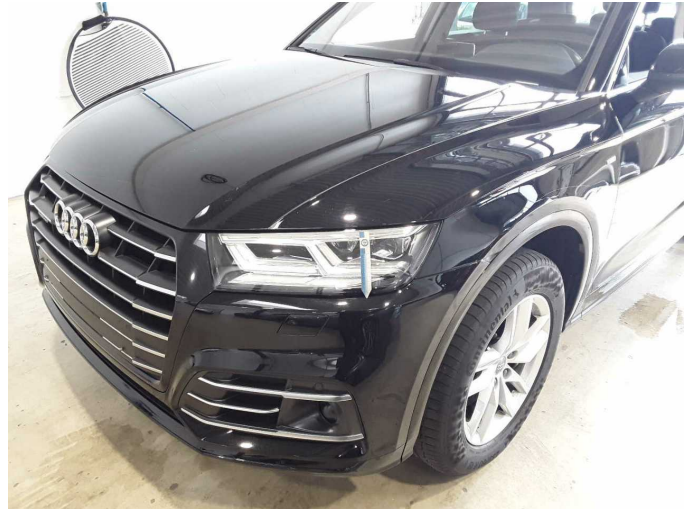
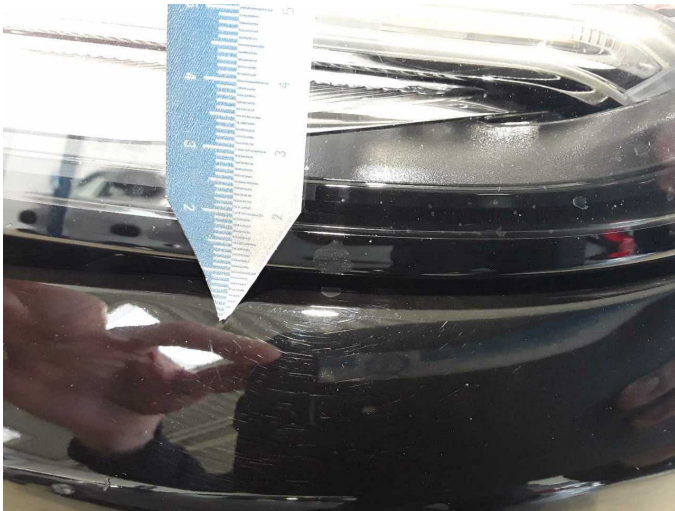
| No. | Accident |
|---|---|
| 2 | Side - left |

Accident 2: Side - left

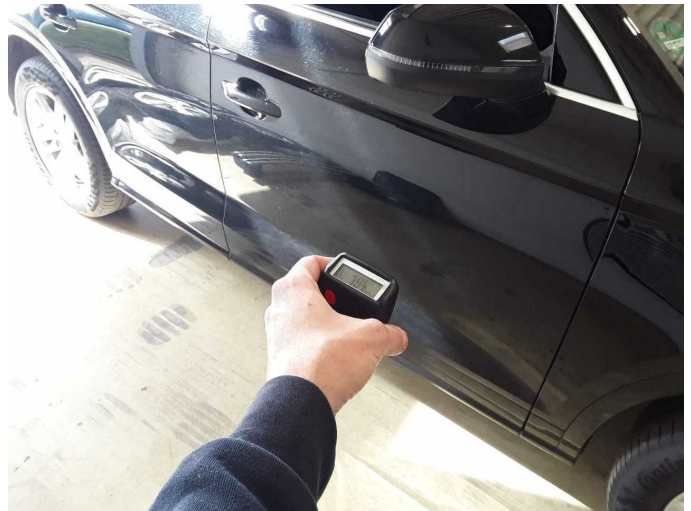
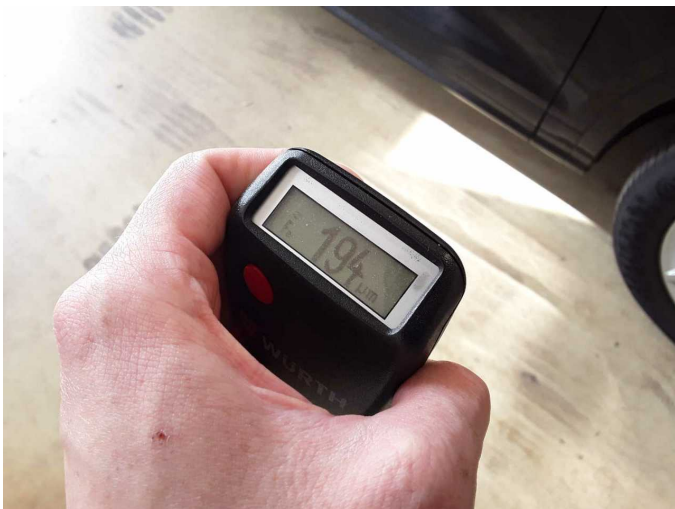
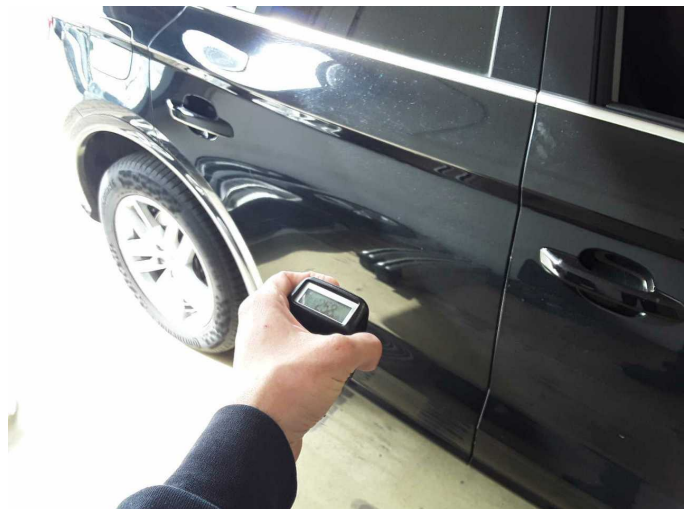
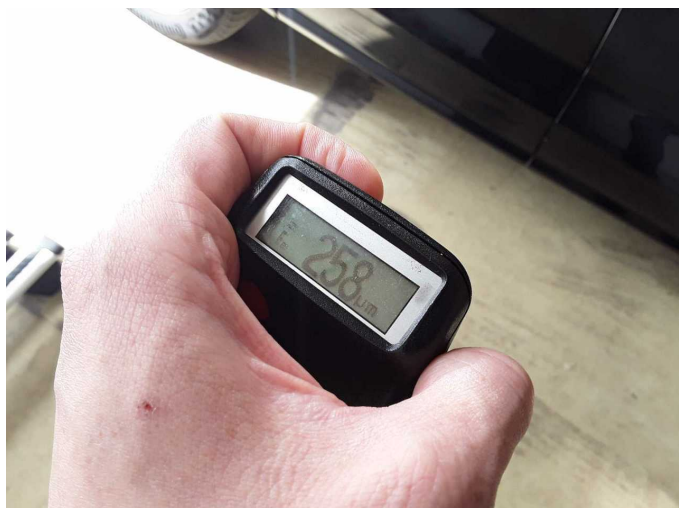
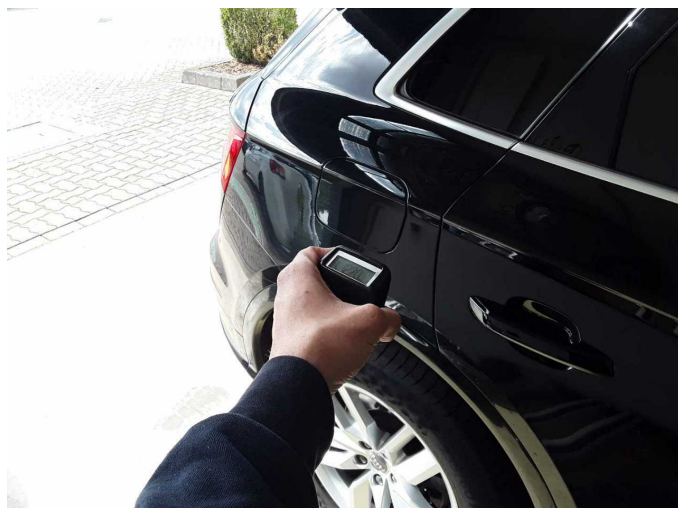
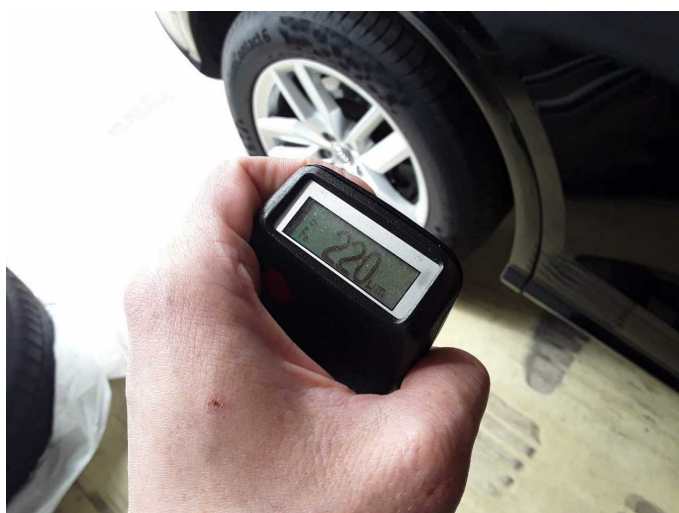
| No. | Repainting |
|---|---|
| 1 | Side panel - rear right side, Door - rear right side, Door - front right side, Professionally carried out, Invoice of repair done Non-existent |

| Side panel - rear right side | 220 µm | Door - rear right side | 250 µm |
| Door - front right side | 194 µm | | |

**Repainting 1:** Side panel - rear right side, Door - rear right side, Door - front right side
