Expertise

Protocol number: 41182827  
Order No. / Reference: 25065159  
Inspection date: 22 Aug 2025

Manufacturer: Audi	Model: Q5 40 TDI quattro S tronic
VIN: WAUZZZFY6N2088320

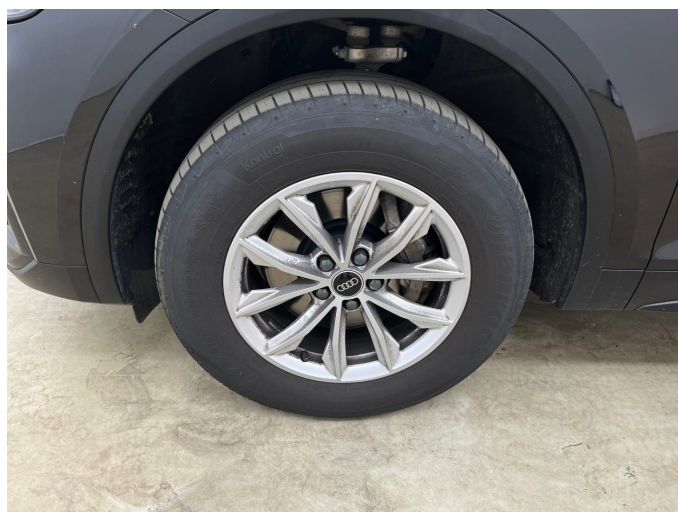
Tyres				
Mounted tyres				
#	Tyre size	Type of tyre	Manufacturer	Tread depth
1)	235/65 R17 104W	Summer tires (with run-flat tires) on Light alloy	Hankook	5mm / 5mm
2)	235/65 R17 104W	Summer tires (with run-flat tires) on Light alloy	Hankook	6mm / 6mm

Figure 12: Mounted tyres

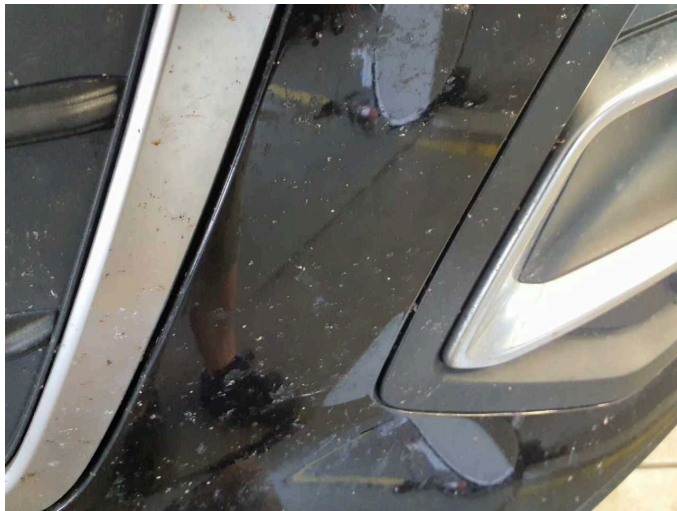
**Damage 1:** Front bumper: Front bumper - Stone chips - Paint

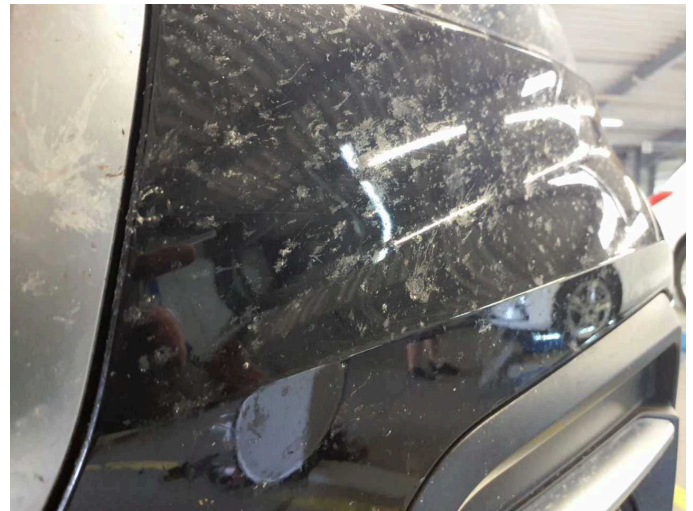
**Damage 1:** Front bumper: Front bumper - Stone chips - Paint

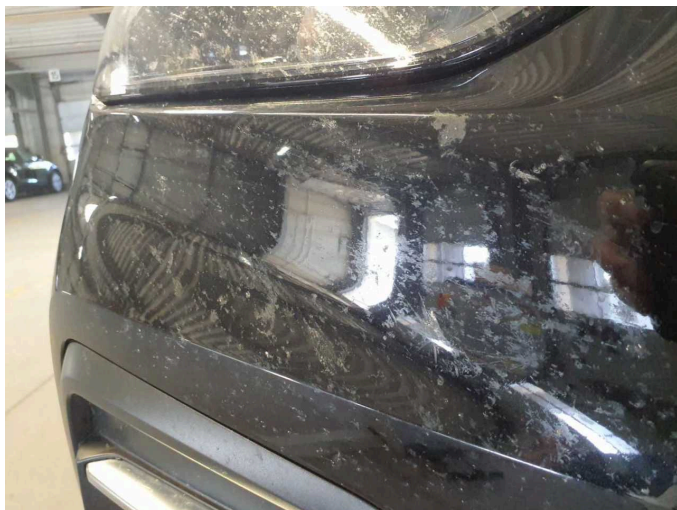
**Damage 1:** Front bumper: Front bumper - Stone chips - Paint
