Expertise

Protocol number: 41215625 Order No. / Reference: 24972730-1 Inspection date: 25 Aug 2025

Manufacturer: Audi

Model: Q2 35 TDI S tronic

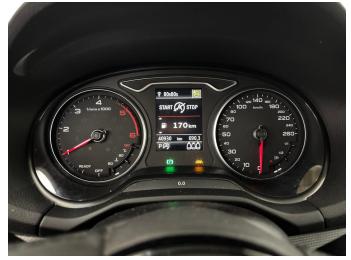
Vehicle details				
Manufacturer / Type / Model / Equipment				
Audi Q2 35 TDI S tronic				
Vehicle Identification number	WAUZZZGAXNA043033			
Mileage (Read)	40,930 km			
First registration	10 May 2022			
Number of holders	1			
Power / Engine displacement	110 kw / 1,968 ccm			
Fuel type / Cylinder	Diesel / 4			
Gearbox / Number of gears	Automatic / 7			
Type of drive	Front drive			
Type of vehicle	SUV			
Colour / colour code	Ibisweiss (Y9C)			
Doors / Seats	5/5			
Upholstery type	Cloth			
Colour of upholstery	Black-Anthracite			
Vehicle with smoke odor	no

Figure 7: Instrument cluster

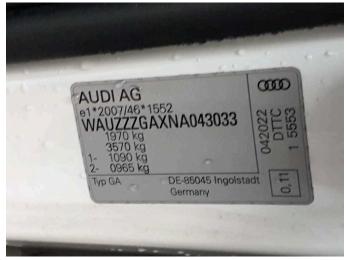
VIN comparison The vehicle identification number (VIN) was read from the vehicle and its conformity with the submitted

documents was verified during the inspection by the undersigned.

Figure 11: VIN

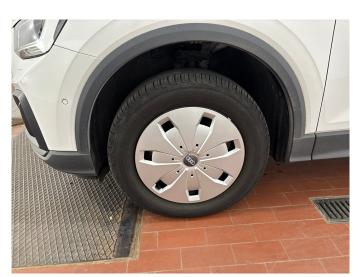
#	Tyre size	Type of tyre		Manufacturer		Tread depth
1)	205/60 R16 92V	Summer tyres on Steel rim with wheel co	over	Bridgestone		6mm / 6mm
2)	205/60 R16 92V	Summer tyres on Steel rim with wheel cover Bridgeston		Bridgestone		6mm / 6mm
Add	itional tyres

Figure 12: Mounted tyres

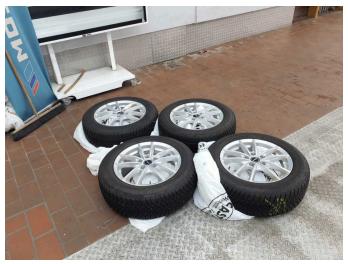
#	Tyre size	Type of tyre		Manufacture	r	Tread depth
1)	205/60 R16 96H	Winter tyres on Light alloy		Dunlop		7mm / 7mm
2)	205/60 R16 96H	Winter tyres on Light alloy		Dunlop		7mm / 7mm
Repl	acement					
Тур	Tyre size	Type of tyre		Manufacture	r	Tread depth
	Tirefit	Expiration date 03/2026

Figure 15: Additional tyres

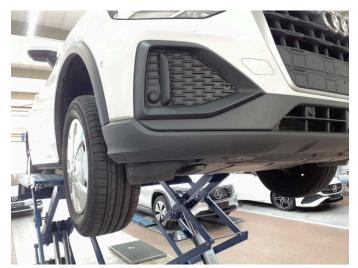
Damage 1: Front bumper: Spoiler - Scratched - Loss in value

No.	Component group	Description
1	Front bumper	Spoiler - Scratched - Loss in value
2	Body	Body - Damage by hail - repair according to calculation

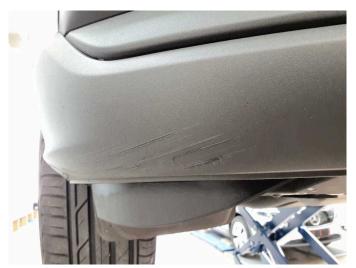
Damage 1: Front bumper: Spoiler - Scratched - Loss in value

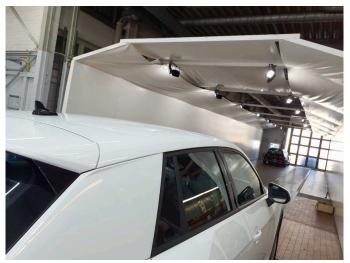
Damage 2: Body: Body - Damage by hail - repair according to calculation

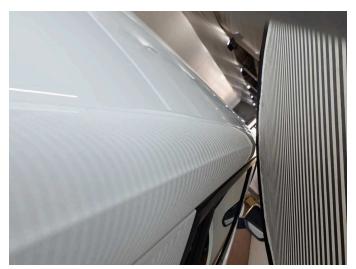
Damage 2: Body: Body - Damage by hail - repair according to calculation Damage 2: Body: Body - Damage by hail - repair according to calculation

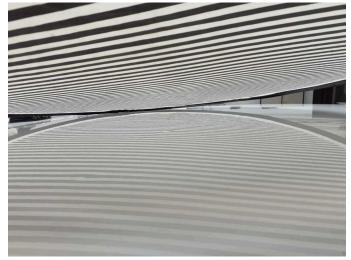
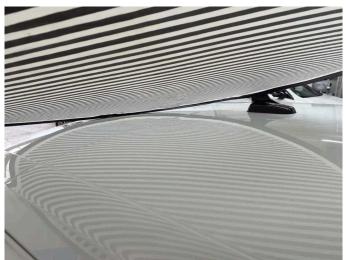
Damage 2: Body: Body - Damage by hail - repair according to calculation Damage 2: Body: Body - Damage by hail - repair according to calculation

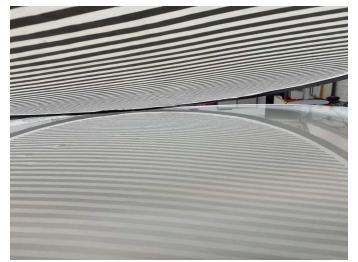
Damage 2: Body: Body - Damage by hail - repair according to calculation Damage 2: Body: Body - Damage by hail - repair according to calculation

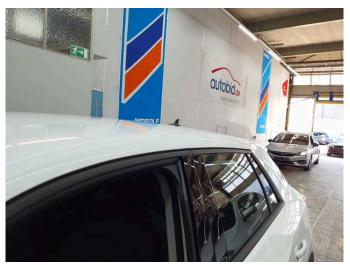
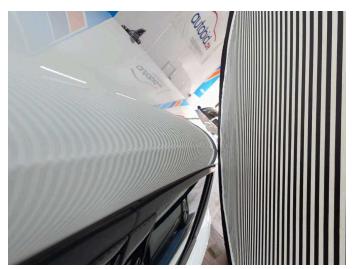
Damage 2: Body: Body - Damage by hail - repair according to calculation
