## Vehicle details

| Licence Plate | J9-45-NV | Model | A1 Sportback 30 TFSI Pro Line S 5d | Maintenance mileage | - |

## Inspection Details

| Inspection date | 15/09/2025 | Inspection loc. | Ayvens Veghel |

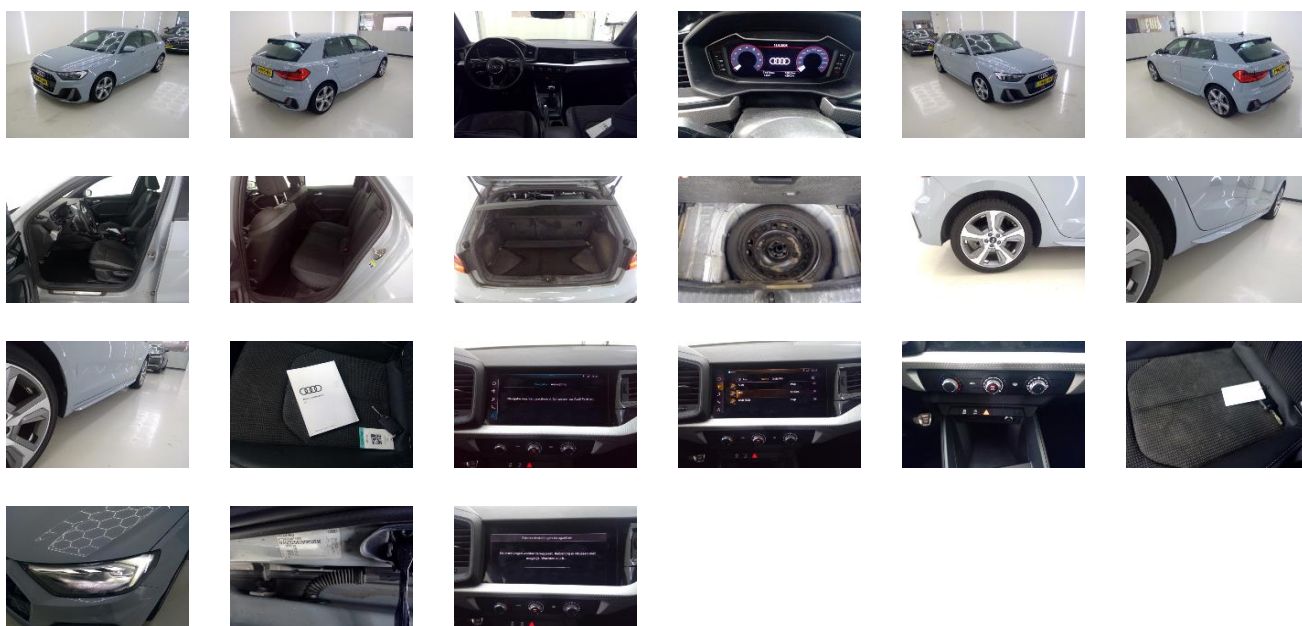
| 1 | | Part: Bumper<br>Position: Front<br>Damages: Scratched<br>Severity: Length (cm) > 10<br>Repair mode: Repair | 2 | | Part: Bonnet<br>Position: -<br>Damages: Chemical deposit<br>Severity: -<br>Repair mode: Lumpsum repair |
| 5 | | Part: Bumper<br>Position: Back<br>Damages: Scratched<br>Severity: Length (cm) > 10<br>Repair mode: Repair | 10 | | Part: Alloy wheel 17"<br>Position: Front left<br>Damages: Scratched<br>Severity: -<br>Repair mode: Lumpsum repair |
| 11 | | Part: Alloy wheel 17"<br>Position: Back left<br>Damages: Scratched<br>Severity: -<br>Repair mode: Lumpsum repair | 12 | | Part: Tailgate / Boot door<br>Position: -<br>Damages: Chemical deposit<br>Severity: -<br>Repair mode: Lumpsum repair |
| 13 | | Part: Roof<br>Position: -<br>Damages: Chemical deposit<br>Severity: -<br>Repair mode: Lumpsum repair | | | |

| 3 | | Part: Other interior<br>Position: -<br>Damages: Stained/dirty<br>Severity: -<br>Repair mode: Cleaning<br>gerookt in voertuig | | | |
| 4 | | Part: Other interior<br>Position: -<br>Damages: Stained/dirty<br>Severity: -<br>Repair mode: Cleaning<br>hond in voertuig | 6 | | Part: Interior tailgate lining<br>Position: Up<br>Damages: Scratched<br>Severity: -<br>Repair mode: Replace |
| 7 | | Part: Interior tailgate lining<br>Position: Down<br>Damages: Scratched<br>Severity: -<br>Repair mode: Replace | 8 | | Part: Interior cleaning<br>Position: Front<br>Damages: Stained/dirty<br>Severity: -<br>Repair mode: Cleaning |
