Expertise

Protocol number: 41680379  
Order No. / Reference: 25223377  
Inspection date: 24 Sept 2025

Manufacturer: Audi  
VIN: WAUZZZGY4RA026179

Model: A3 35 TFSI Limousine S tronic

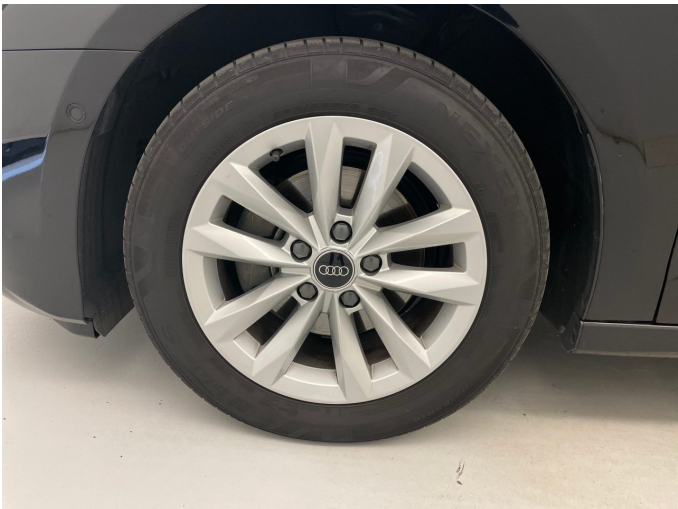
#	Tyre size	Type of tyre	Manufacturer	Tread depth
1)	205/55 R16 91V	Summer tyres on Light alloy	Nexen	5mm / 5mm
2)	205/55 R16 91V	Summer tyres on Light alloy	Nexen	6mm / 6mm

Figure 12: Mounted tyres

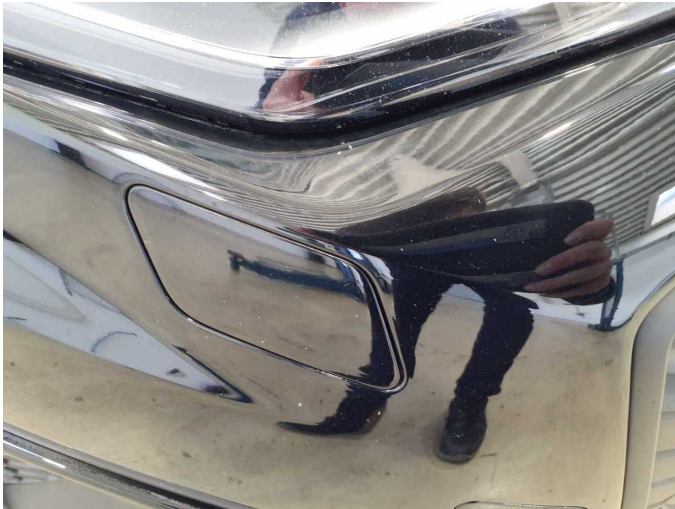
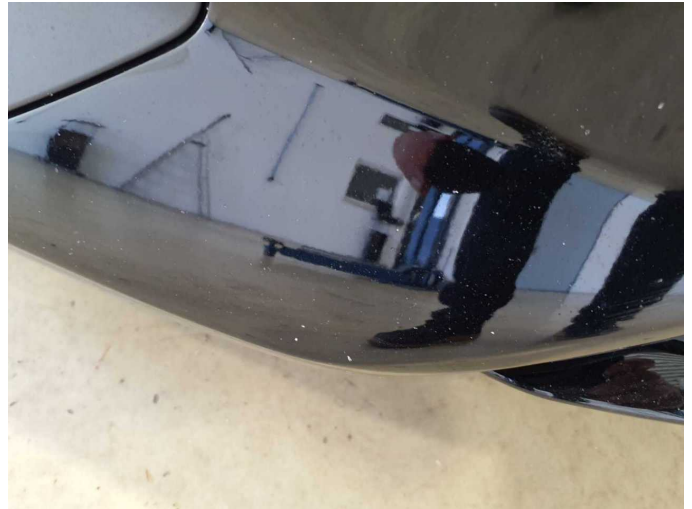
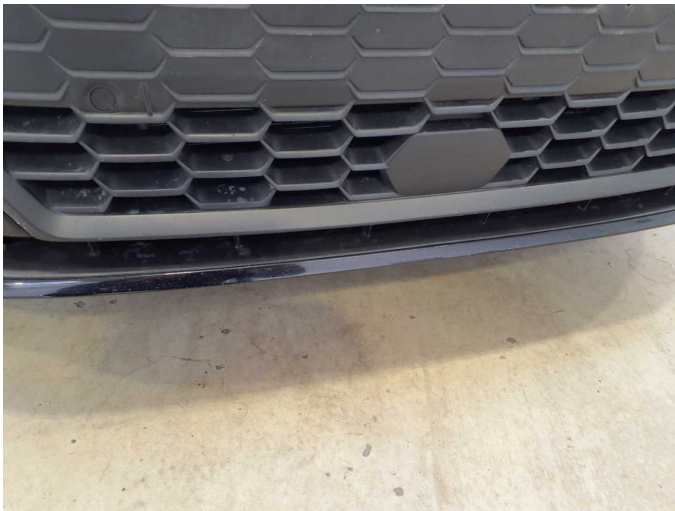
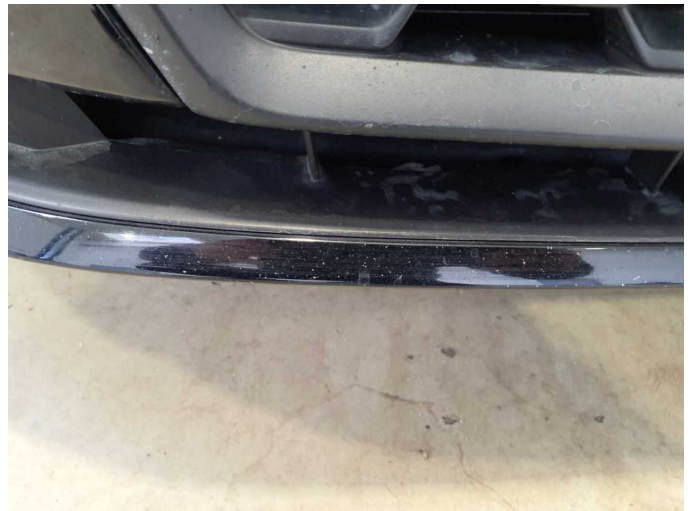
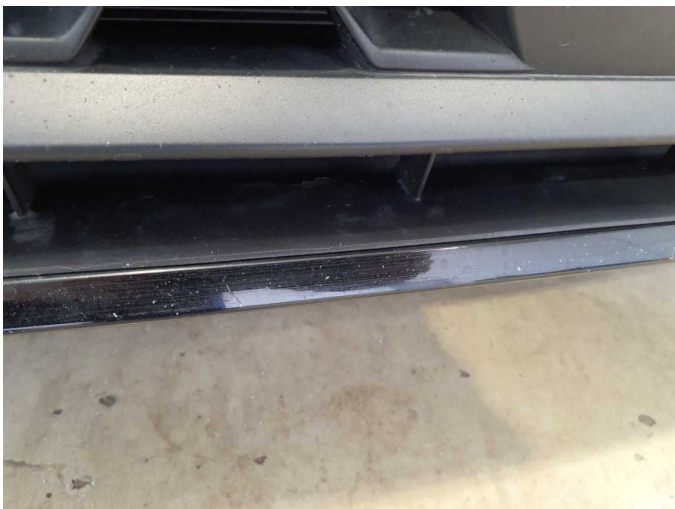
No.	Component group	Description
1	Front bumper	Front bumper - Stone chips - Paint
2	Mudguard - left side	Mudguard - left side (Schleifspuren) - Unprofessionally repaired - Paint
3	Bonnet	Bonnet - Stone chips - Paint

Damage 1: Front bumper: Front bumper - Stone chips - Paint

**Damage 1:** Front bumper: Front bumper - Stone chips - Paint

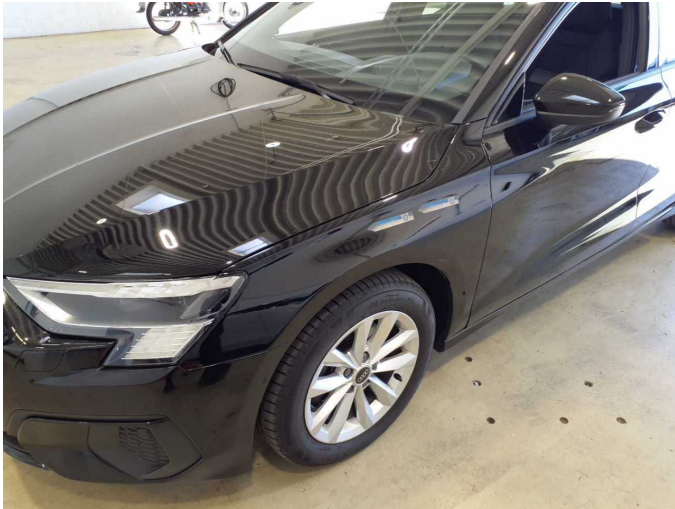
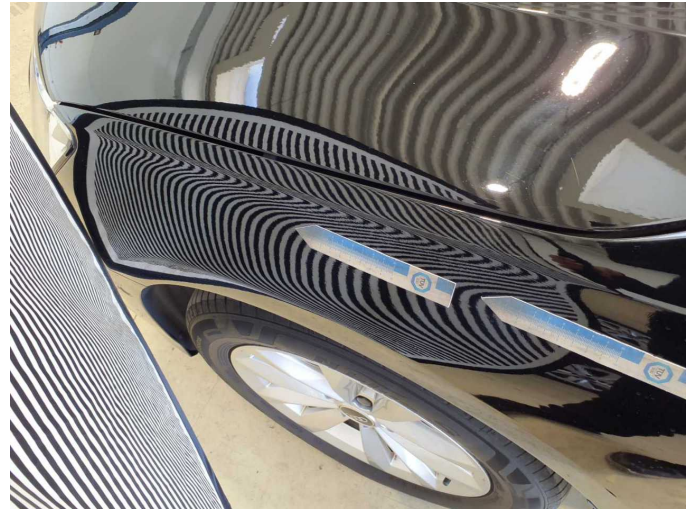
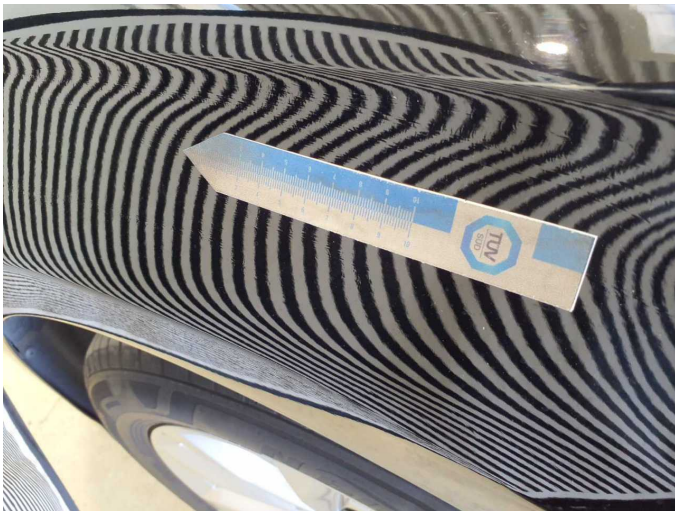
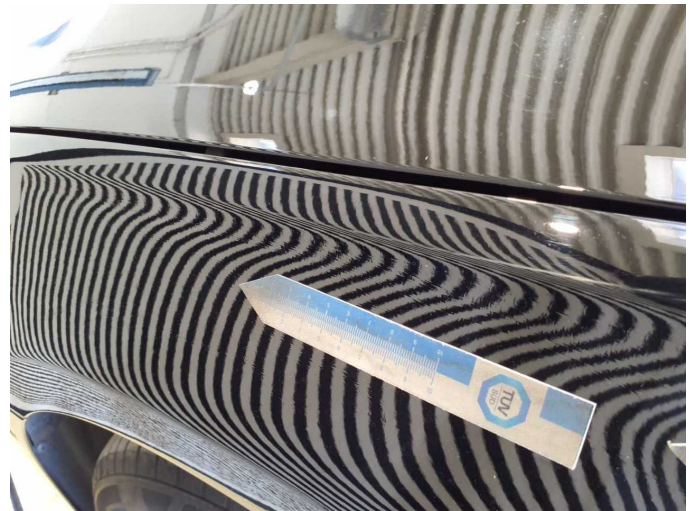
Mudguard - left side	527 µm
----------------------	--------

**Damage 1:** Front bumper: Front bumper - Stone chips - Paint

**Damage 2:** Mudguard - left side: Mudguard - left side (Schleifspuren) - Unprofessionally repaired - Paint

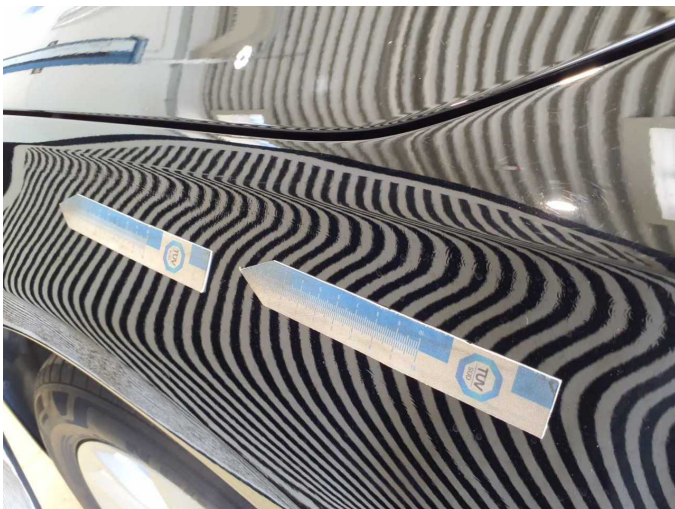
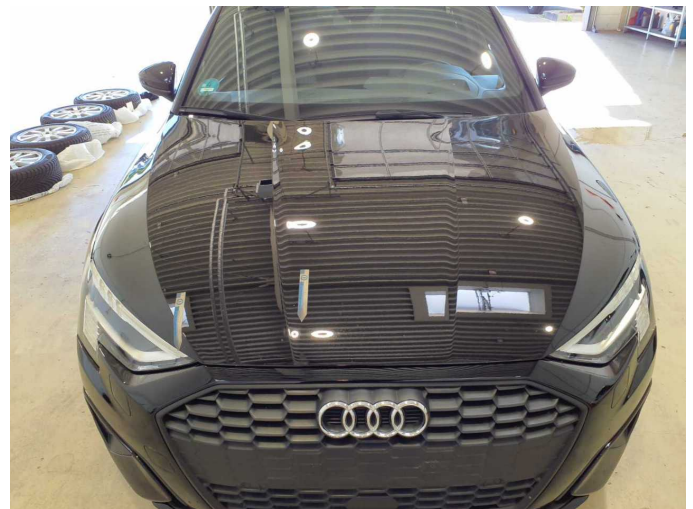
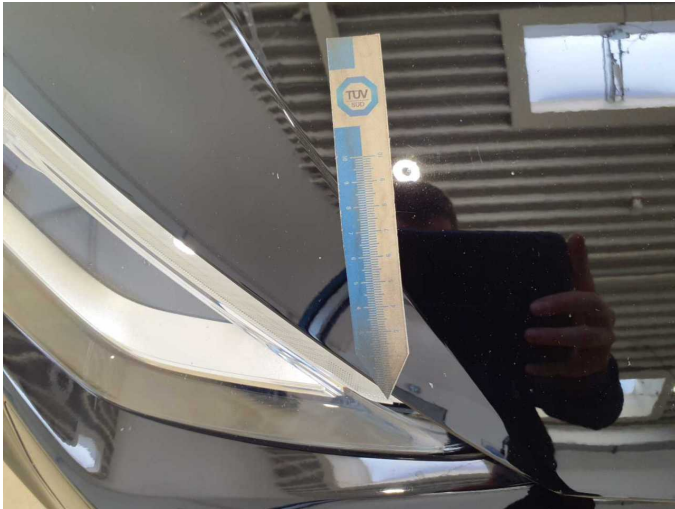
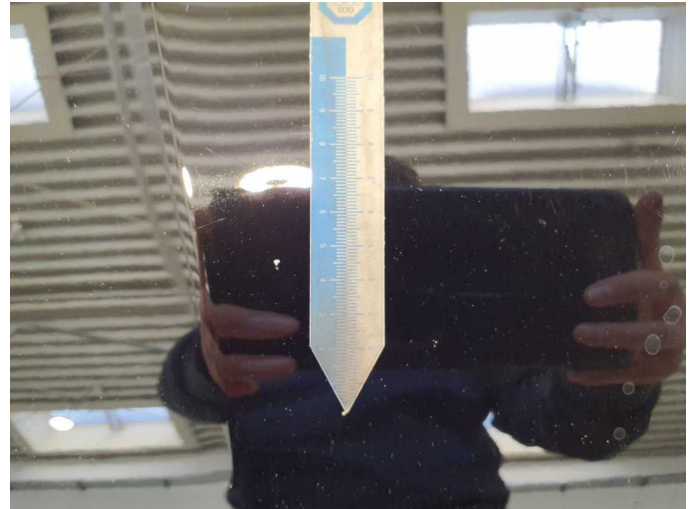
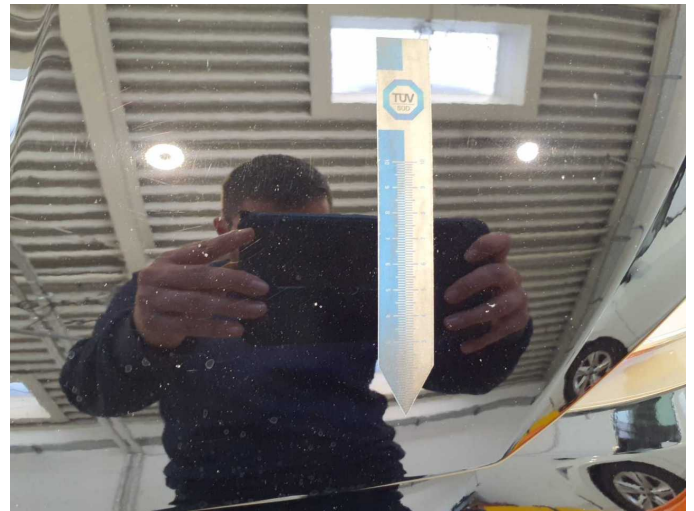
**Damage 2:** Mudguard - left side: Mudguard - left side (Schleifspuren) - Unprofessionally repaired - Paint

**Damage 3:** Bonnet: Bonnet - Stone chips - Paint

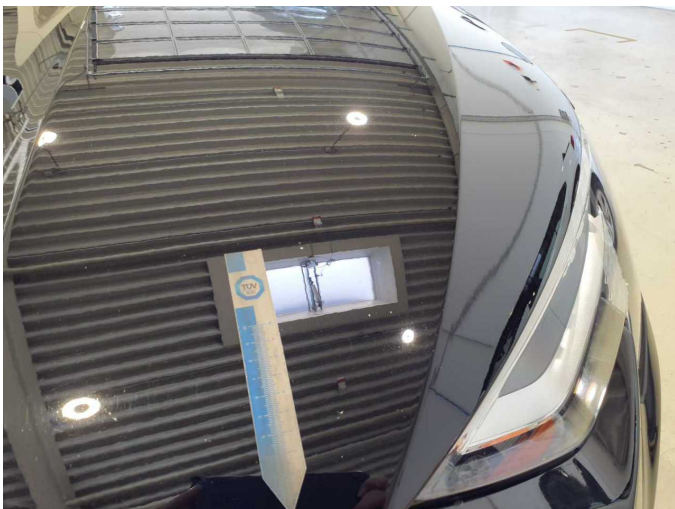
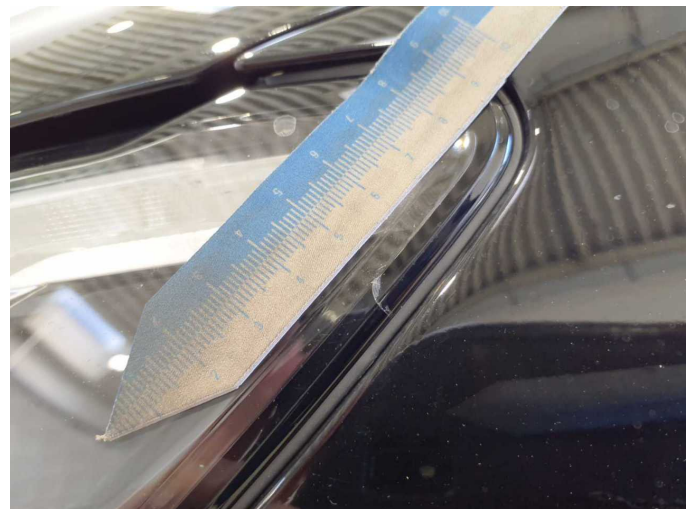
No.	Component group	Description
1	Door - front left side	Door - dent(s) - No deduction
2	Vehicle glazing	Windscreen - Stone chips - No deduction
3	Mudguard - right side	Mudguard - right side - Stone chips - No deduction
4	Headlight	Headlight - left side (außerhalb Streubereich) - Stone chips - No deduction

**Damage 3:** Bonnet: Bonnet - Stone chips - Paint

**Wear and tear 4:** Headlight: Headlight - left side (außerhalb Streubereich) - Stone chips - No deduction
