MERCEDES-BENZ A-Klasse A 180 d 7G DCT

Inspection Report Summary

Customer	BCA Online	Report Number	P20250925100628
Inspection Date / Place	2025-09-25 / BCA Neuss	Cosmetic Grade	2

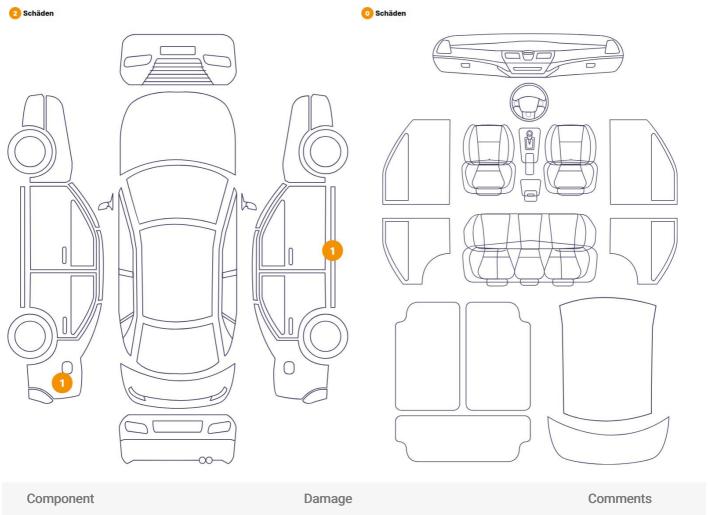
Component	Damage	Comments
1 Fender / Back Left	Paint / Poor Previous Repair	
2 Rocker Panel / Center Right	Paint / Scratch / Scuff

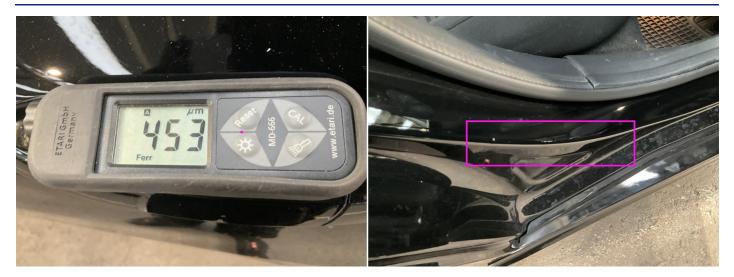
1. Fender / Back Left Paint / Poor Previous Repair -

2. Rocker Panel / Center Right Paint / Scratch / Scuff -
