## X200LN

X200LN · 2.0 TDCI 130pk 310 L2H1 Automaat S&S Titanium + luchtvering · 17  
September 2025 · Schiphol

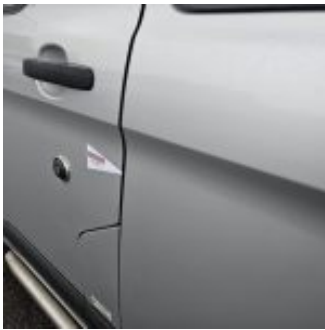
Fender – Rear Left

Small scratch(es)

Acceptable

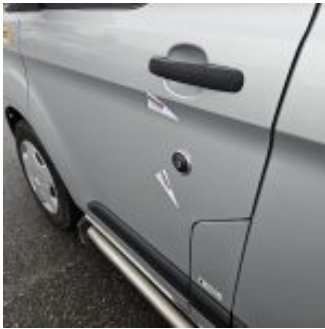
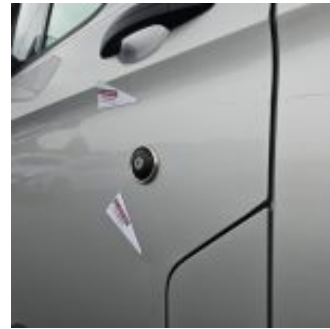
Frontdoor – Left

small dents / small scratches

Restyle / Polish

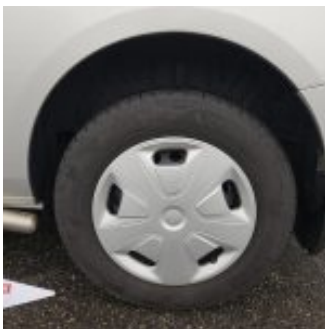
Wheelcover - Left Rear

Small scratch(es)

Acceptable

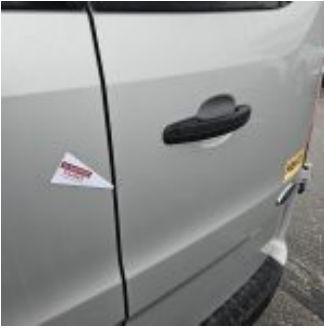
| Cargodoor - Right | Small dent(s) | Acceptable | Yes |

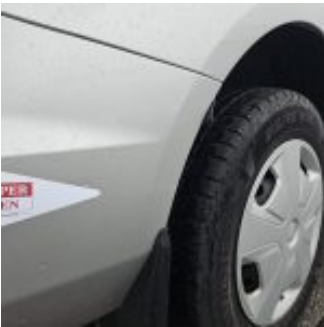
| Bumper - Rear | Small scratch(es) | Acceptable | Yes |

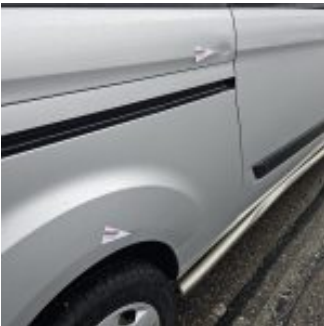
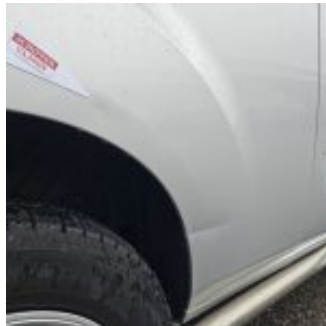
| Fender - Rear Right | Dent(s) & Scratch(es) | Panelbeating & Spray | No |

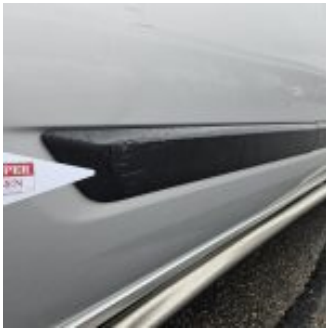
| Damage Part | Damage Type | Notes | Repair Type | Acceptable |
|---|---|---|---|---|
| Reardoor – Right | Scratch(es) | Stootlijst<br>krassen | Replace | No |

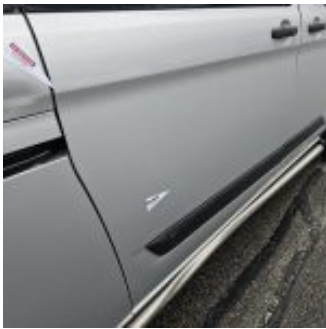
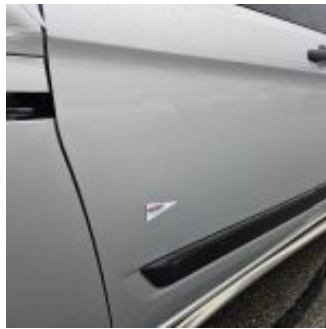
| Damage Part | Damage Type | Repair Type | Acceptable |
|---|---|---|---|
| Reardoor – Right | Scratch(es) | Spray | No |

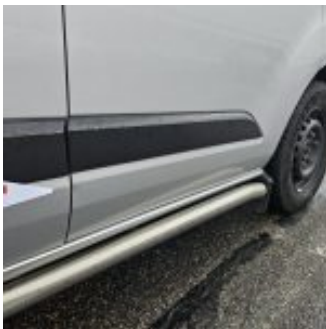
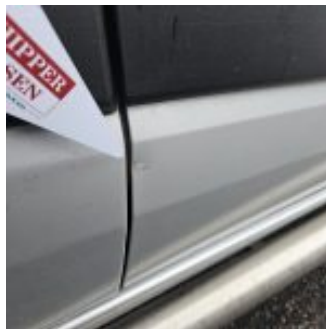
| Damage Part | Damage Type | Repair Type | Acceptable |
|---|---|---|---|
| Frontdoor – Right | Small dent(s) | Panelbeating &<br>Spotrepair | No |

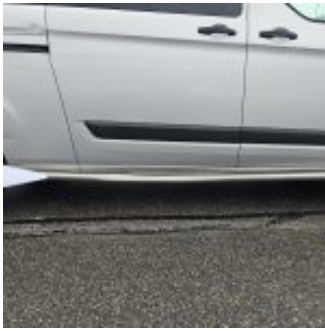
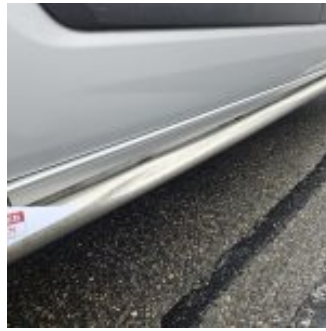
| Damage Part | Damage Type | Notes | Repair Type | Acceptable |
|---|---|---|---|---|
| Other | Dent(s) | Sidebar rechts vervormd | Replace | No |

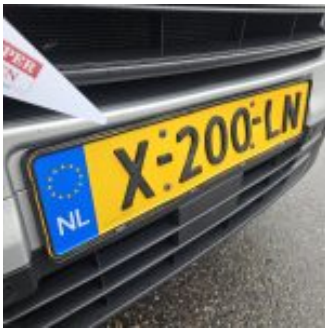
| Damage Part | Damage Type | Notes | Repair Type | Acceptable |
|---|---|---|---|---|
| Other | Dislocated / Loose | Kentekenplaat voorzijde vervormd | Replace | No |

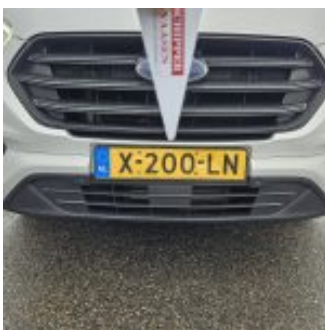
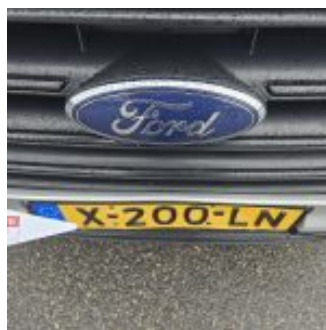
| Damage Part | Damage Type | Repair Type | Acceptable |
|---|---|---|---|
| Bumper – Front | Dent(s) | Panelbeating & Spray | No |

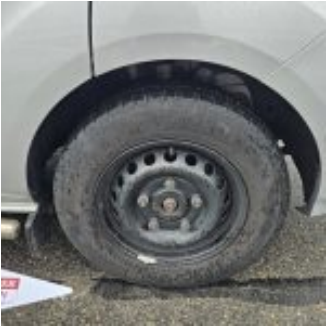
| Damage Part | Damage Type | Repair Type | Acceptable |
|---|---|---|---|
| Wheelcover - Right Front | Missing | Replace | No |
