# FORD Ka

VIN NO WF0BXXWPRBYR29958  
Registration Number PRBYR29958

## Inspection Report Summary

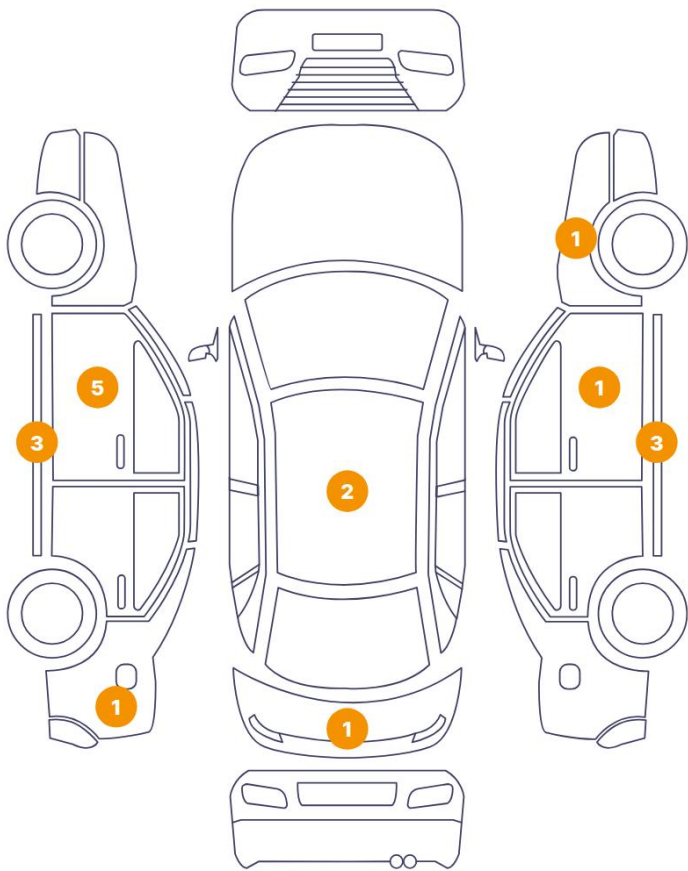
17 Schäden

| Component | | Damage | Comments |

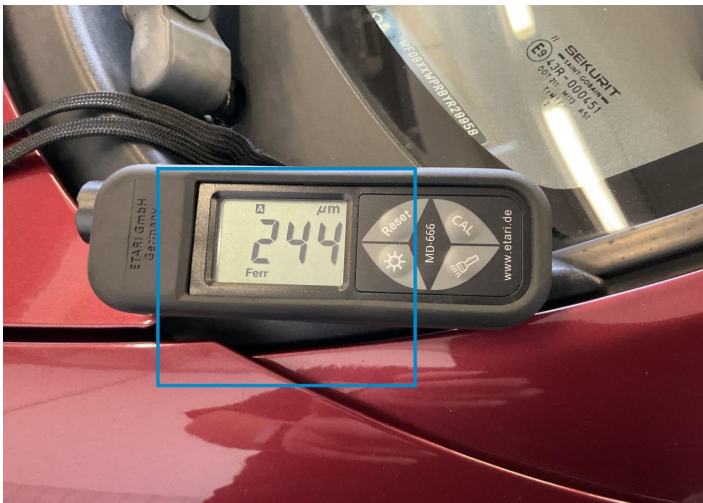
| Component | | Damage | Comments |
|---|---|---|---|
| 1 | Door / Front Left | Paint / Poor Previous Repair | |

1. Door / Front Left  
Paint / Poor Previous Repair -

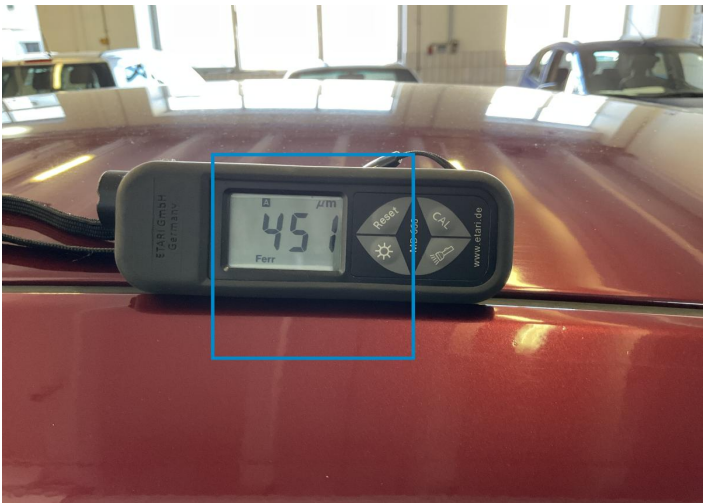
| Component | | Damage | Comments |
|---|---|---|---|
| 2 | Roof | Paint / Poor Previous Repair | |

2. Roof  
Paint / Poor Previous Repair -

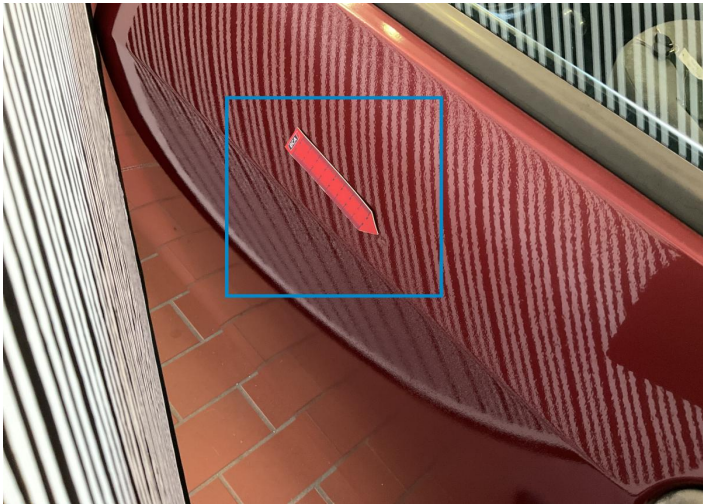
| Component | | Damage | Comments |
|---|---|---|---|
| 3 | Door / Front Left | Bodywork / Dent / Dent | |

3. Door / Front Left  
Bodywork / Dent / Dent -

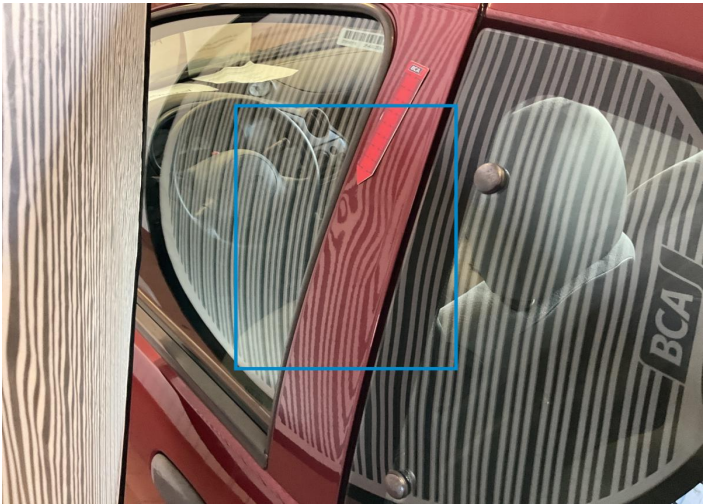
| Component | | Damage | Comments |
|---|---|---|---|
| 4 | Door / Front Left | Bodywork / Dent / Dent | |

4. Door / Front Left  
Bodywork / Dent / Dent -

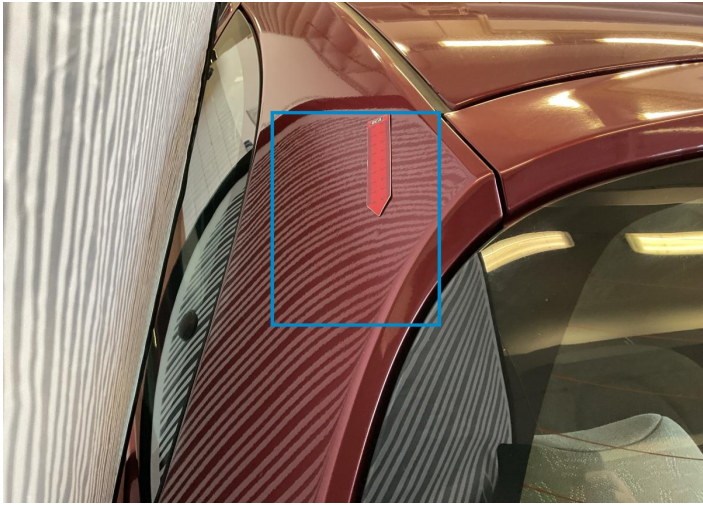
| Component | | Damage | Comments |
|---|---|---|---|
| 5 | Fender / Back Left | Bodywork / Dent / Dent | |

5. Fender / Back Left  
Bodywork / Dent / Dent -

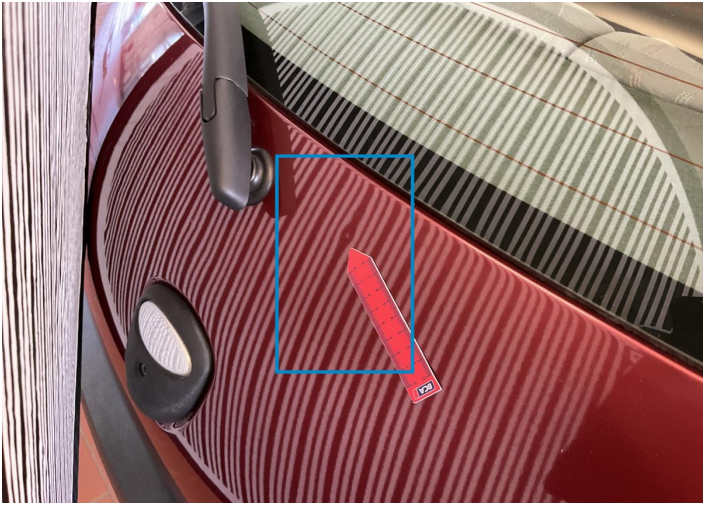
| Component | | Damage | Comments |
|---|---|---|---|
| 6 | Tailgate | Bodywork / Dent / Dent | |

6. Tailgate  
Bodywork / Dent / Dent -

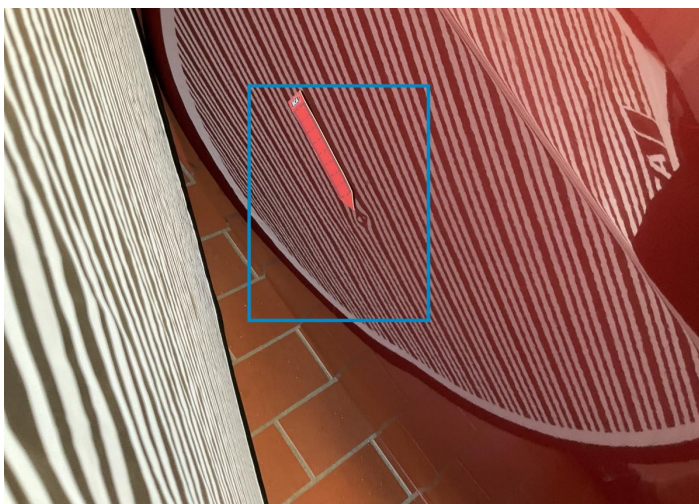
| Component | | Damage | Comments |
|---|---|---|---|
| 7 | Door / Front Right | Bodywork / Dent / Dent | |

7. Door / Front Right  
Bodywork / Dent / Dent -

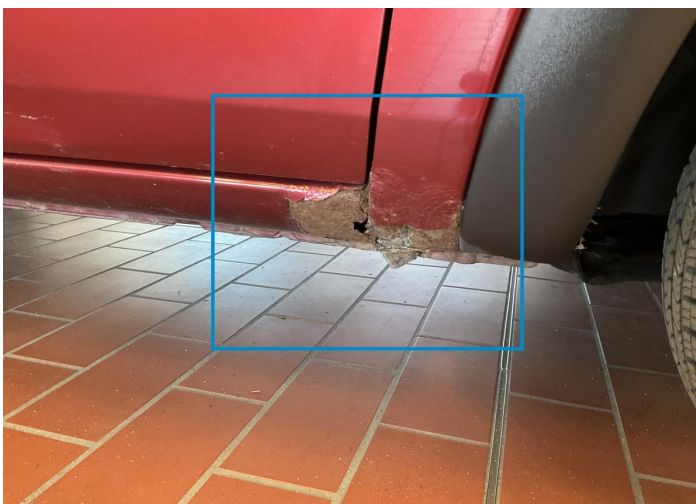
| Component | | Damage | Comments |
|---|---|---|---|
| 8 | Rocker Panel / Center Right | Paint / Corrosion | |

8. Rocker Panel / Center Right  
Paint / Corrosion -

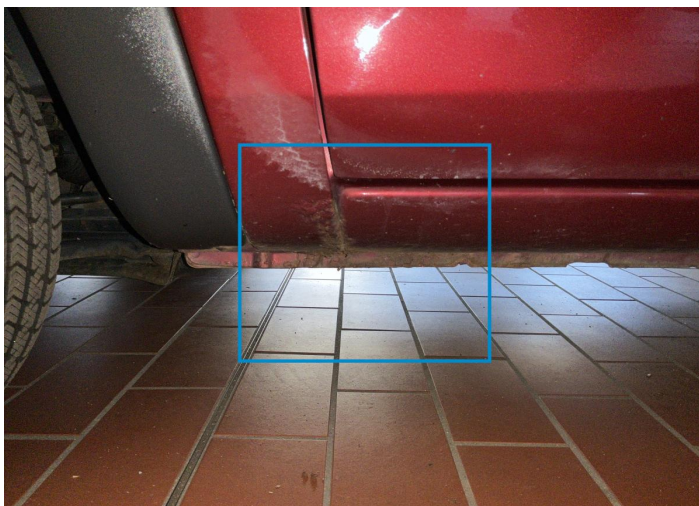
| Component | | Damage | Comments |
|---|---|---|---|
| 9 | Rocker Panel / Center Left | Paint / Corrosion | |

9. Rocker Panel / Center Left  
Paint / Corrosion -

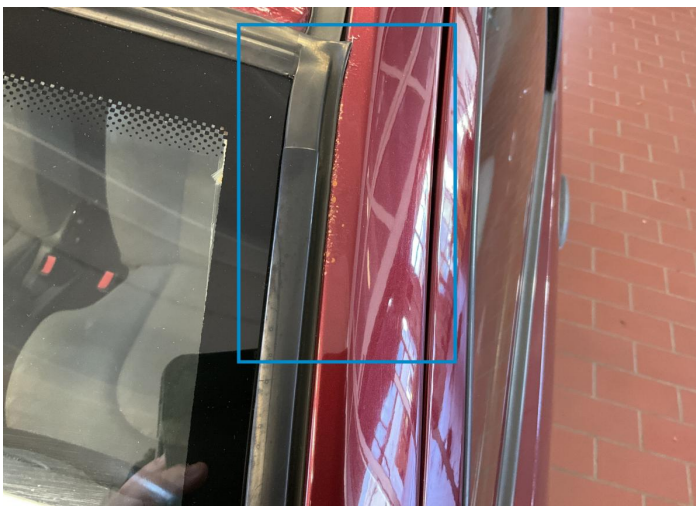
| Component | | Damage | Comments |
|---|---|---|---|
| 10 | Pillar / Front Left | Paint / Corrosion | |

10. Pillar / Front Left  
Paint / Corrosion -

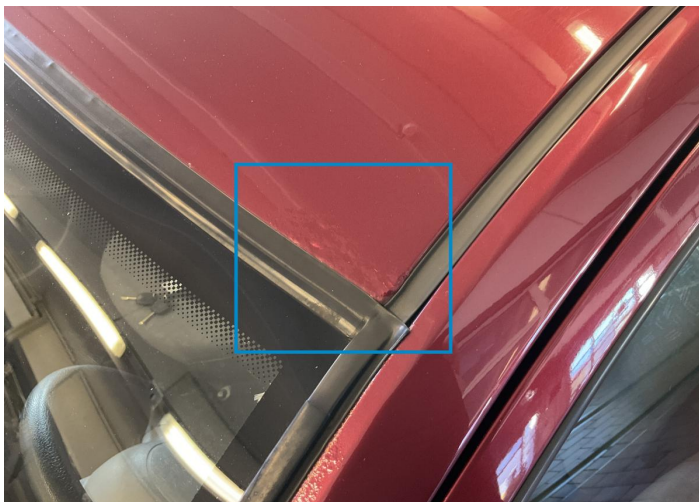
| Component | | Damage | Comments |
|---|---|---|---|
| 11 | Roof | Paint / Corrosion | |

11. Roof  
Paint / Corrosion -

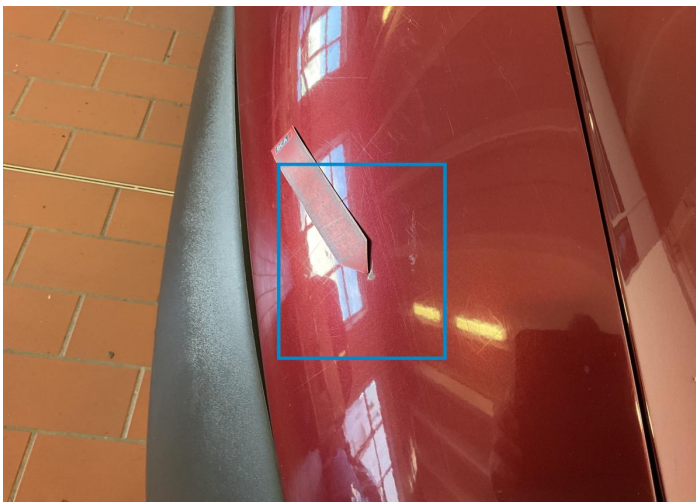
| Component | | Damage | Comments |
|---|---|---|---|
| 12 | Fender / Front Right | Paint / Chipping | |

12. Fender / Front Right  
Paint / Chipping -

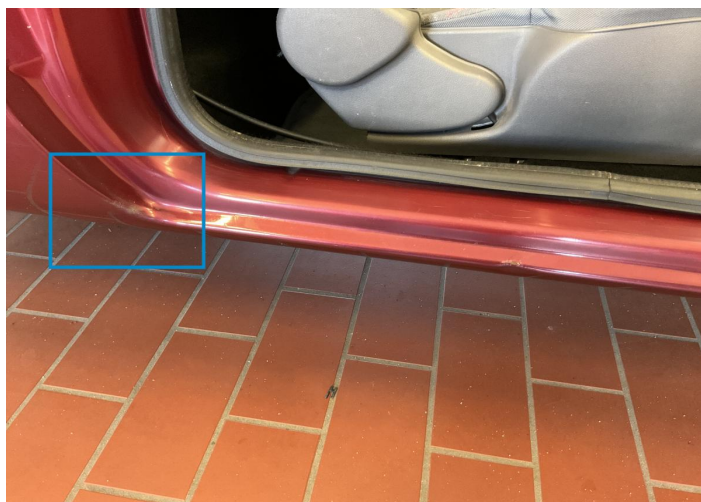
| 13 | Rocker Panel / Center Right | Paint / Corrosion |

13. Rocker Panel / Center Right  
Paint / Corrosion -

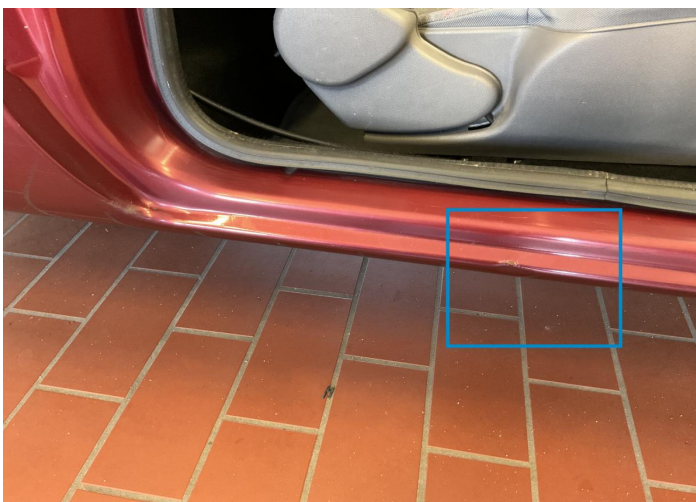
| 14 | Rocker Panel / Center Right | Paint / Corrosion |

14. Rocker Panel / Center Right  
Paint / Corrosion -

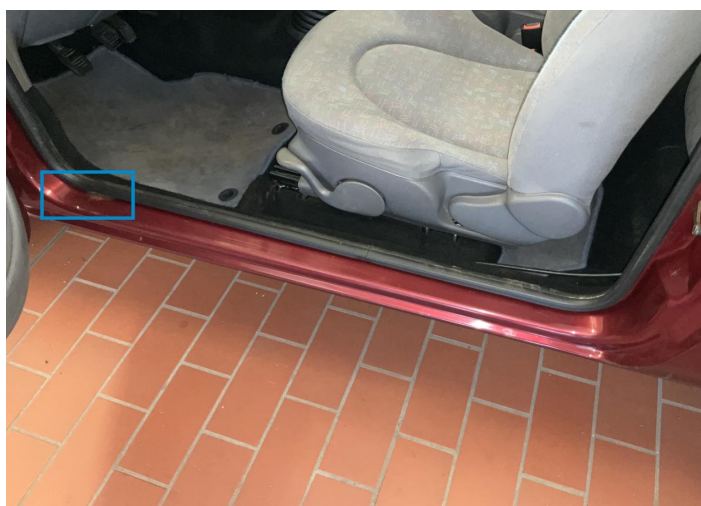
| 15 | Rocker Panel / Center Left | Paint / Corrosion |

15. Rocker Panel / Center Left  
Paint / Corrosion -

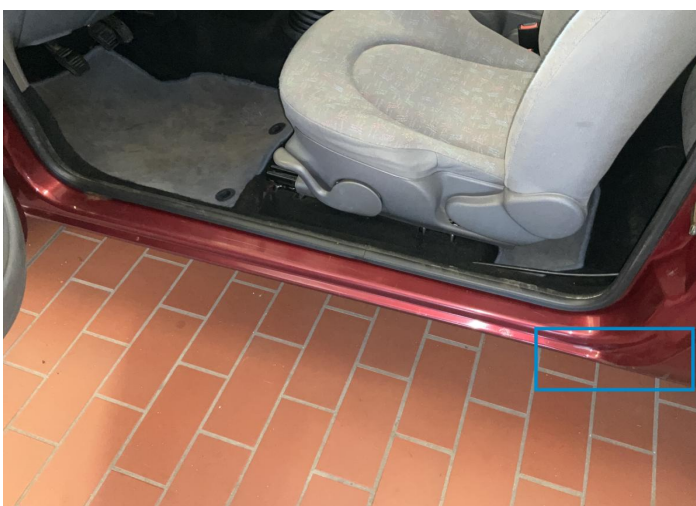
| 16 | Rocker Panel / Center Left | Paint / Corrosion |

16. Rocker Panel / Center Left  
Paint / Corrosion -

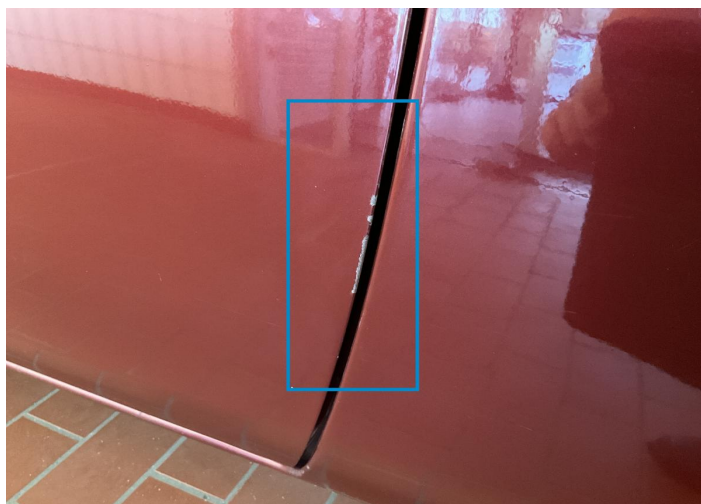
| 17 | Door / Front Left | Paint / Chipping |

17. Door / Front Left  
Paint / Chipping -
