Expertise

Protocol number: 39945622
Order No. / Reference: 24775514
Inspection date: 30 May 2025

Manufacturer: Ford

Model: Mondeo Turnier 2.0 EcoBlue Aut. Titanium

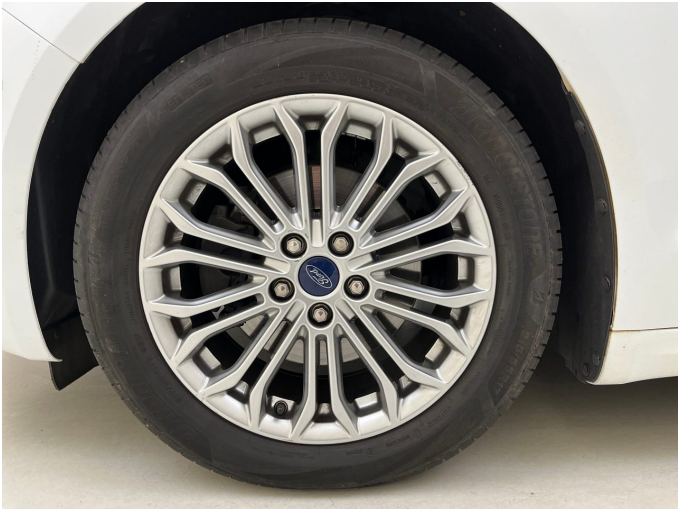
Figure 12: Mounted tyres

#	Tyre size	Type of tyre	Manufacturer	Tread depth
1)	215/55 R17 98W	Summer tyres on Light alloy	Bridgestone	5mm / 6mm
2)	215/55 R17 98W	Summer tyres on Light alloy	Bridgestone	5mm / 5mm

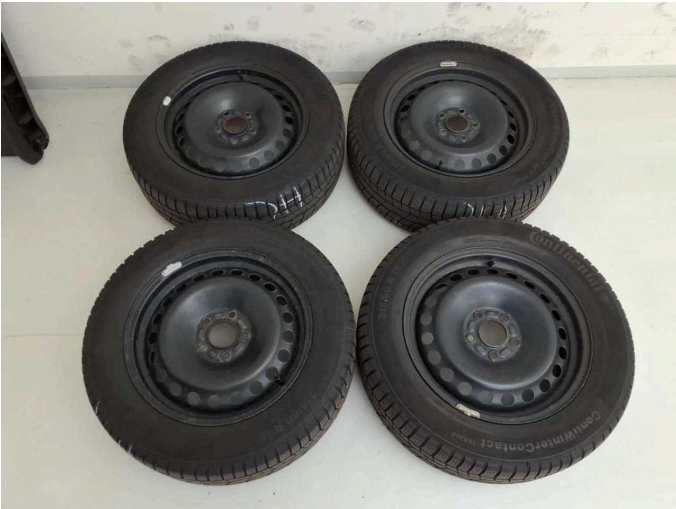
Figure 15: Additional tyres

#	Tyre size	Type of tyre	Manufacturer	Tread depth
1)	215/60 R16 99H	Winter tyres on Steel	Continental	5mm / 5mm
2)	215/60 R16 99H	Winter tyres on Steel	Continental	5mm / 6mm

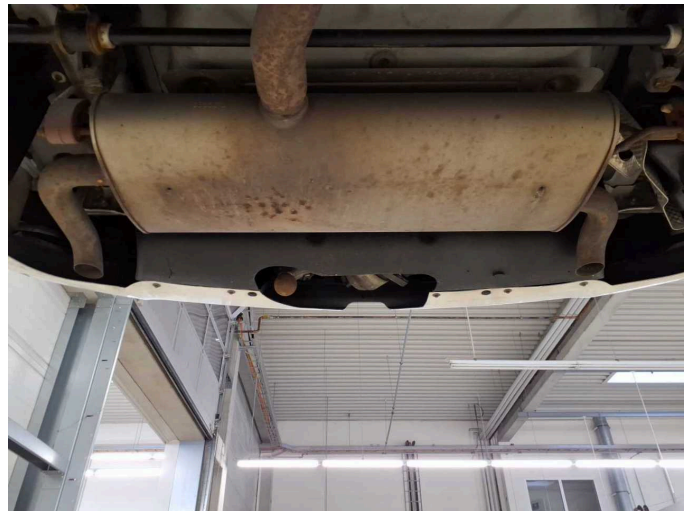
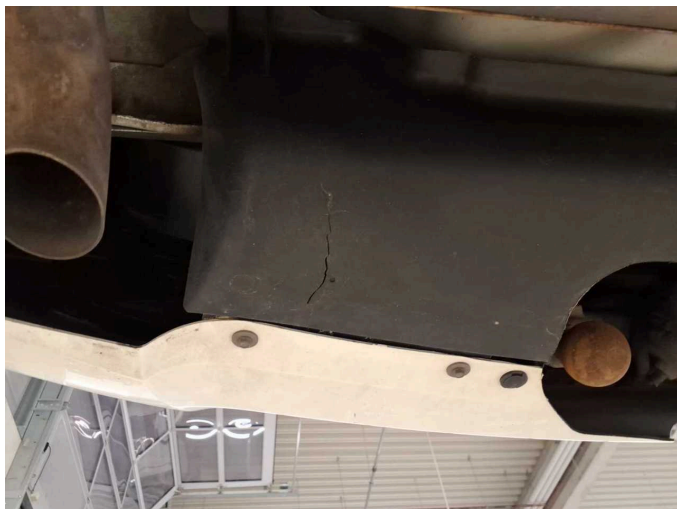
Damage 1: Body: Underbody panelling - Broken / torn - Replace

No.	Component group	Description
1	Body	Underbody panelling - Broken / torn - Replace
2	Rear bumper	Rear bumper - Scratch(es) - Paint
3	Front bumper	Front bumper - Scratch(es) - Paint
4	Bonnet	Bonnet - Dent / paintcoat damage - Repair and paint

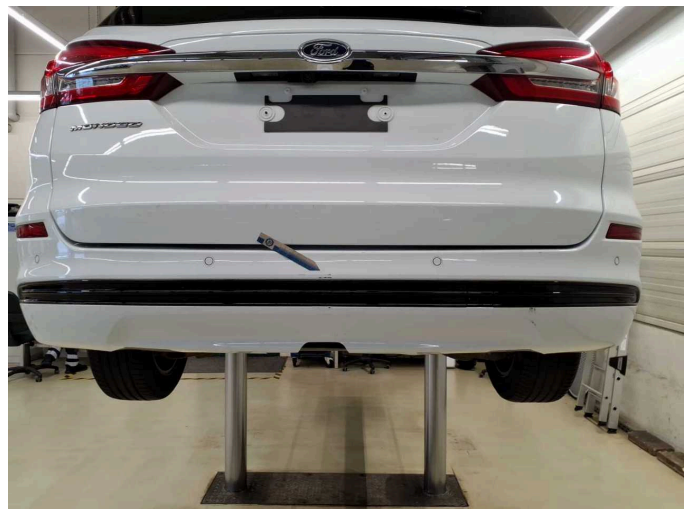
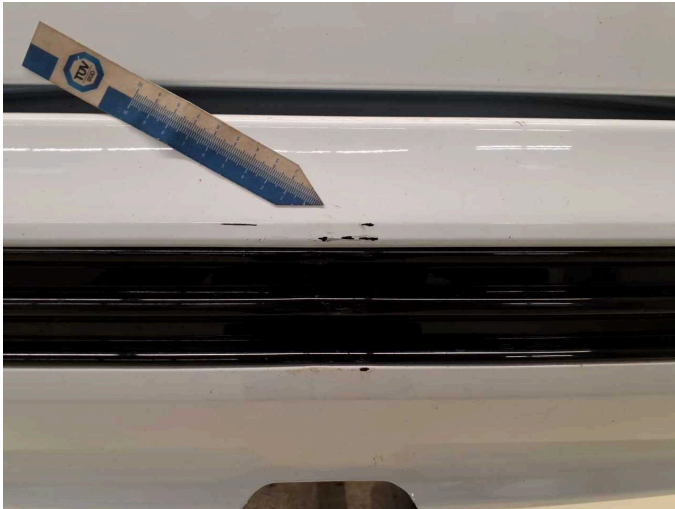
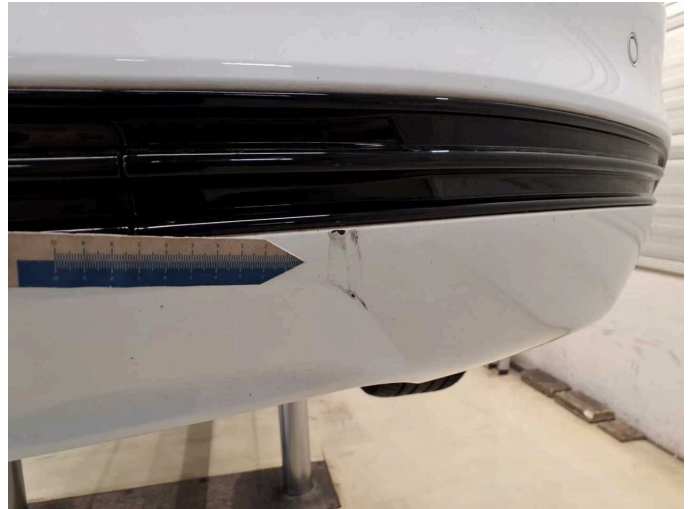
Damage 2: Rear bumper: Rear bumper - Scratch(es) - Paint

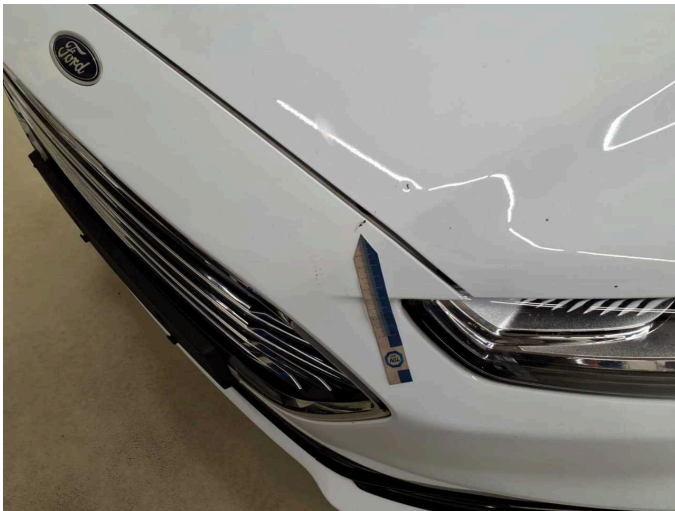
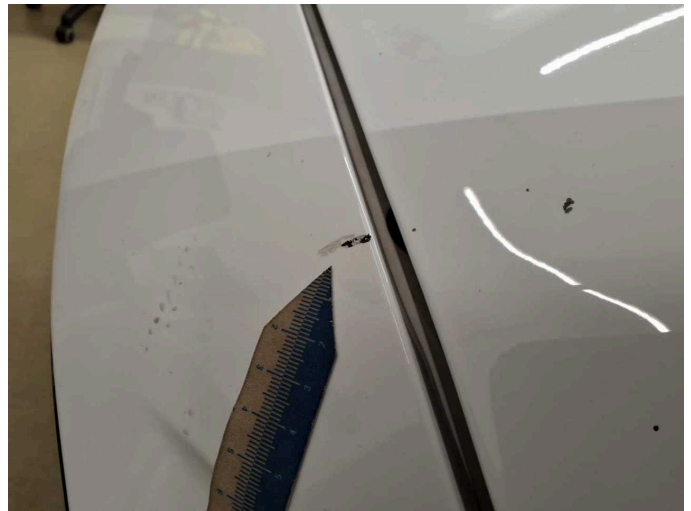
Damage 3: Front bumper: Front bumper - Scratch(es) - Paint

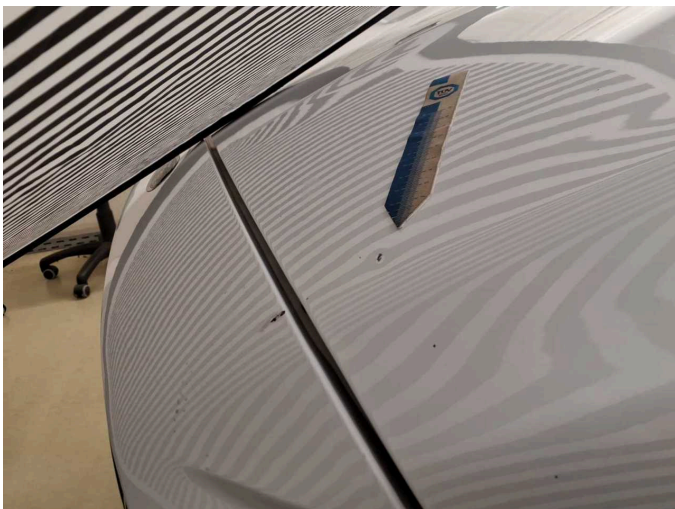
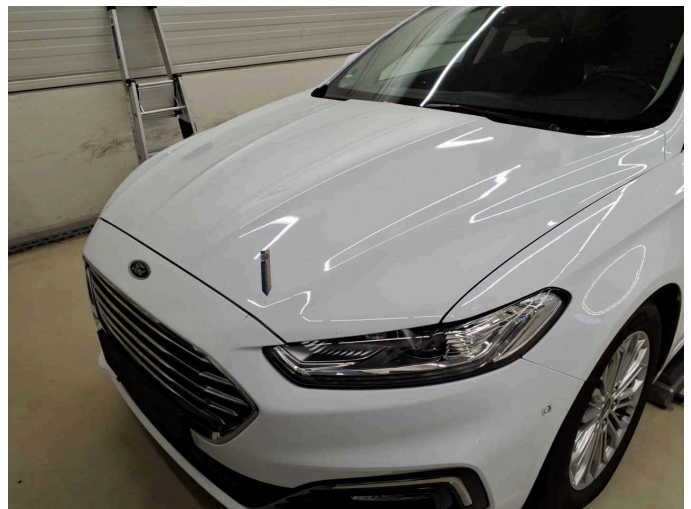
Damage 4: Bonnet: Bonnet - Dent / paintcoat damage - Repair and paint
