Expertise

Protocol number: 41611002  
Order No. / Reference: 25199698  
Inspection date: 18 Sept 2025

Manufacturer: Ford	Model: Mondeo Turnier 2.0 EcoBlue Aut. Titanium
VIN: WF0FXXWPCFMJ36842

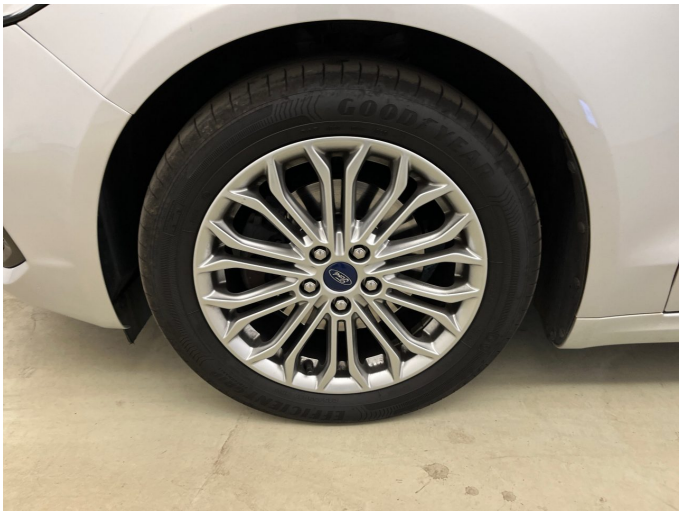
#	Tyre size	Type of tyre	Manufacturer	Tread depth
1)	215/55 R17 98W	Summer tyres on Light alloy	Goodyear	3mm / 3mm
2)	215/55 R17 98W	Summer tyres on Light alloy	Goodyear	6mm / 6mm

Figure 12: Mounted tyres

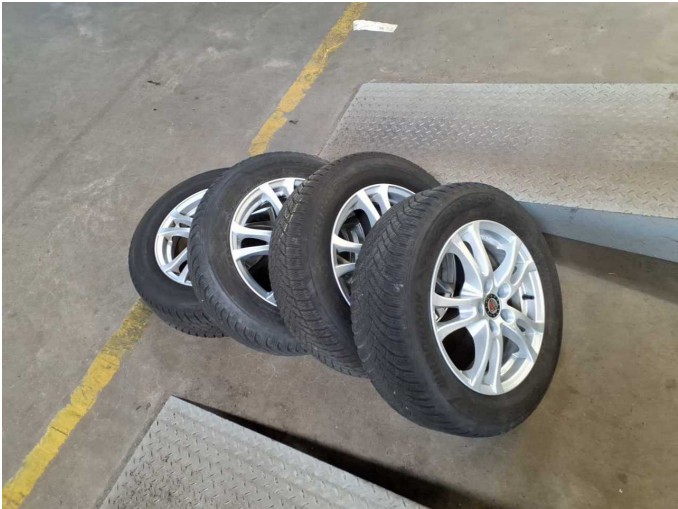
#	Tyre size	Type of tyre	Manufacturer	Tread depth
1)	215/60 R16 99H	Winter tyres on Light alloy	Hankook	6mm / 6mm
2)	215/60 R16 99H	Winter tyres on Light alloy	Hankook	6mm / 6mm

Figure 14: Additional tyres

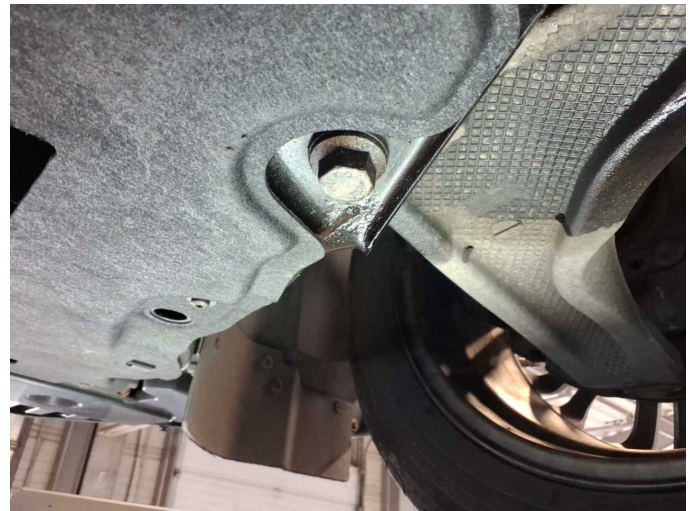
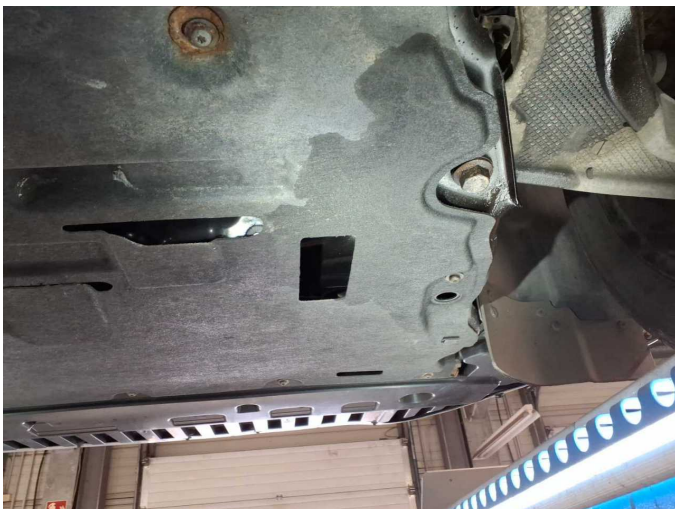
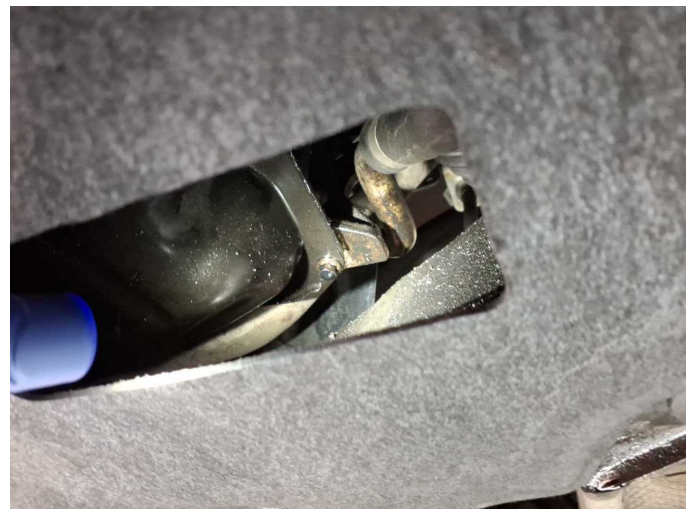
**Damage 3:** Engine: Engine - Leaking - Perform diagnosis

No.	Component group	Description
1	Misc.	Main inspection - No evidence - No deduction
2	Engine	Toothed belt - No evidence - No deduction
3	Engine	Engine - Leaking - Perform diagnosis
4	Sill - right side	Trim - Broken / torn - Replace
5	Drive train	Sleeve prop shaft - front right side - Broken / torn - Replace

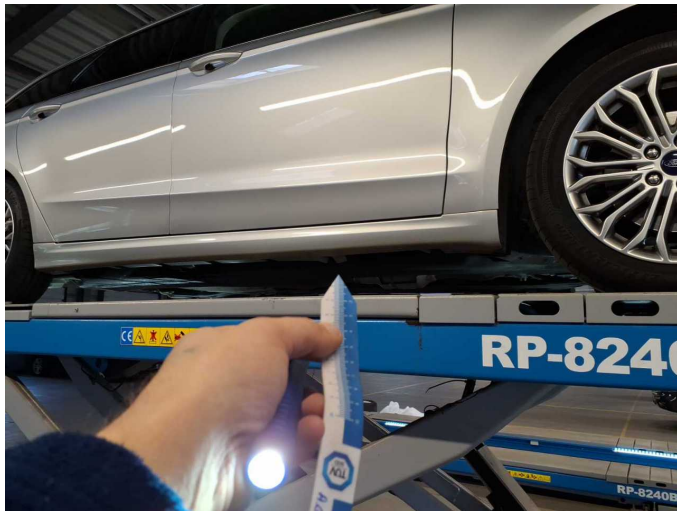
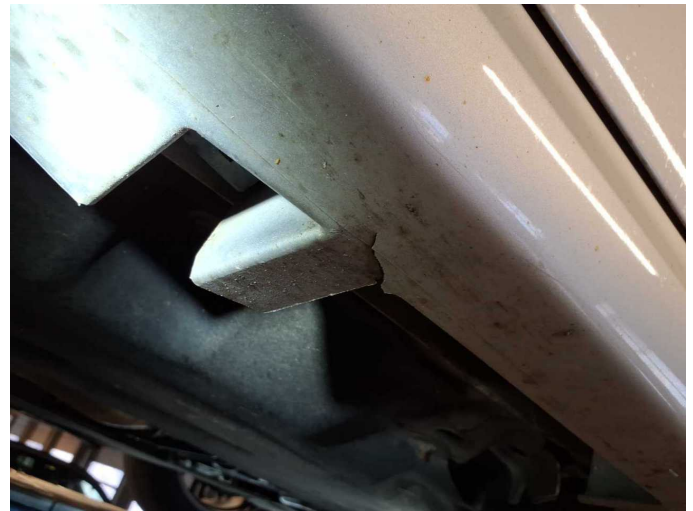
**Damage 4:** Sill - right side: Trim - Broken / torn - Replace

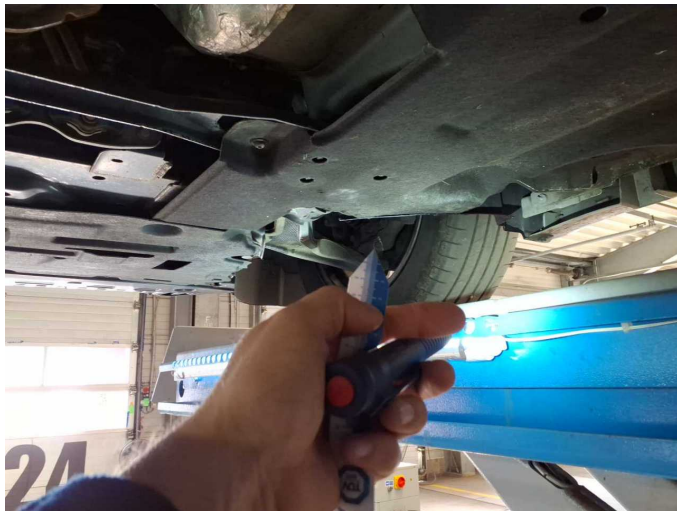
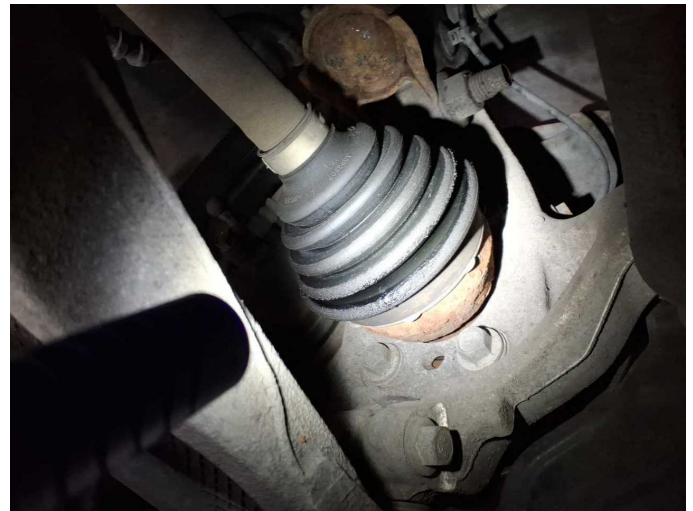
**Damage 5:** Drive train: Sleeve prop shaft - front right side - Broken / torn - Replace

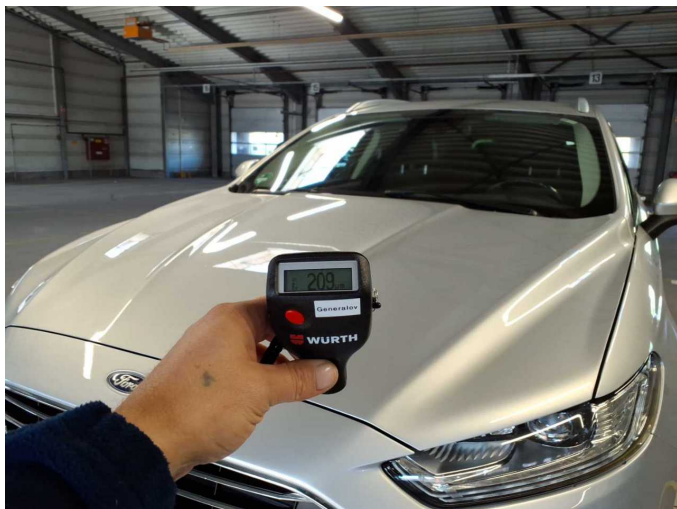
Bonnet	209 µm	Door - rear right side	145 µm
--------	--------	------------------------	--------

**Repainting 1:** Bonnet

- 1 Bonnet, Professionally carried out, Invoice of repair done Non-existent
- 2 Door - rear right side, Professionally carried out, Invoice of repair done Non-existent

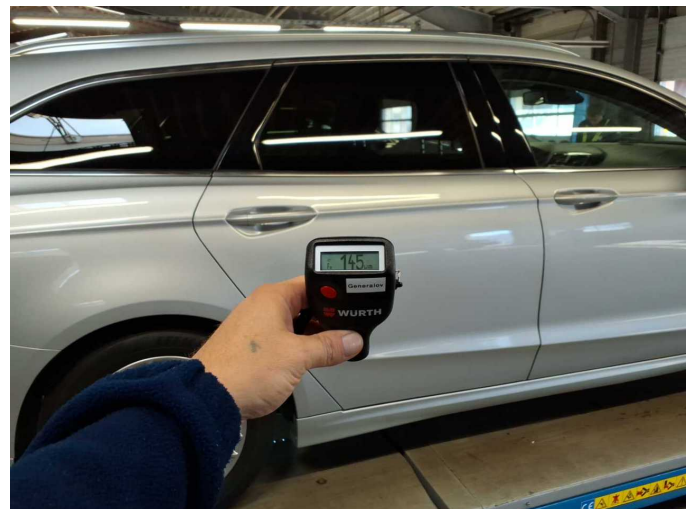
**Repainting 2:** Door - rear right side
