Expertise

Protocol number: 41761566
Order number / reference: 25246519
Inspection date: 30 Sept 2025

Manufacturer: Ford

Model: Mondeo Turnier 2.0 EcoBlue Aut. Titanium

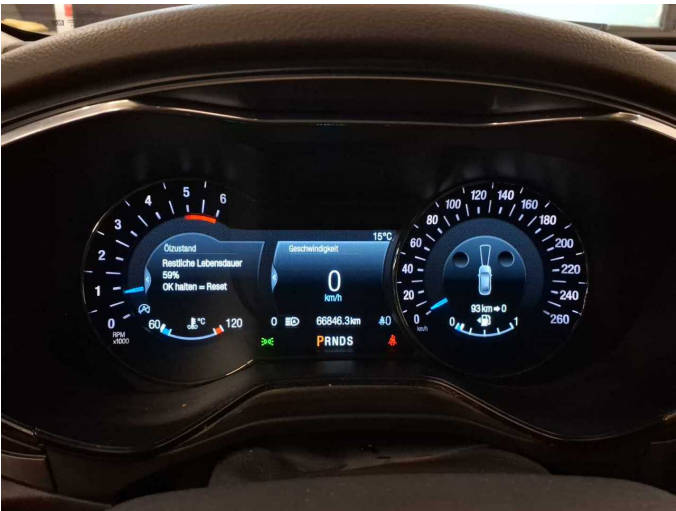
Figure 7: Instrument cluster

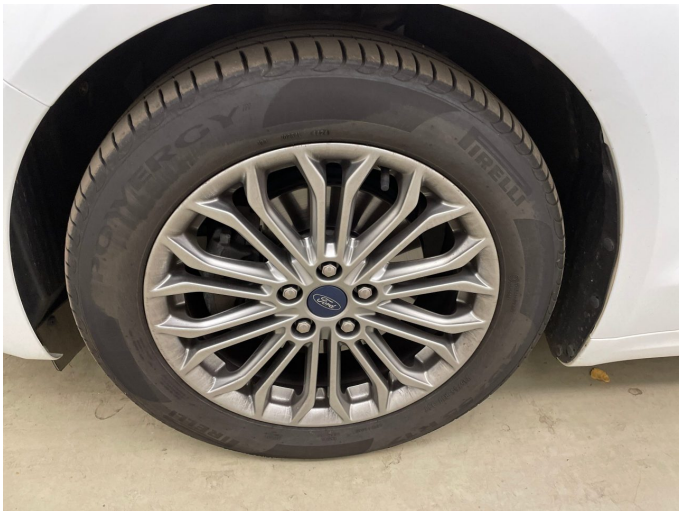
Figure 12: Mounted tyres

#	Tyre size	Type of tyre	Manufacturer	Tread depth
1)	215/55 R17 98Y	Summer tyres on Light alloy	Pirelli	5mm / 5mm
2)	215/55 R17 98Y	Summer tyres on Light alloy	Pirelli	6mm / 6mm

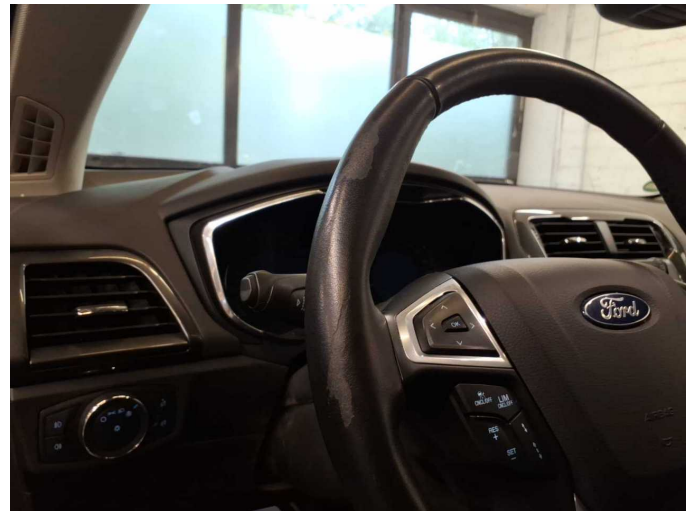
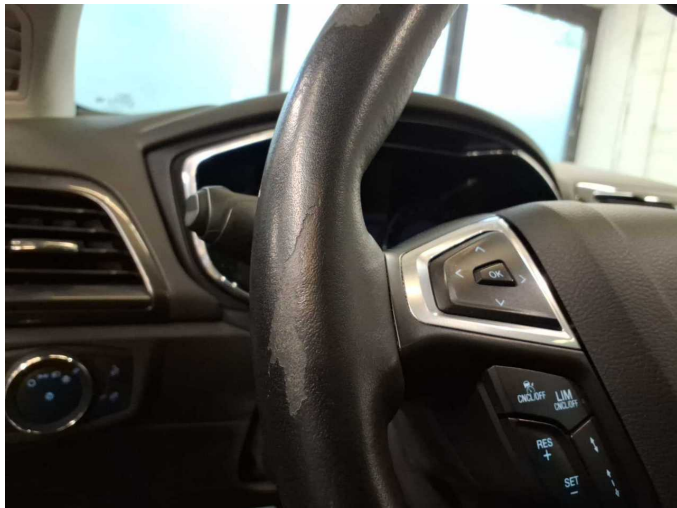
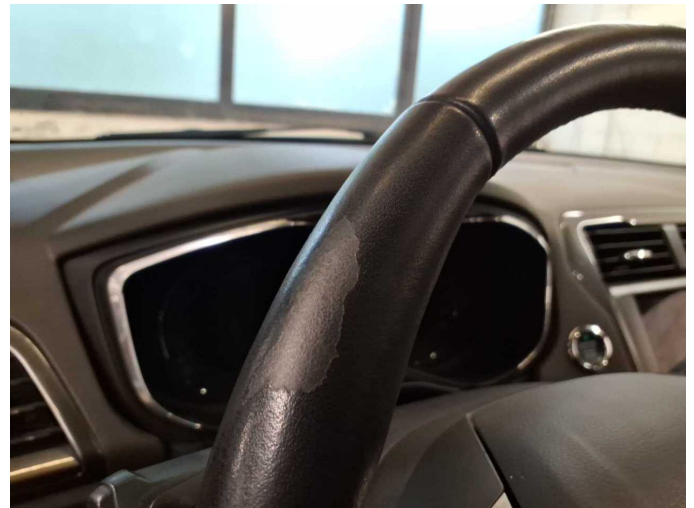
Damage 2: Steering system: Steering wheel - Scratch(es) - Smart repair

No.	Component group	Description
1	Rear bumper	Rear bumper - Scratch(es) - No deduction
2	Steering system	Steering wheel - Scratch(es) - Smart repair
3	Sill - right side	Sill - Dent / paintcoat damage - Repair and paint

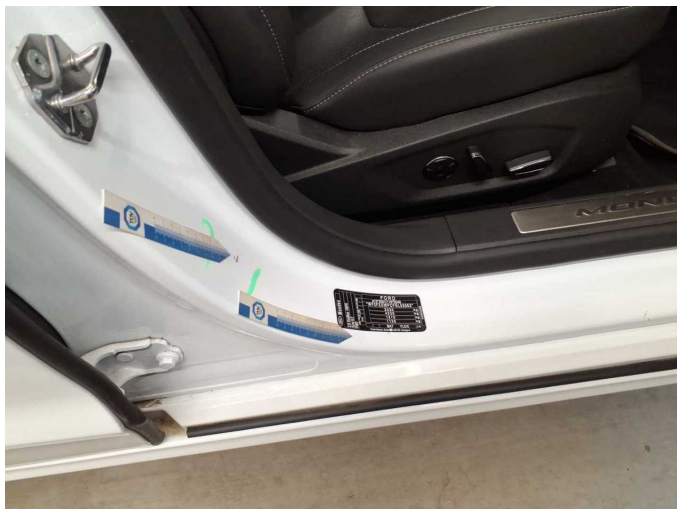
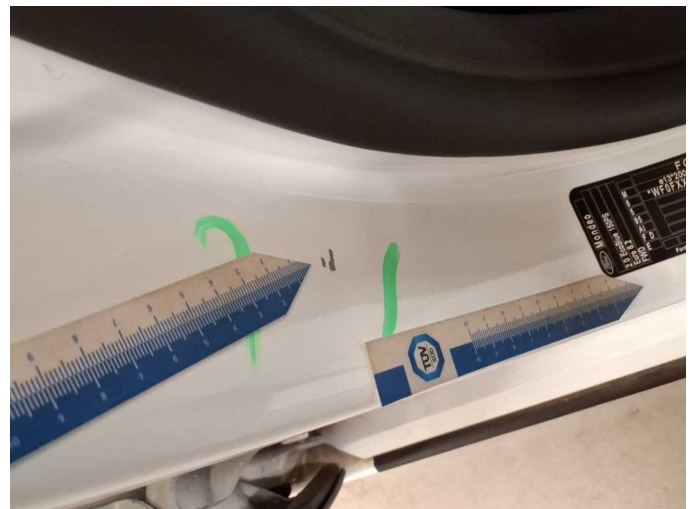
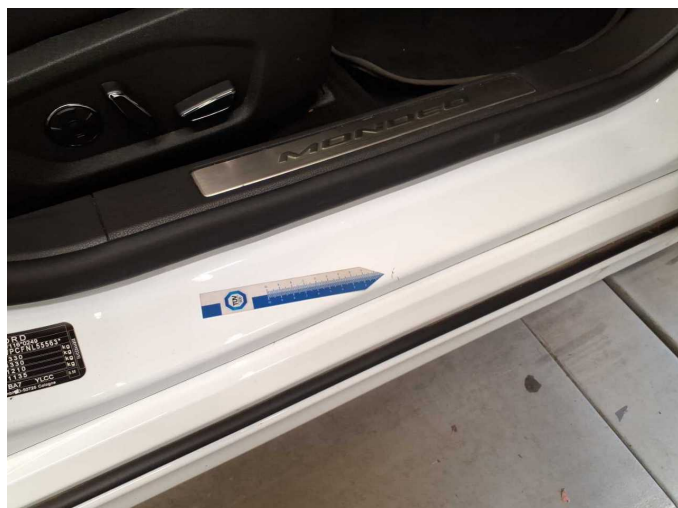
Damage 3: Sill - right side: Sill - Dent / paintcoat damage - Repair and paint

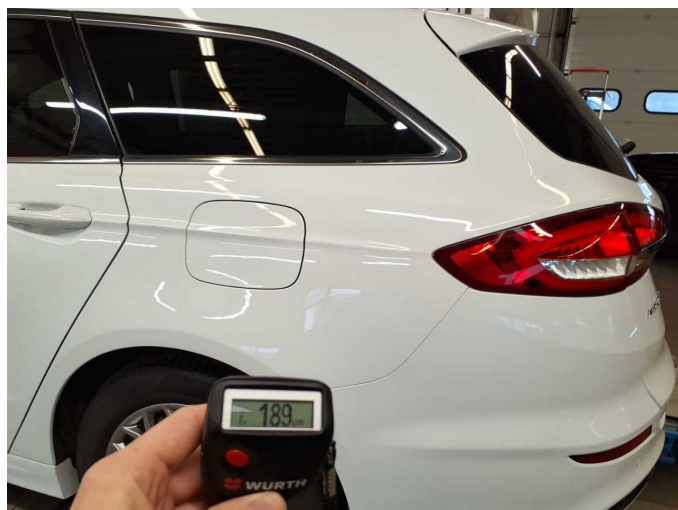
Repainting 1: Side panel - rear left side

- 1 Side panel - rear left side, Professionally carried out, Invoice of repair done Non-existent
- 2 Door - rear left side, Professionally carried out, Invoice of repair done Non-existent

Side panel - rear left side	189 µm	Door - rear left side	194 µm
-----------------------------	--------	-----------------------	--------

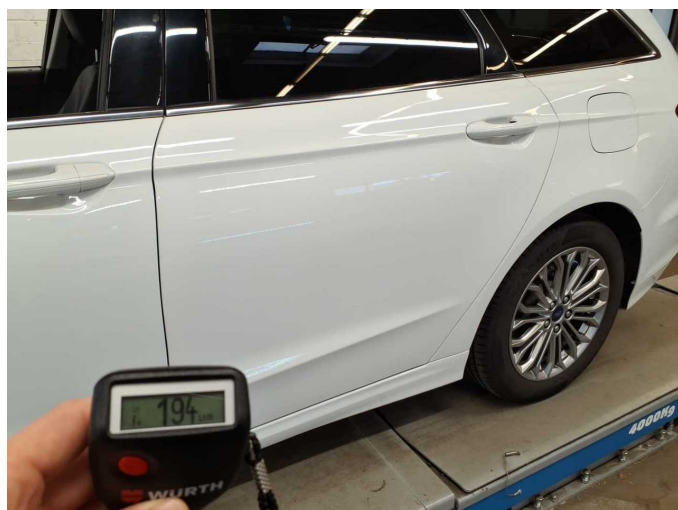
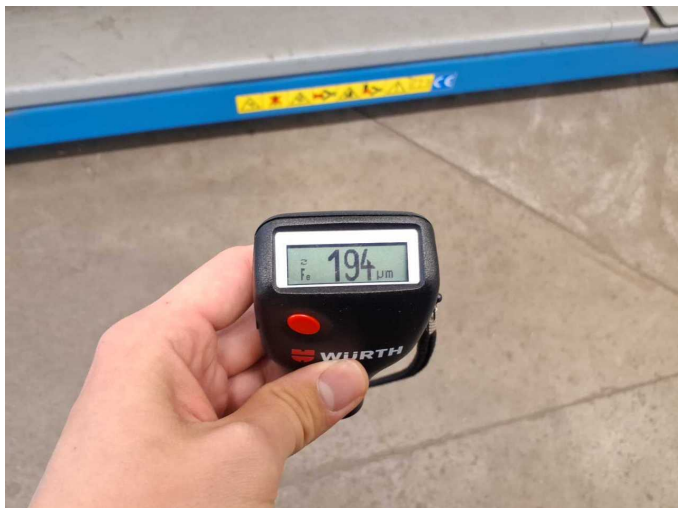
Repainting 2: Door - rear left side
