Expertise

Protocol number: 40712616  
Order No. / Reference: 24903101  
Inspection date: 23 Jul 2025

Manufacturer: Ford

Model: Kuga 2.0 EcoBlue 4x4 Aut. ST-LINE

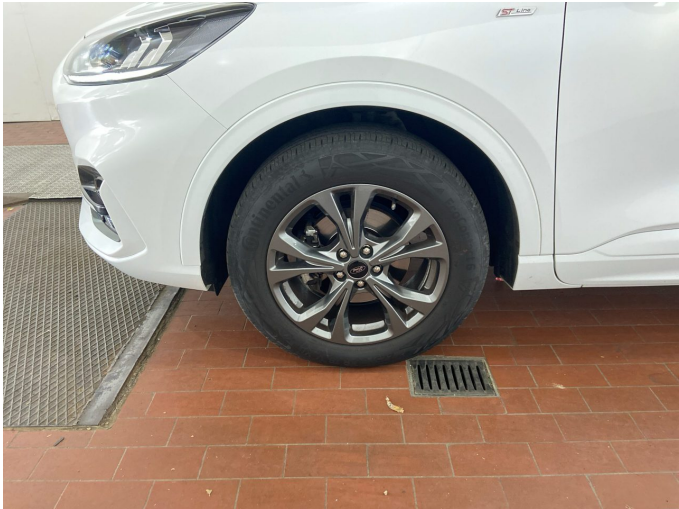
| # | Tyre size | Type of tyre | Manufacturer | Tread depth |
|---|---|---|---|---|
| 1) | 225/60 R18 104V | Summer tyres on Light alloy | Continental | 6mm / 6mm |
| 2) | 225/60 R18 104V | Summer tyres on Light alloy | Continental | 6mm / 6mm |

Figure 12: Mounted tyres

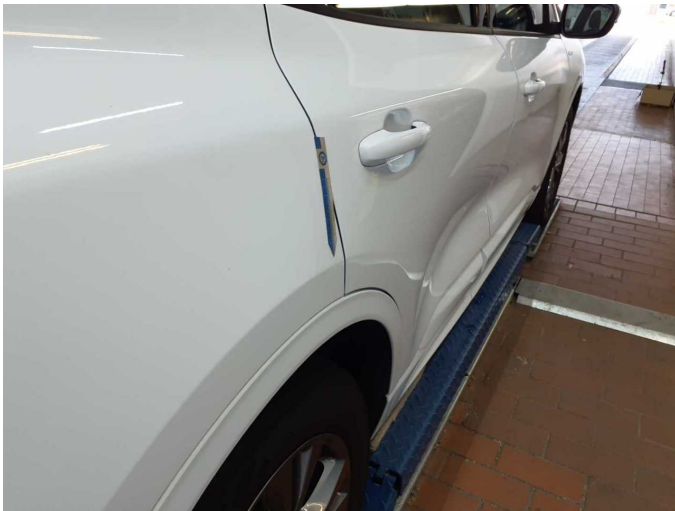
**Damage 1:** Side panel - rear right side: Side panel - dent(s) - Smart repair

| No. | Component group | Description |
|---|---|---|
| 1 | Side panel - rear right side | Side panel - dent(s) - Smart repair |

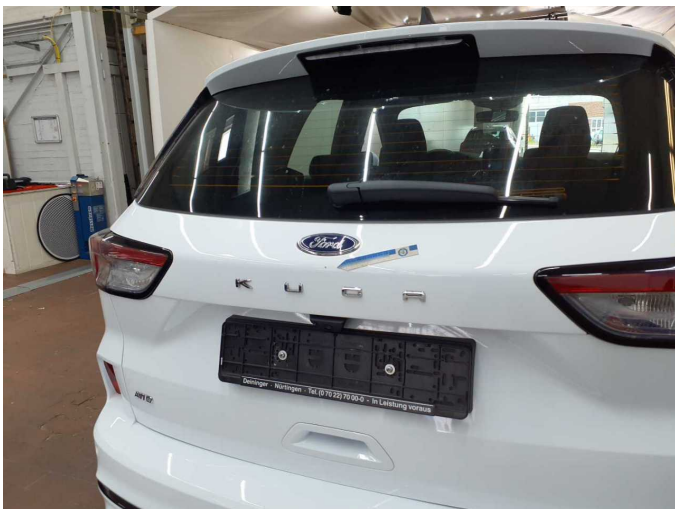
**Damage 2:** Boot lid / rear door: Boot lid - Scratch(es) - Smart repair

| No. | Component group | Description |
|---|---|---|
| 2 | Boot lid / rear door | Boot lid - Scratch(es) - Smart repair |

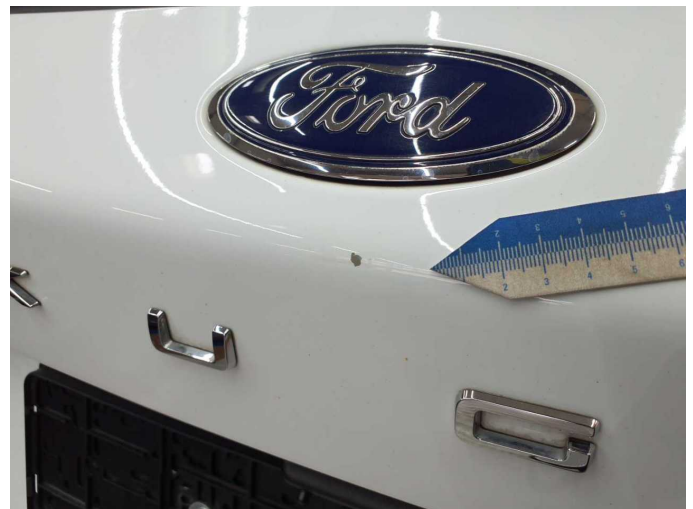
**Damage 2:** Boot lid / rear door: Boot lid - Scratch(es) - Smart repair

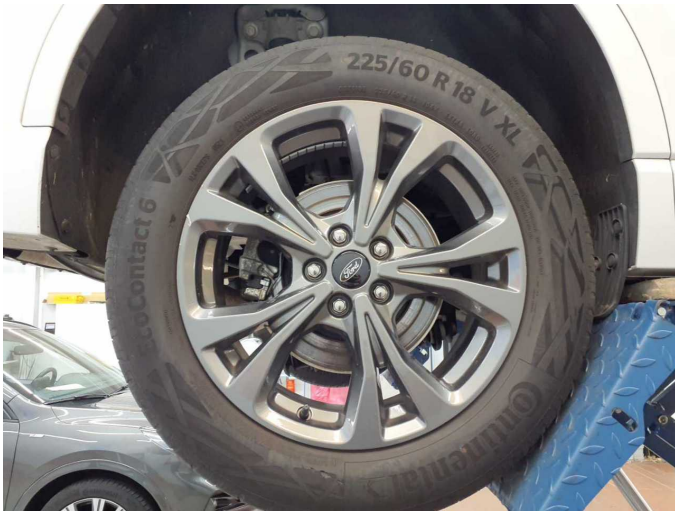
**Damage 3:** Wheel / tyres: Alloy rim - rear right side - Scratched - Loss in value

| No. | Component group | Description |
|---|---|---|
| 3 | Wheel / tyres | Alloy rim - rear right side - Scratched - Loss in value |

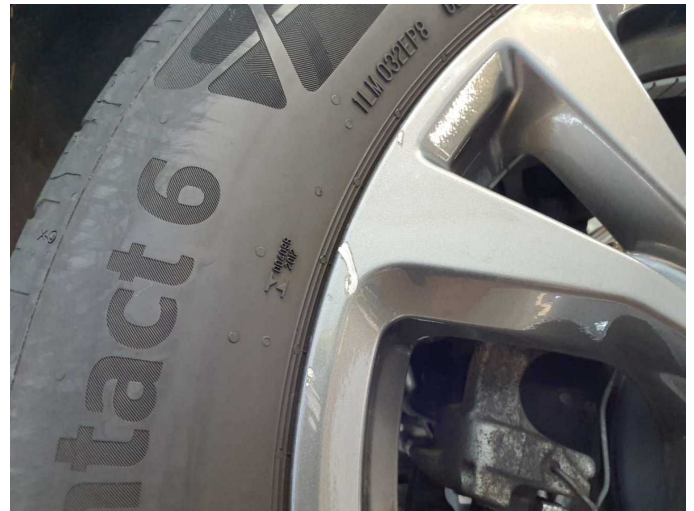
**Damage 3:** Wheel / tyres: Alloy rim - rear right side - Scratched - Loss in value

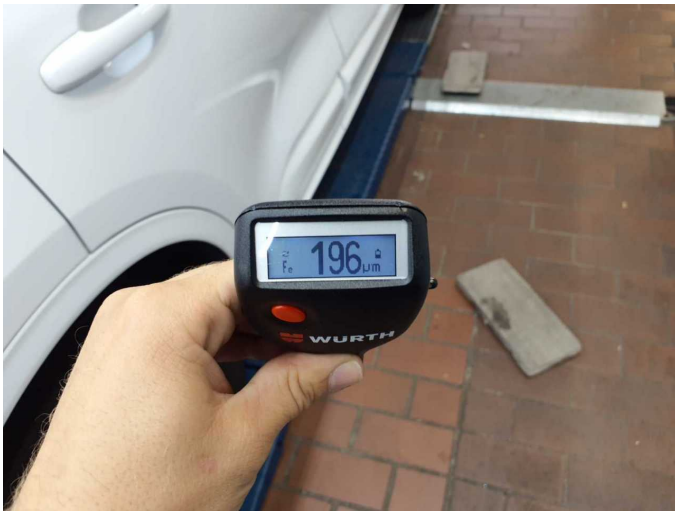
1 Roof, Professionally carried out, Invoice of repair done Non-existent

Roof 196 µm |

**Repainting 1:** Roof

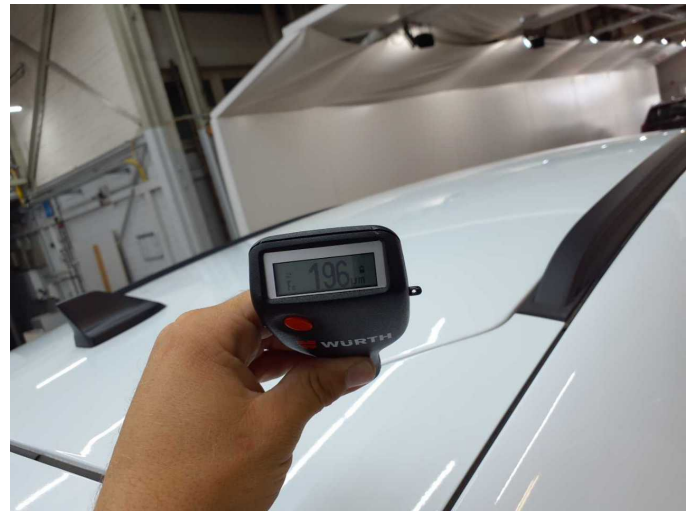
**Repainting 1:** Roof
