Expertise

Protocol number: 41583568
Order No. / Reference: 25146577
Inspection date: 16 Sept 2025

Manufacturer: Ford

Model: Kuga 1.5 EcoBlue Aut. TITANIUM X

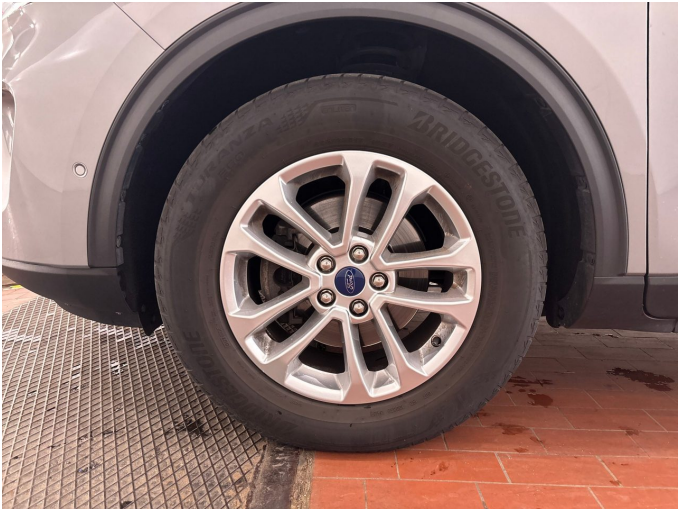
Figure 12: Mounted tyres

#	Tyre size	Type of tyre	Manufacturer	Tread depth
1)	225/65 R17 102V	Summer tyres on Light alloy	Bridgestone	5mm / 5mm
2)	225/65 R17 102V	Summer tyres on Light alloy	Bridgestone	6mm / 6mm

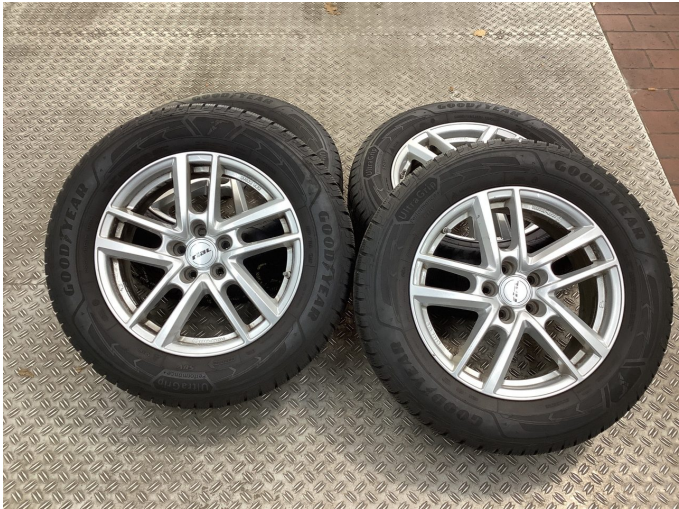
Figure 16: Additional tyres

#	Tyre size	Type of tyre	Manufacturer	Tread depth
1)	225/65 R17 102H	Winter tyres on Light alloy	Goodyear	7mm / 7mm
2)	225/65 R17 102H	Winter tyres on Light alloy	Goodyear	7mm / 7mm

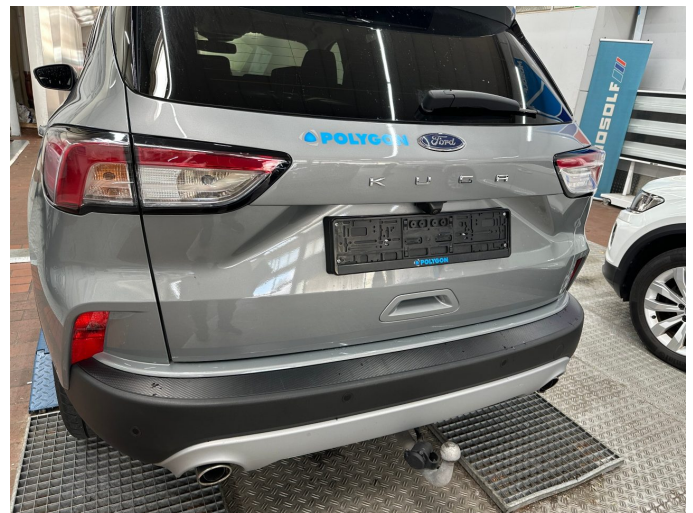
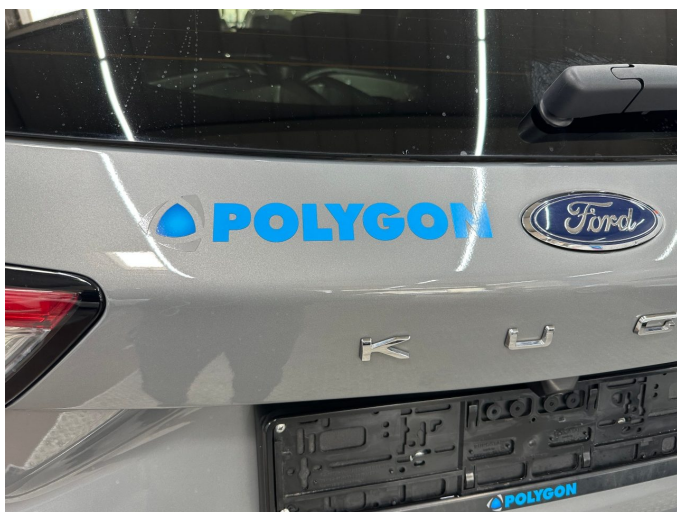
Damage 1: Boot lid / rear door: Boot lid - Glued / labelled - De-glue / neutralise

No.	Component group	Description
1	Boot lid / rear door	Boot lid - Glued / labelled - De-glue / neutralise
2	Side panel - rear left side	Side panel - Scratch(es) - Smart repair
3	Boot lid / rear door	Boot lid - dent(s) - Smart repair
4	Bonnet	Bonnet - dent(s) - Smart repair

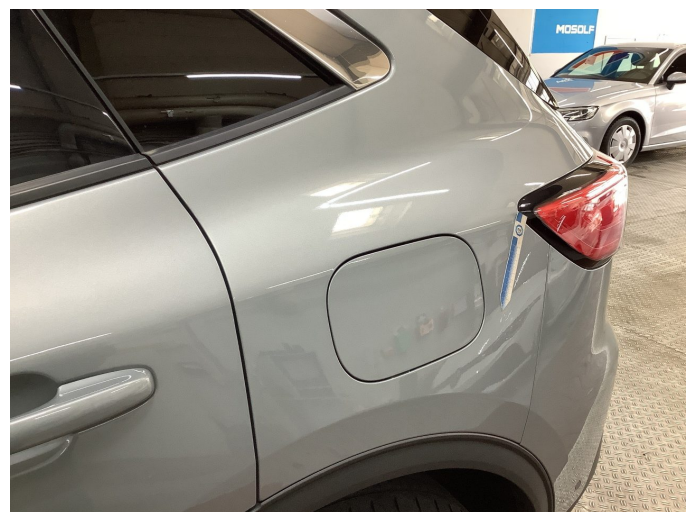
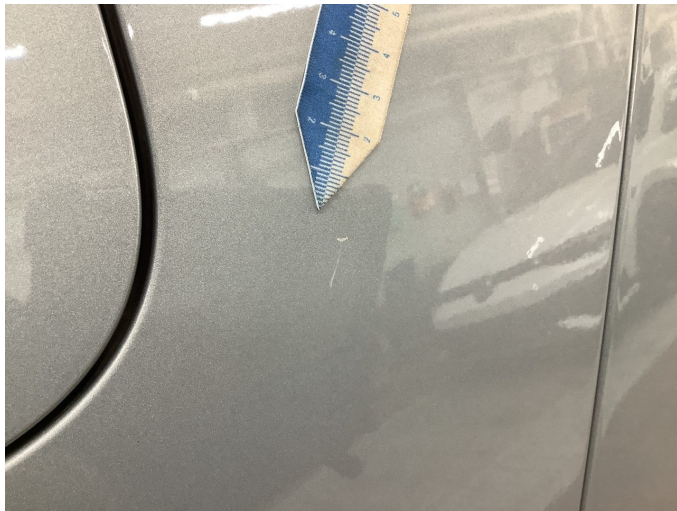
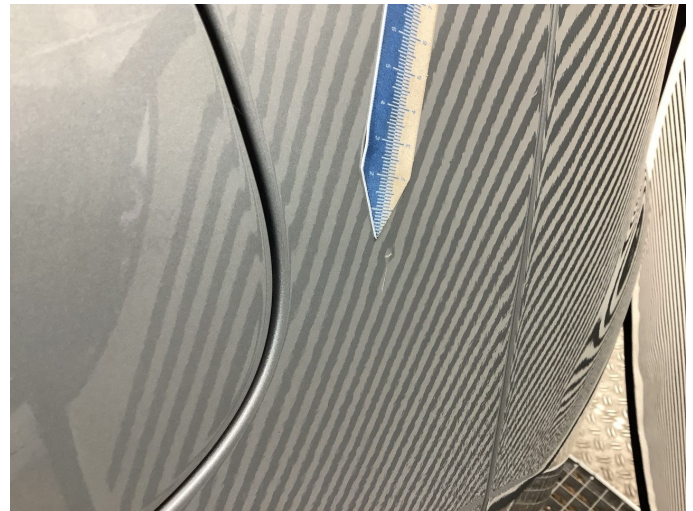
Damage 2: Side panel - rear left side: Side panel - Scratch(es) - Smart repair

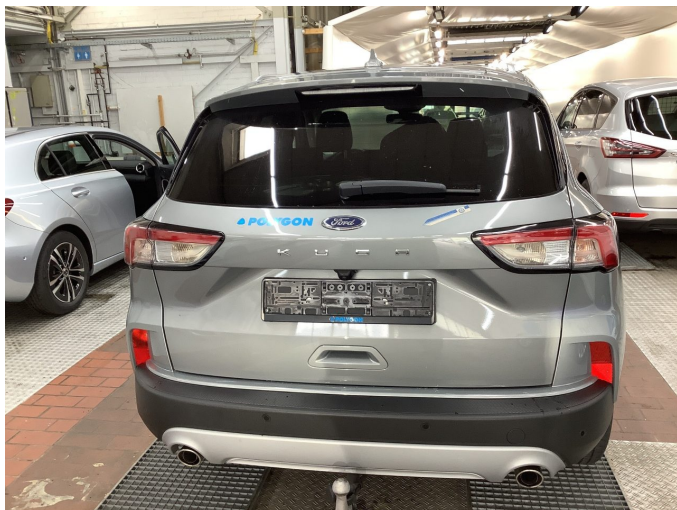
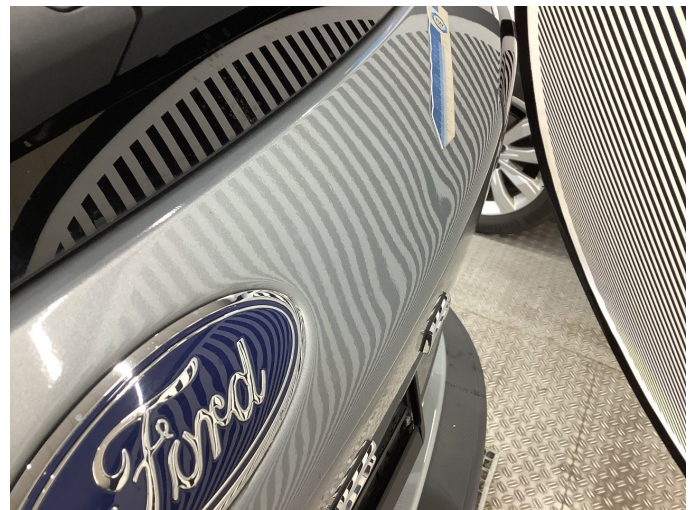
Damage 3: Boot lid / rear door: Boot lid - dent(s) - Smart repair

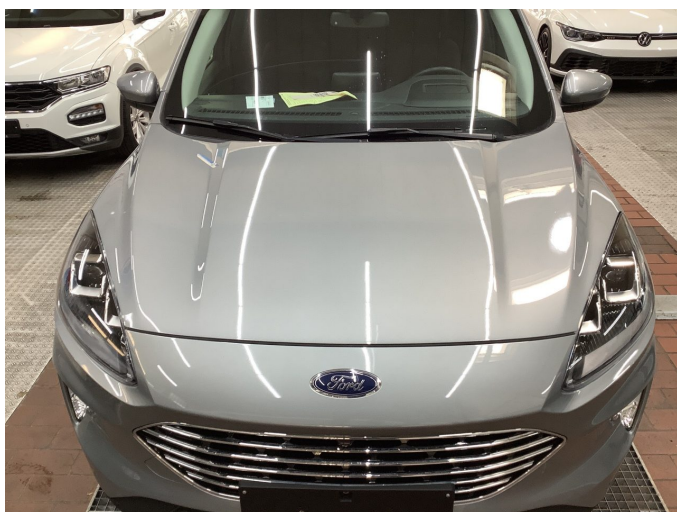
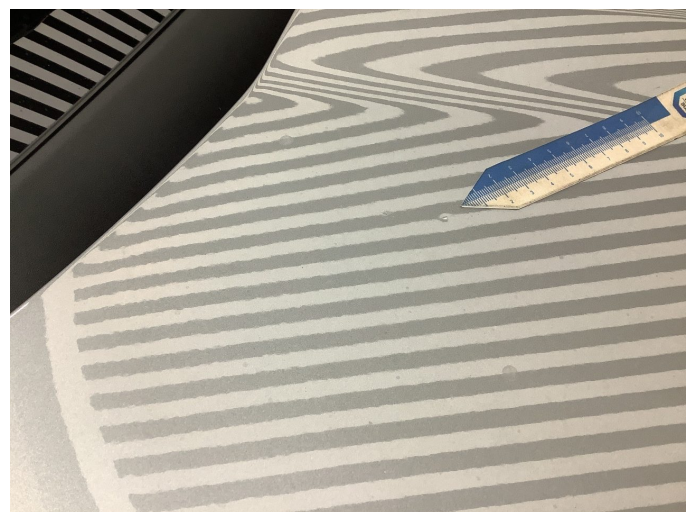
Damage 4: Bonnet: Bonnet - dent(s) - Smart repair

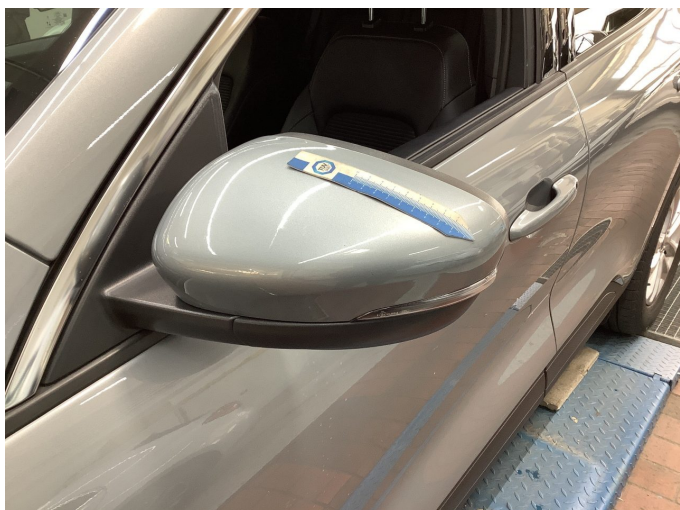
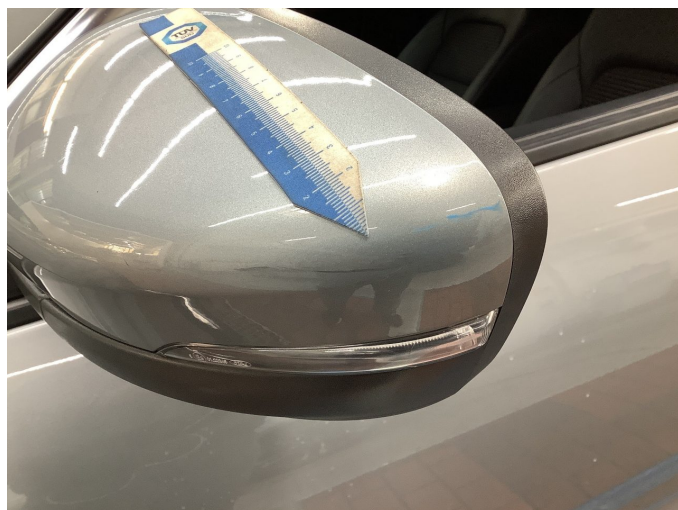
Wear and tear 1: Wing mirror - left side: Cap - Scratch(es) - No deduction

No.	Component group	Description
1	Wing mirror - left side	Cap - Scratch(es) - No deduction
