Expertise

Protocol number: 41483111
Order No. / Reference: 25090467
Inspection date: 11 Sept 2025

Manufacturer: Ford

Model: Kuga 2.5 Duratec PHEV ST-LINE X

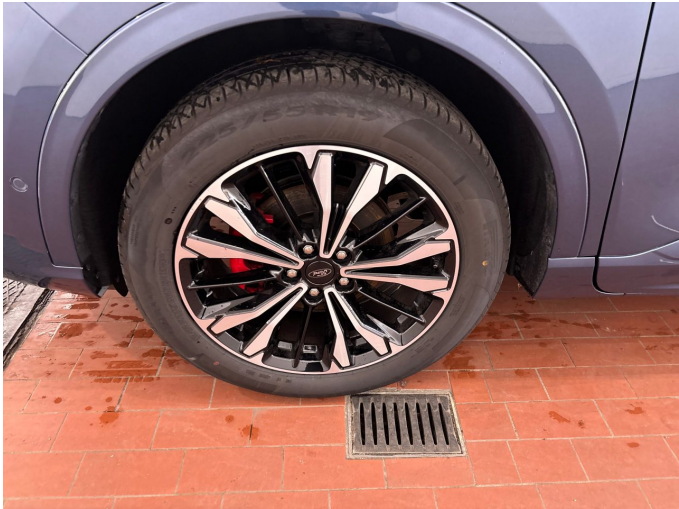
#	Tyre size	Type of tyre	Manufacturer	Tread depth
1)	225/55 R19 99V	Summer tyres on Light alloy	Pirelli	6mm / 6mm
2)	225/55 R19 99V	Summer tyres on Light alloy	Pirelli	5mm / 5mm

Figure 12: Mounted tyres

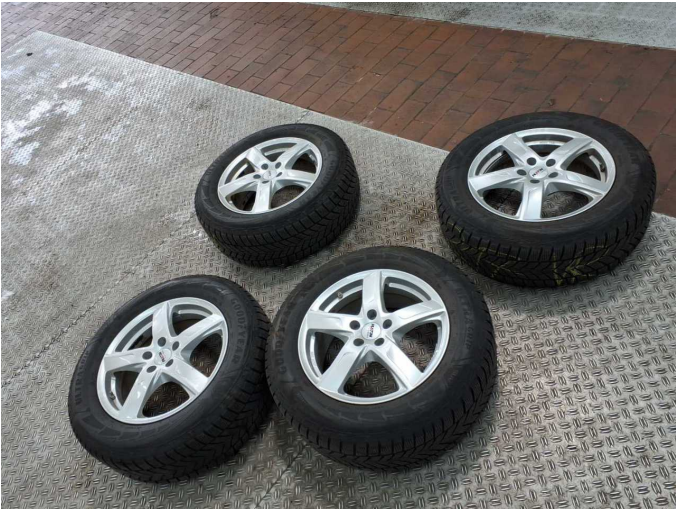
#	Tyre size	Type of tyre	Manufacturer	Tread depth
1)	225/65 R17 106H	Winter tyres on Light alloy	Goodyear	6mm / 6mm
2)	225/65 R17 106H	Winter tyres on Light alloy	Goodyear	7mm / 7mm

- Winterradsatz ist kein Bestandteil des Auslieferungsumfangs

Figure 17: Additional tyres

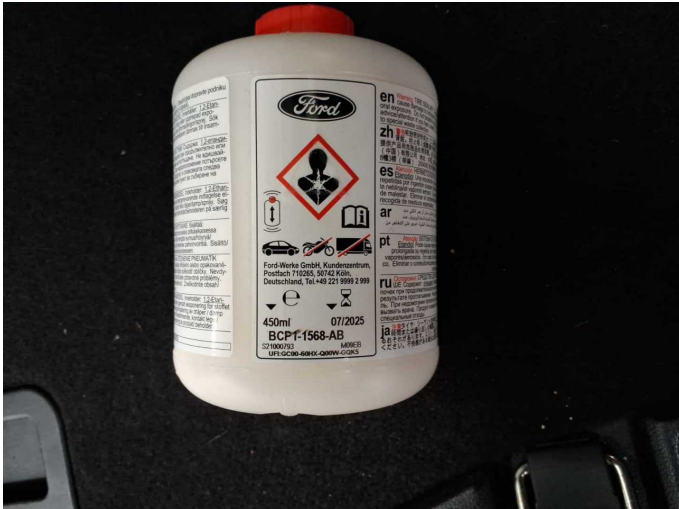
No.	Component group	Description
1	Equipment	Tirefit filler - Expired - Replace
2	Door - front left side	Door (Ausblenden/polieren) - dent(s) - Smart repair

Damage 1: Equipment: Tirefit filler - Expired - Replace
