Expertise

Protocol number: 40591169
Order No. / Reference: 24966429
Inspection date: 15 Jul 2025

Manufacturer: Ford

Model: S-Max 2.0 EcoBlue Aut. TREND

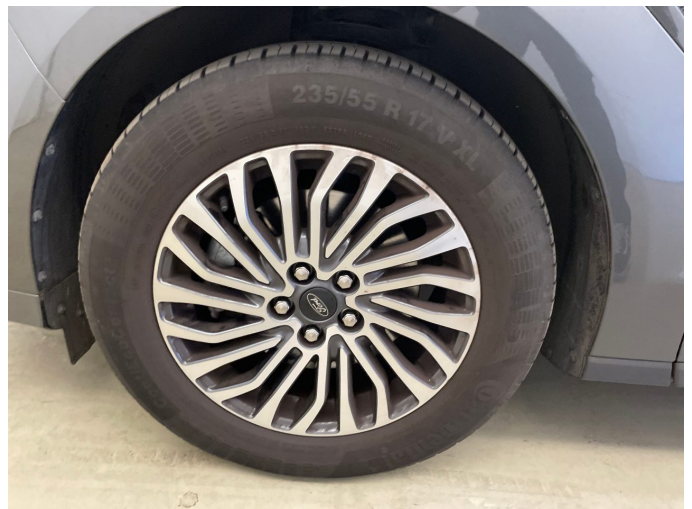
Figure 12: Mounted tyres

#	Tyre size	Type of tyre	Manufacturer	Tread depth
1)	235/55 R17 103V	Summer tyres on Light alloy	Continental	5mm / 5mm
2)	235/55 R17 103V	Summer tyres on Light alloy	Continental	5mm / 5mm

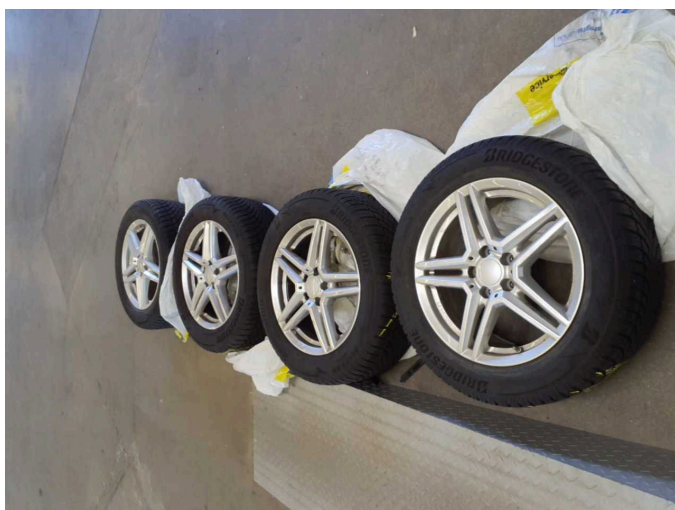
Figure 17: Additional tyres

#	Tyre size	Type of tyre	Manufacturer	Tread depth
1)	235/55 R17 103V	Winter tyres on Light alloy	Bridgestone	6mm / 6mm
2)	235/55 R17 103V	Winter tyres on Light alloy	Bridgestone	7mm / 7mm

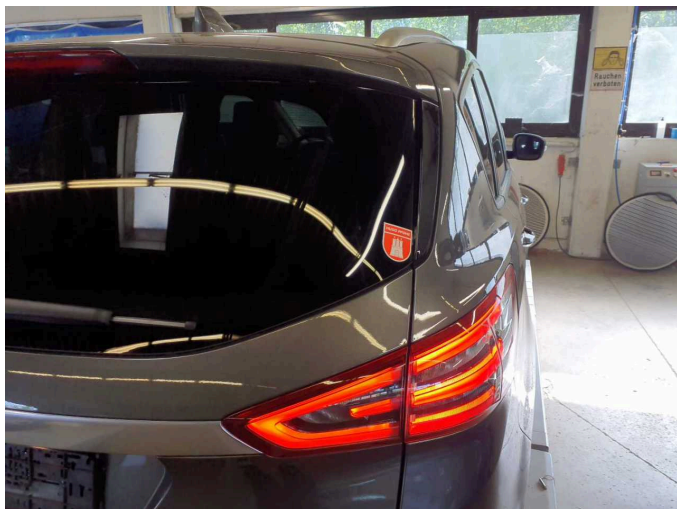
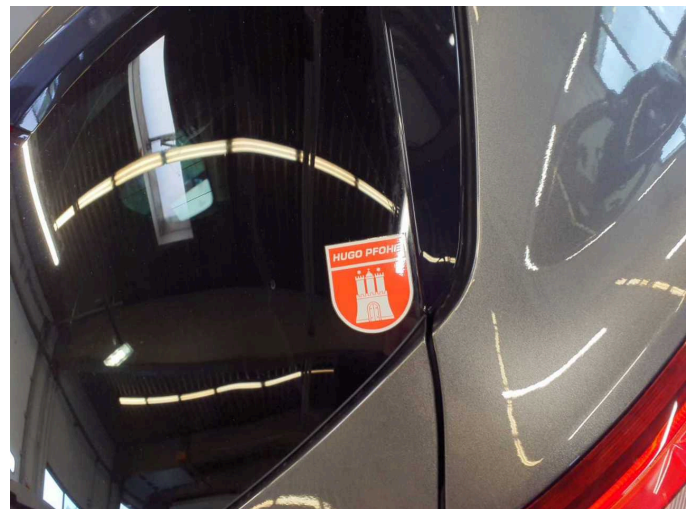
Damage 1: Vehicle glazing: Rear window - Glued / labelled - De-glue / neutralise

No.	Component group	Description
1	Vehicle glazing	Rear window - Glued / labelled - De-glue / neutralise
2	Engine	Engine cover - top / cover - Damage caused by marten / rodent - Replace
3	Side panel - rear right side	Interior trim - Scratch(es) - Loss in value
4	Front bumper	Spoiler - Scratched - Repair and paint

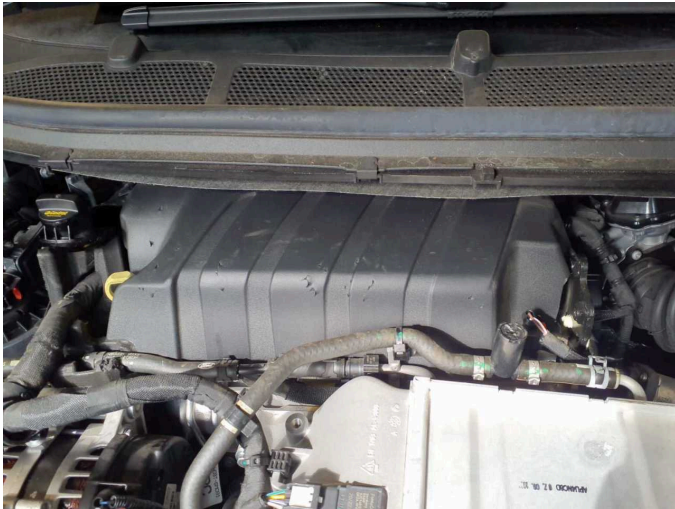
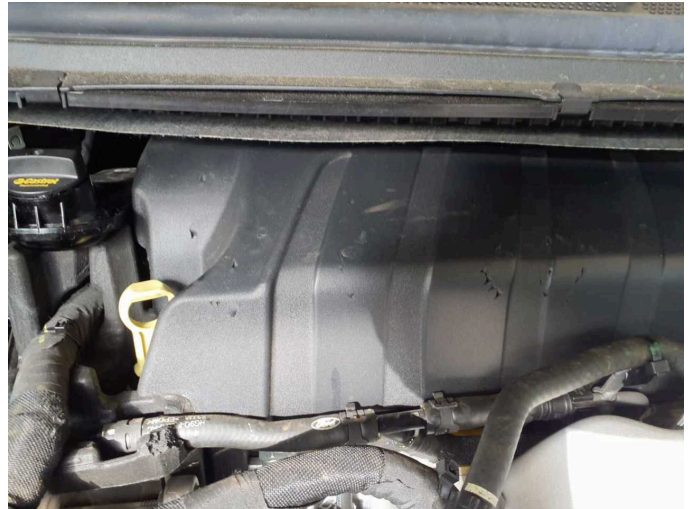
Damage 2: Engine: Engine cover - top / cover - Damage caused by marten / rodent - Replace

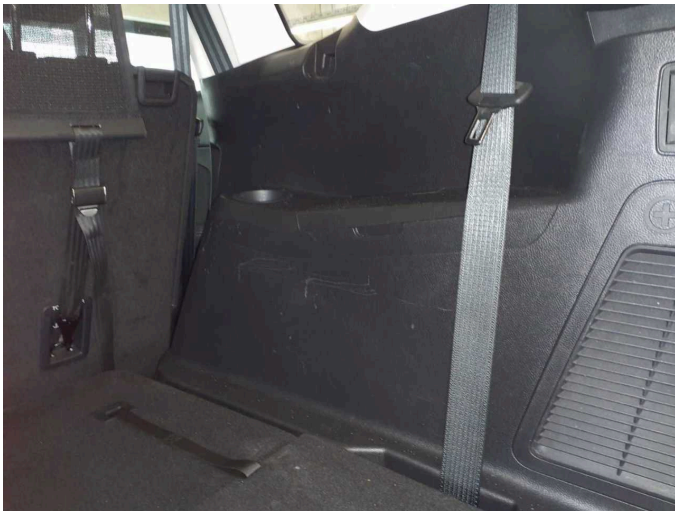
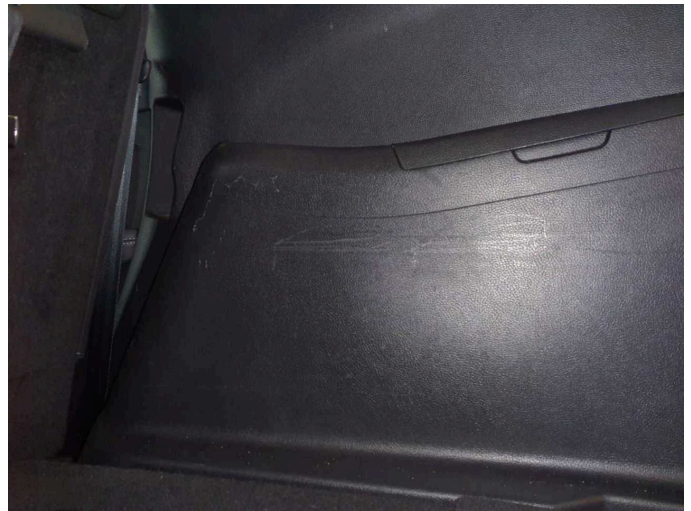
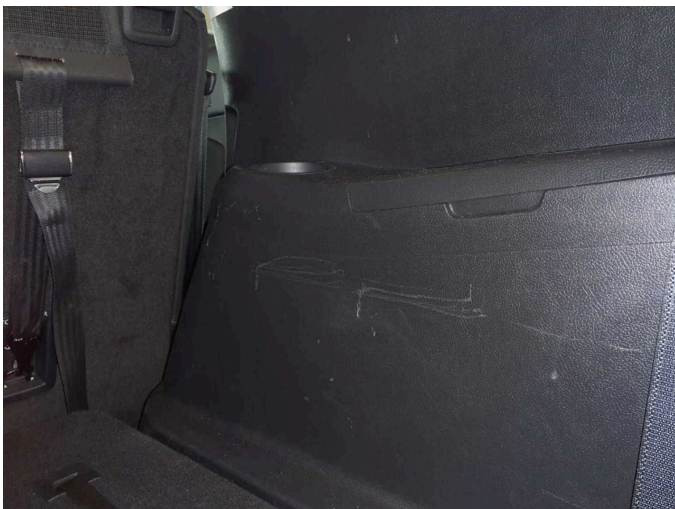
Damage 3: Side panel - rear right side: Interior trim - Scratch(es) - Loss in value

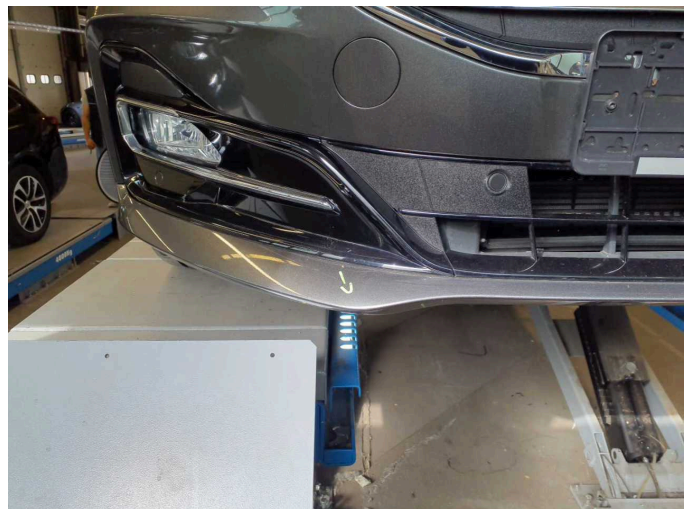
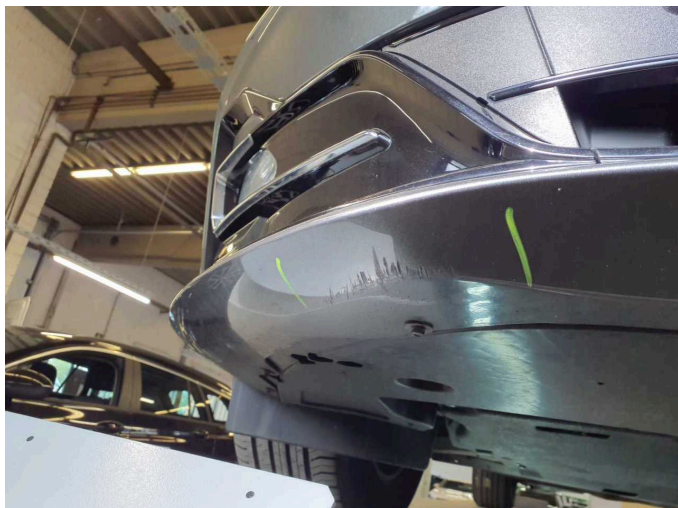
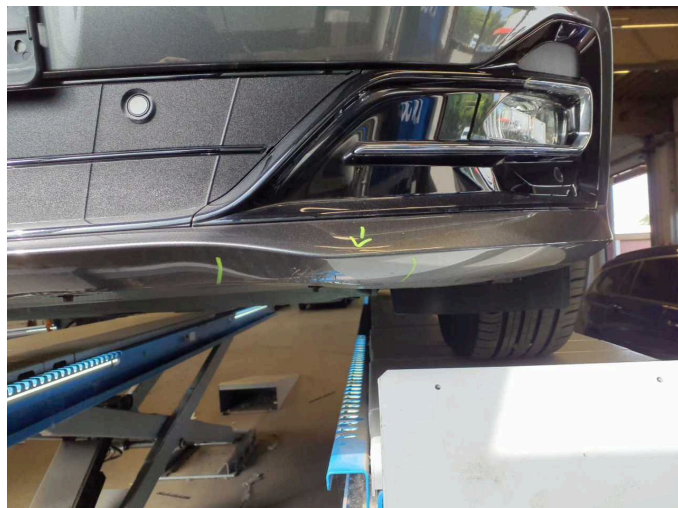
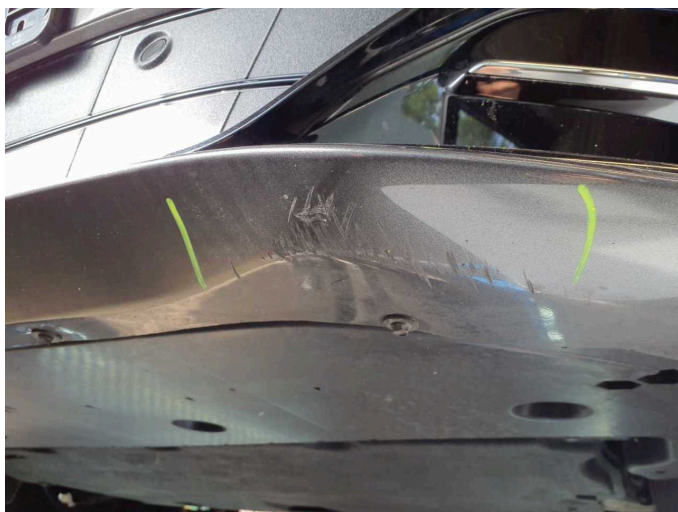
Damage 4: Front bumper: Spoiler - Scratched - Repair and paint
