Expertise

Protocol number: 40959799
Order No. / Reference: 24852237
Inspection date: 7 Aug 2025

Manufacturer: Ford	Model: S-Max 2.0 EcoBlue Aut. ST-Line
VIN: WF0JXXWPCJNS12032

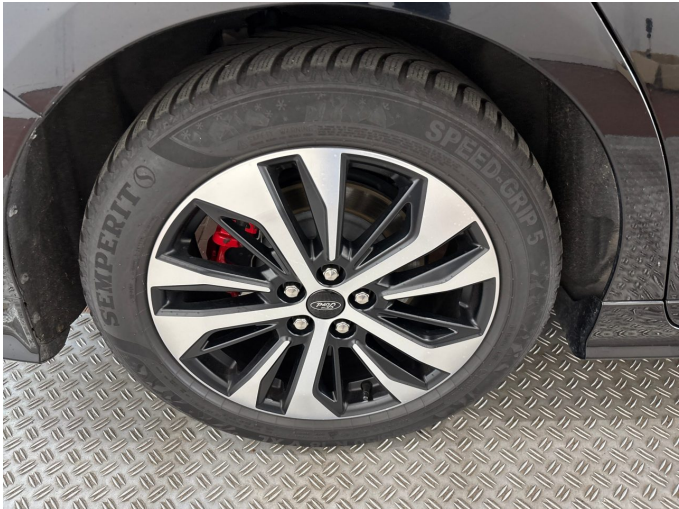
Figure 12: Mounted tyres

#	Tyre size	Type of tyre	Manufacturer	Tread depth
1)	235/50 R18 101V	Winter tyres on Light alloy	Continental	4mm / 5mm
2)	235/50 R18 101V	Winter tyres on Light alloy	Continental	6mm / 6mm

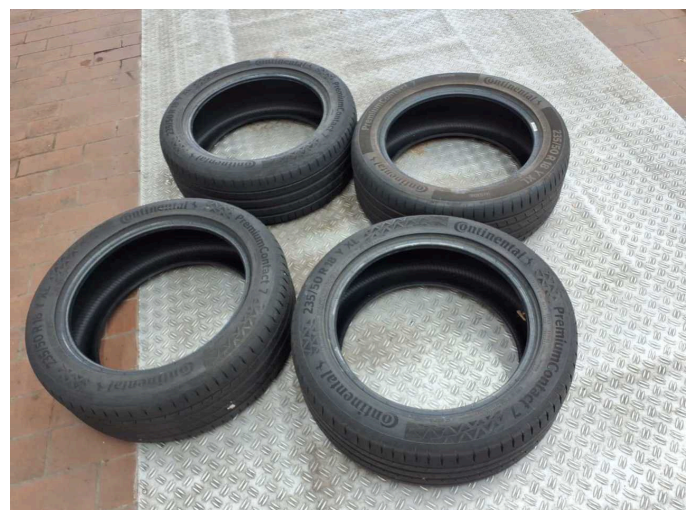
Figure 18: Additional tyres

#	Tyre size	Type of tyre	Manufacturer	Tread depth
1)	235/50 R18 101Y	Summer tyres (Without wheel rim)	Continental	4mm / 4mm
2)	235/50 R18 101Y	Summer tyres (Without wheel rim)	Continental	5mm / 5mm

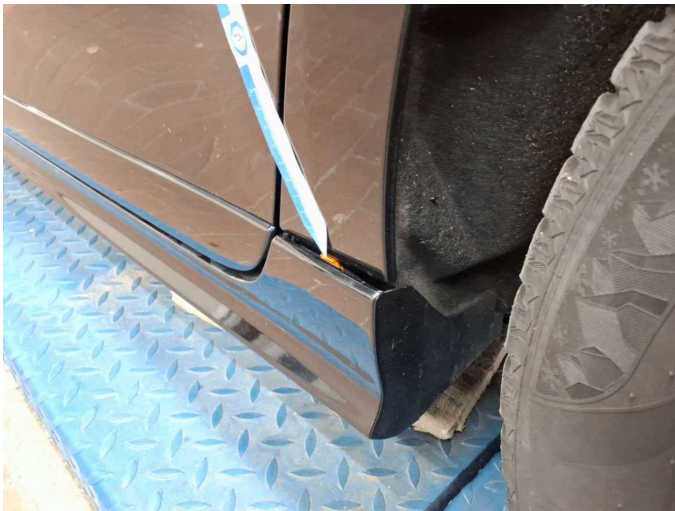
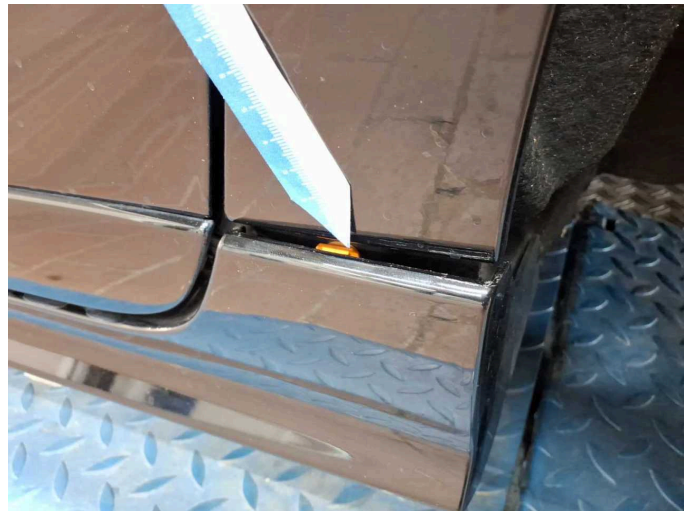
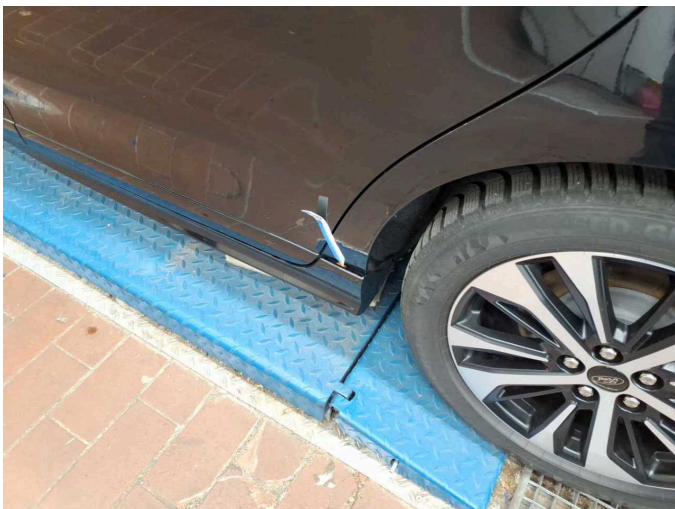
Damage 3: Sill - left side: Sill - Loose - Un- / install

No.	Component group	Description
1	Misc.	Main inspection - No evidence - No deduction
2	Wheel / tyres	Tyres - complete set - Differs from the original configuration - No deduction
3	Sill - left side	Sill - Loose - Un- / install
4	Front bumper	Spoiler - Scratched - Paint
5	Side panel - rear left side	Side panel - Scratch(es) - Paint
6	Rear bumper	Rear bumper - Scratch(es) - Paint

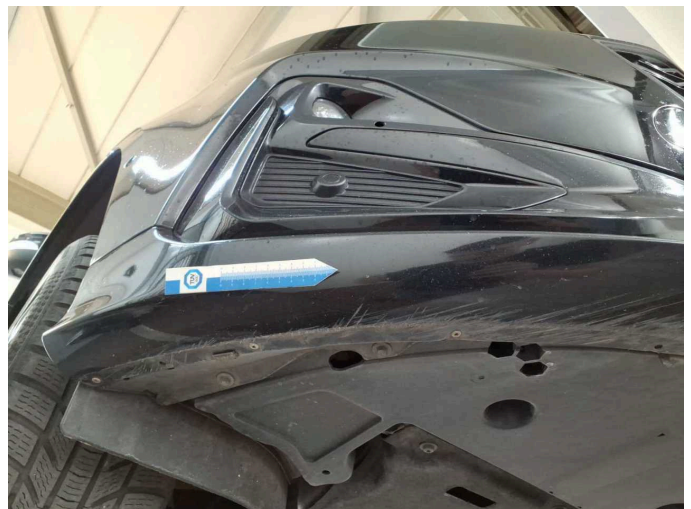
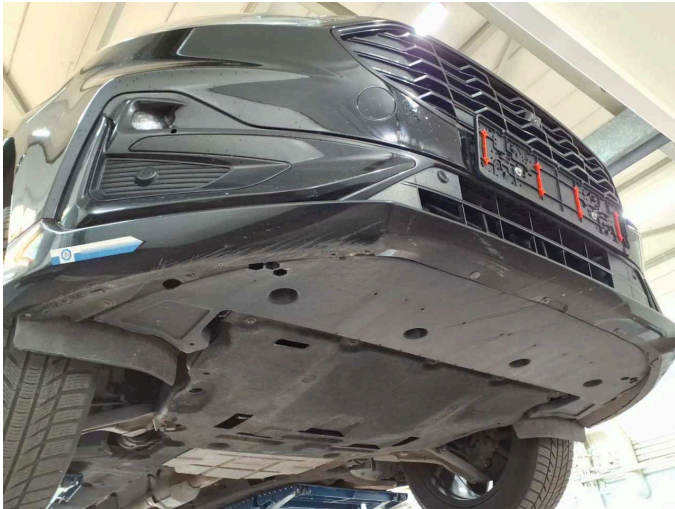
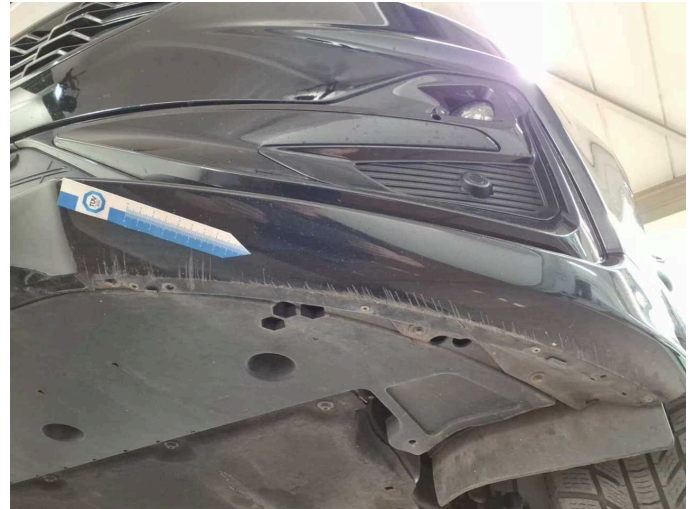
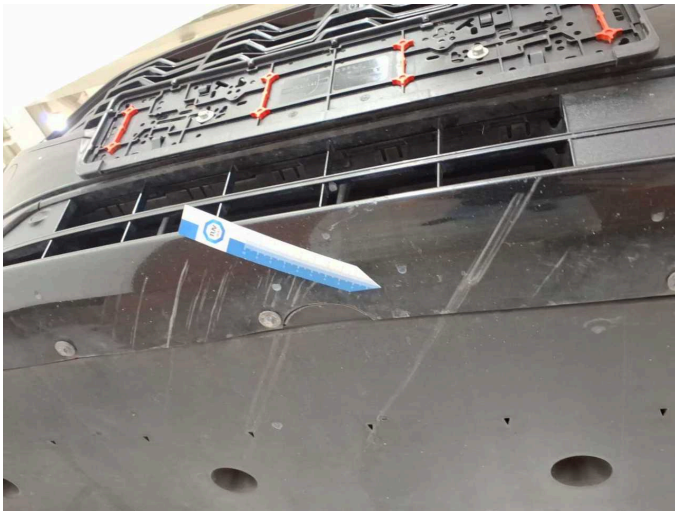
Damage 4: Front bumper: Spoiler - Scratched - Paint

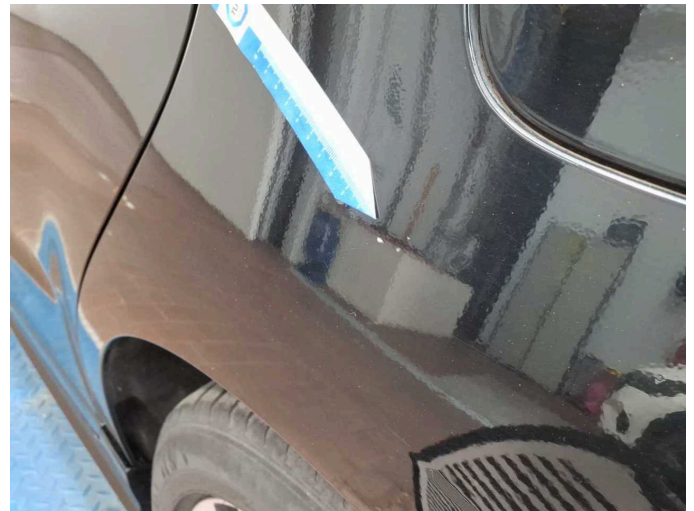
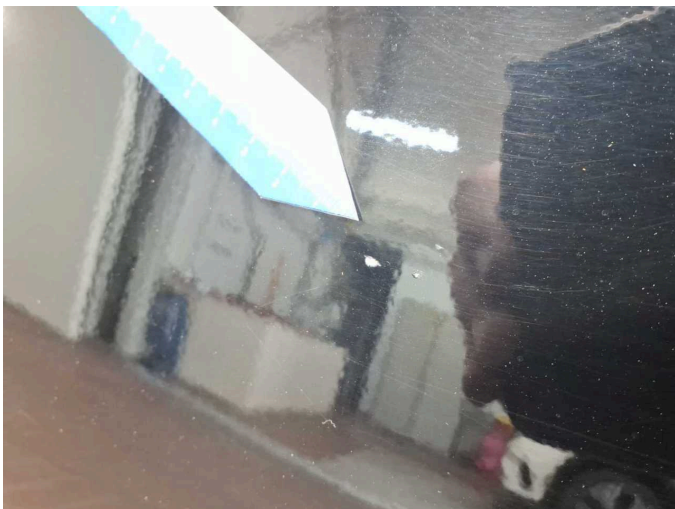
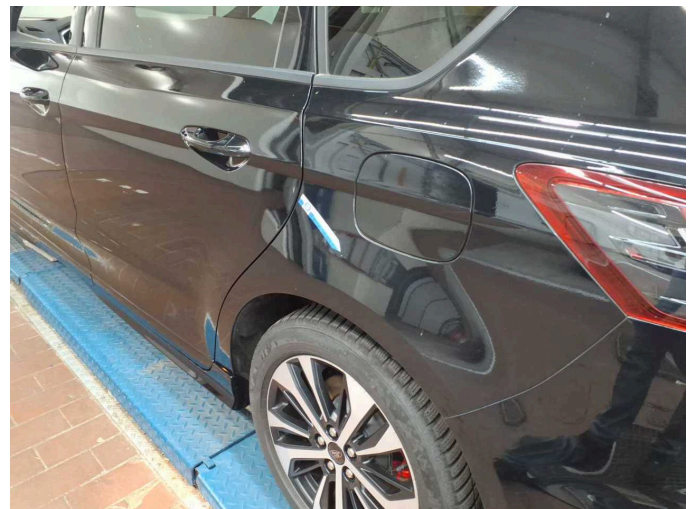
Damage 5: Side panel - rear left side: Side panel - Scratch(es) - Paint

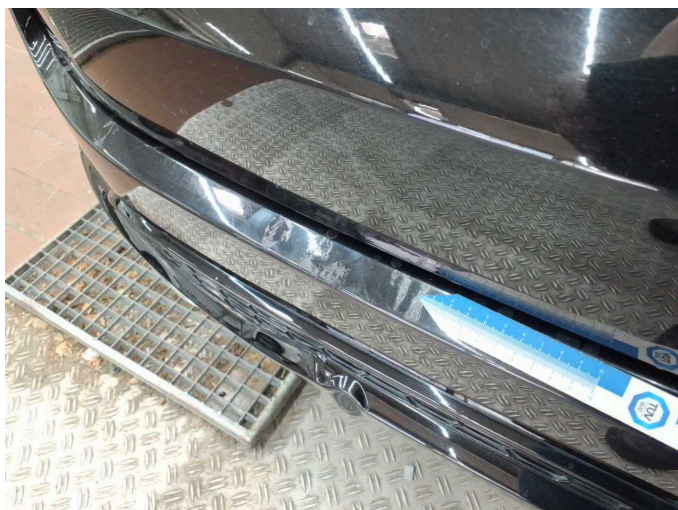
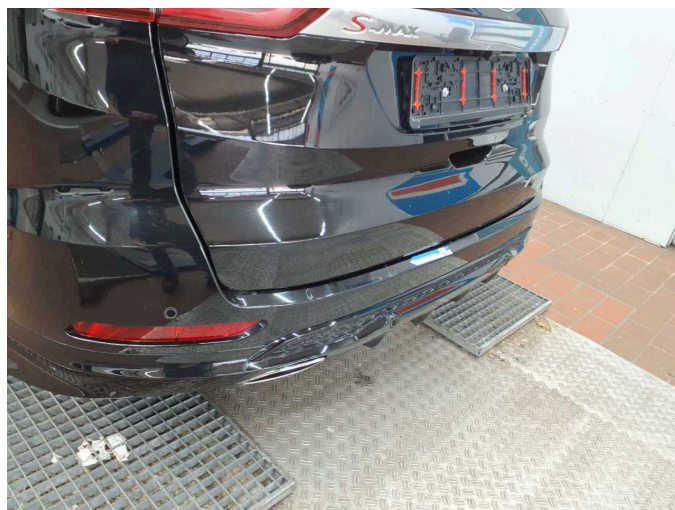
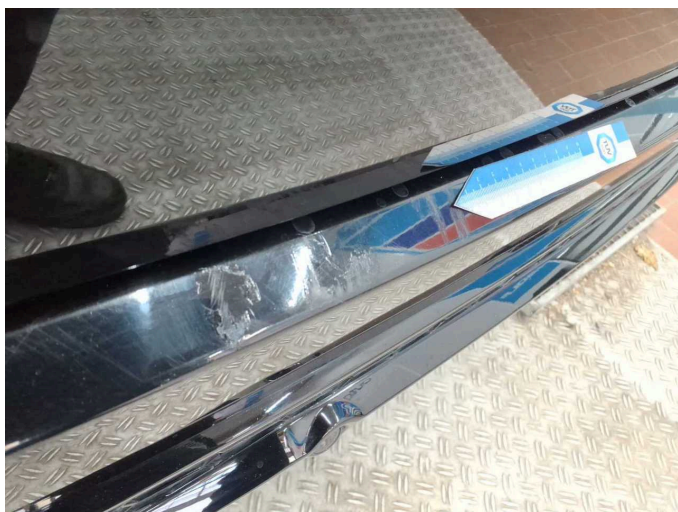
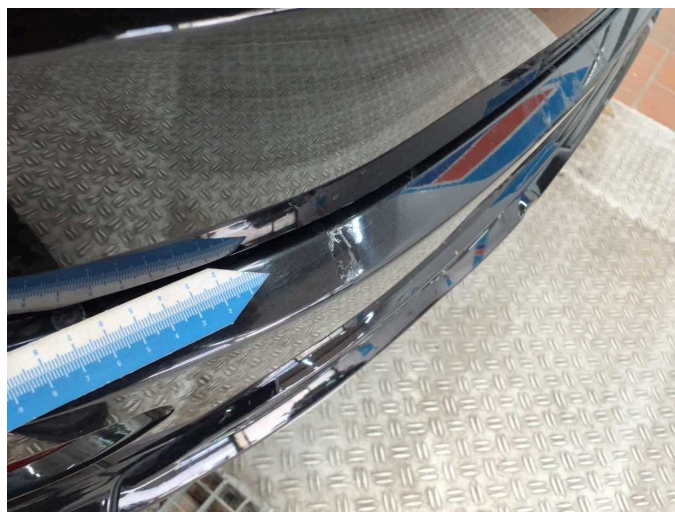
Damage 6: Rear bumper: Rear bumper - Scratch(es) - Paint
