Expertise

Protocol number: 41241102
Order No. / Reference: 25007889
Inspection date: 26 Aug 2025

Manufacturer: Ford

Model: Galaxy 2.0 EcoBlue Aut. Titanium

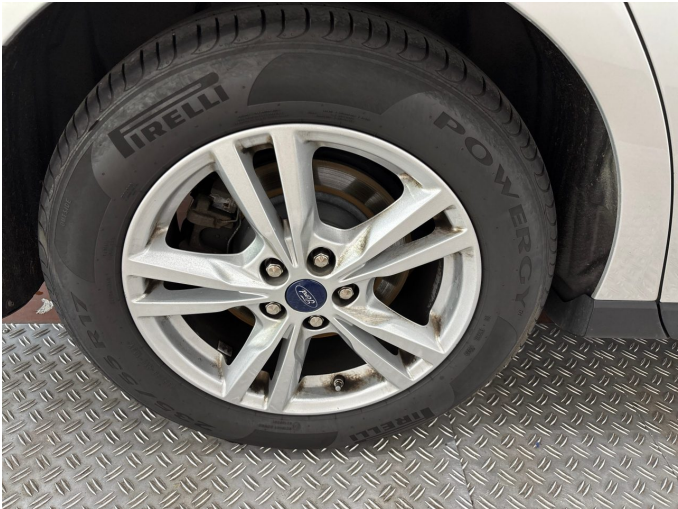
Figure 12: Mounted tyres

#	Tyre size	Type of tyre	Manufacturer	Tread depth
1)	235/55 R17 103Y XL	Summer tyres on Light alloy	Pirelli	5mm / 5mm
2)	235/55 R17 103Y XL	Summer tyres on Light alloy	Pirelli	4mm / 4mm

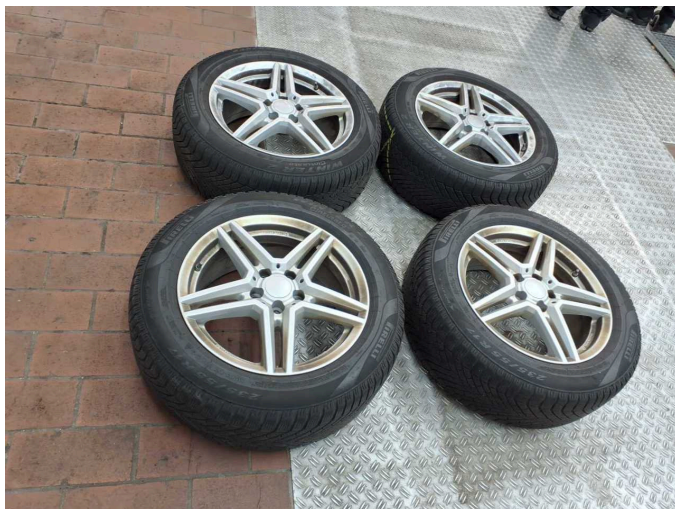
Figure 17: Additional tyres

#	Tyre size	Type of tyre	Manufacturer	Tread depth
1)	235/55 R17 103V XL	Winter tyres on Light alloy	Pirelli	5mm / 5mm
2)	235/55 R17 103V XL	Winter tyres on Light alloy	Pirelli	5mm / 5mm

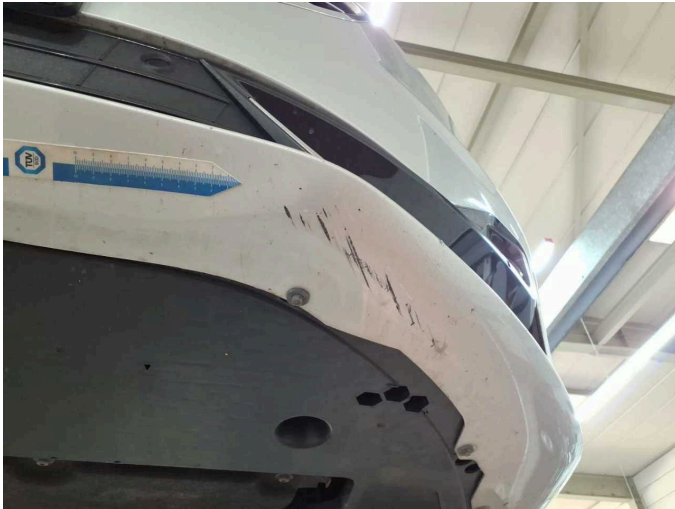
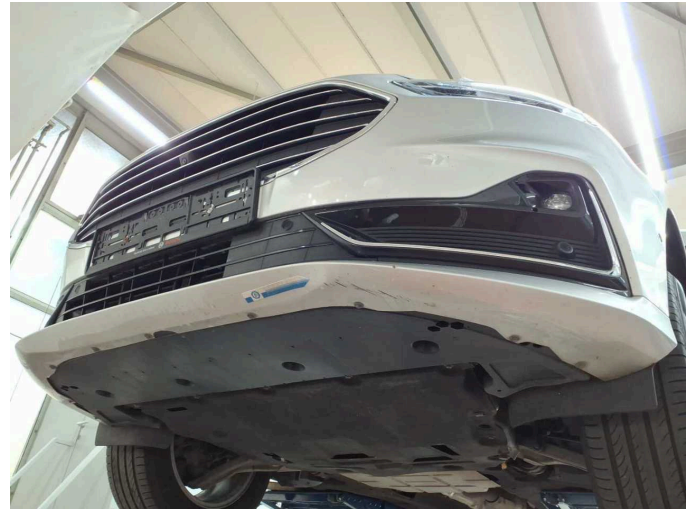
No.	Component group	Description
1	Front bumper	Front bumper - Scratched - Smart repair
2	Side panel - rear right side	Side panel - dent(s) - Smooth repair work

No.	Component group	Description
1	Front bumper	Front bumper - Scratched - No deduction
2	Rear bumper	Rear bumper - Scratched - No deduction
3	Body	Body - Scratch(es) - No deduction
4	Body	Body - Stone chips - No deduction
5	Vehicle glazing	Windscreen - Stone chips - No deduction

Damage 1: Front bumper: Front bumper - Scratched - Smart repair
