Expertise

Protocol number: 41592873  
Order No. / Reference: 25147420  
Inspection date: 17 Sept 2025

| Manufacturer: Ford | Model: Focus 1.5 EcoBlue Start-Stopp-System Aut. ACTIVE |

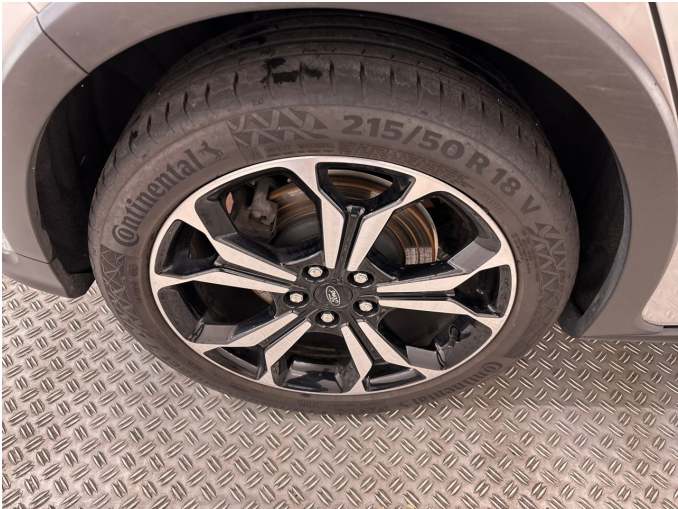
Figure 12: Mounted tyres

| # | Tyre size | Type of tyre | Manufacturer | Tread depth |
|---|---|---|---|---|
| 1) | 215/50 R18 92V | Summer tyres on Light alloy | Continental | 5mm / 5mm |
| 2) | 215/50 R18 92V | Summer tyres on Light alloy | Continental | 5mm / 5mm |

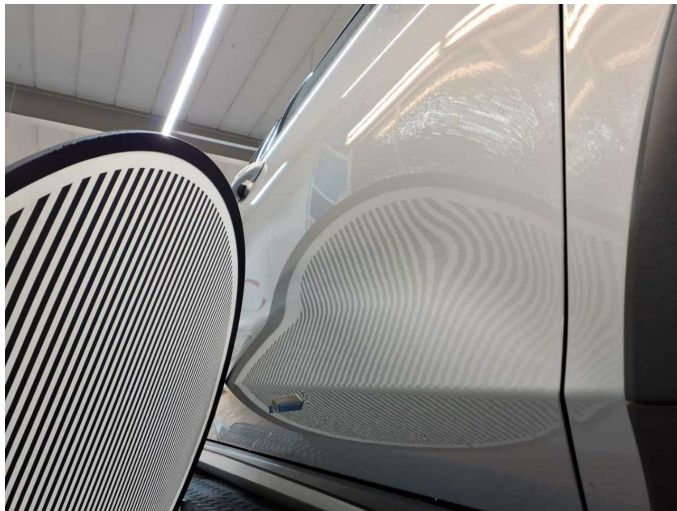
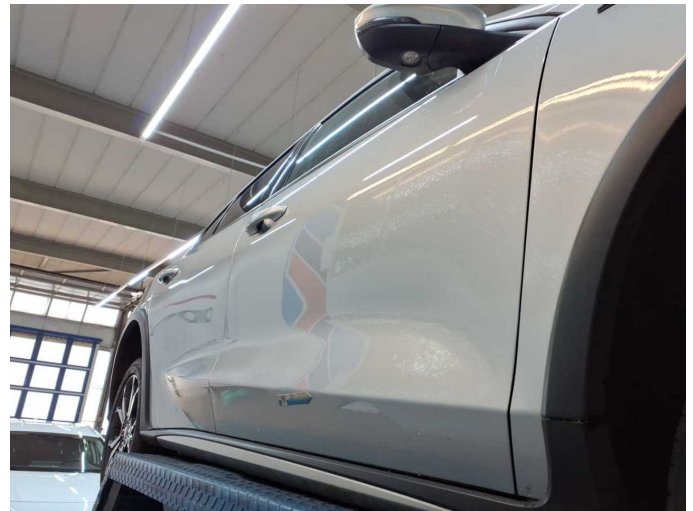
| No. | Component group | Description |
|---|---|---|
| 1 | Door - front right side | Door - dent(s) - Smart repair |

**Damage 1:** Door - front right side: Door - dent(s) - Smart repair

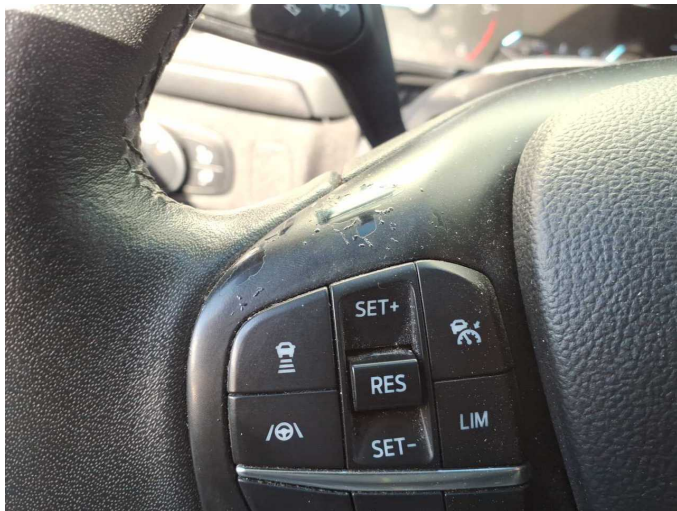
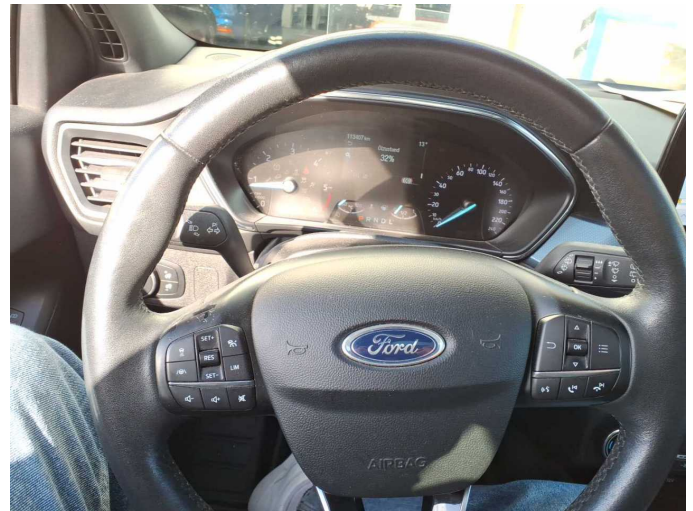
| No. | Component group | Description |
|---|---|---|
| 2 | Steering system | Steering wheel - Paint defect - Replace |

**Damage 2:** Steering system: Steering wheel - Paint defect - Replace

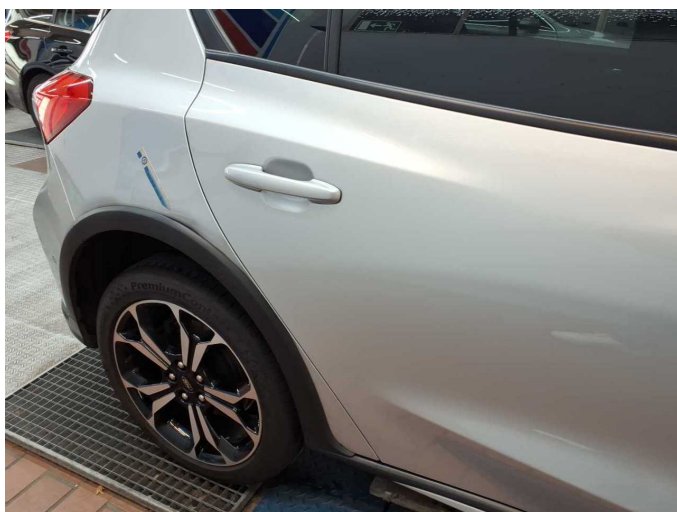
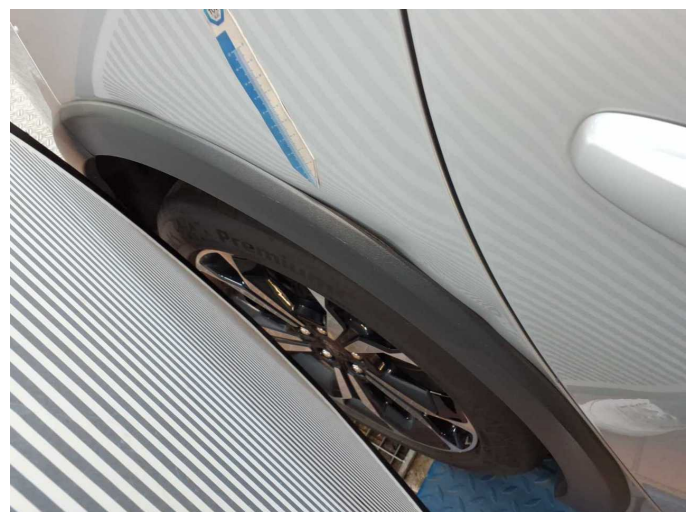
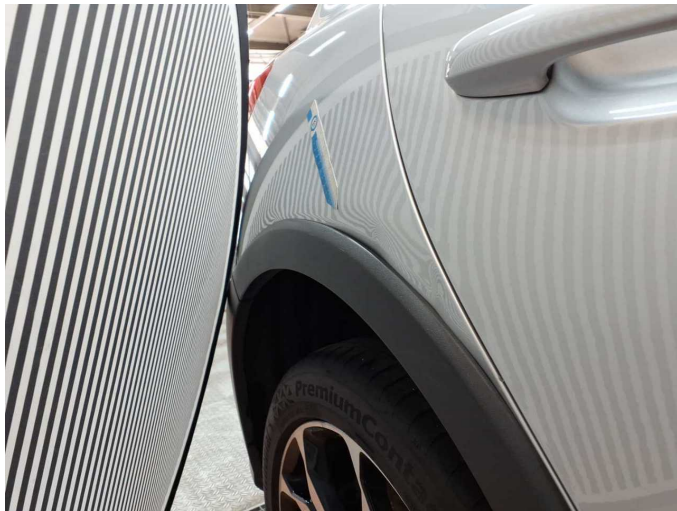
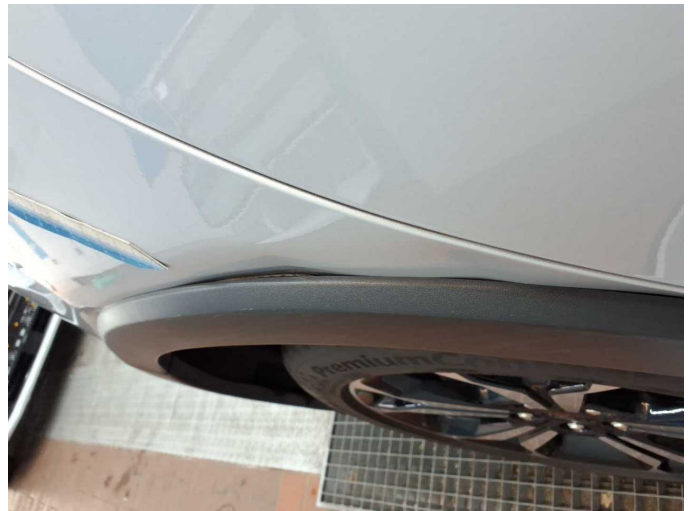
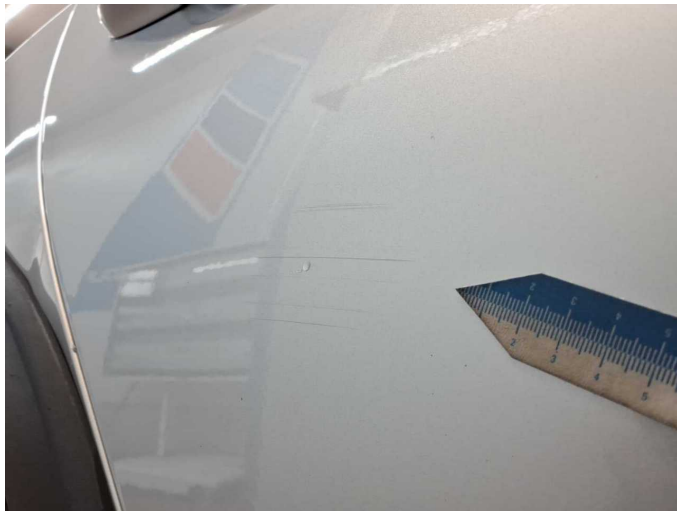
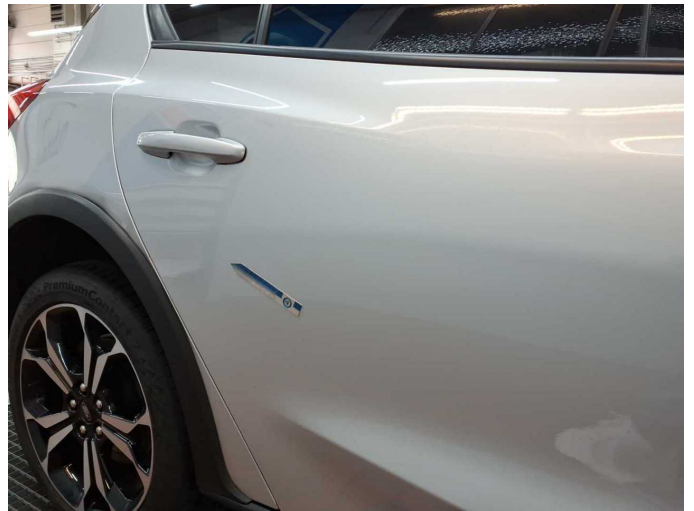
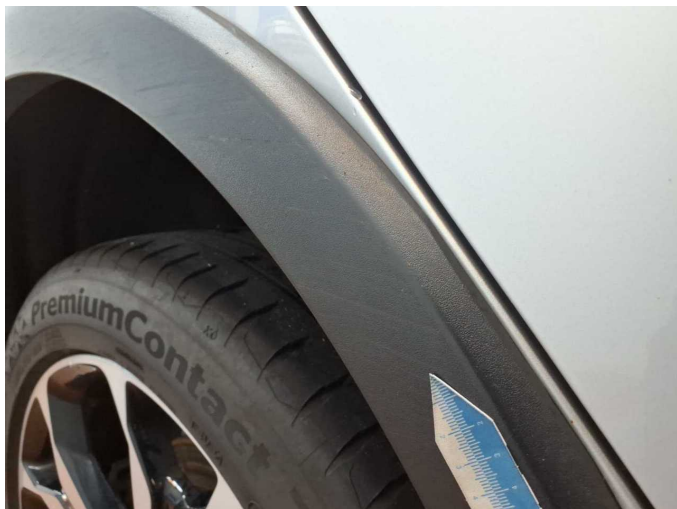
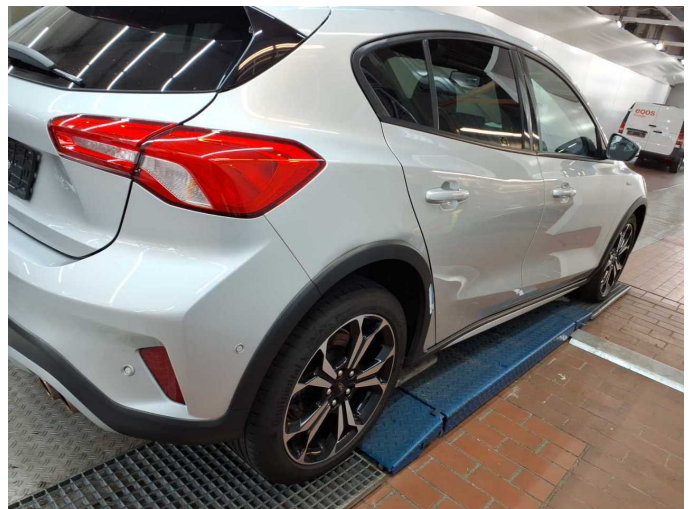
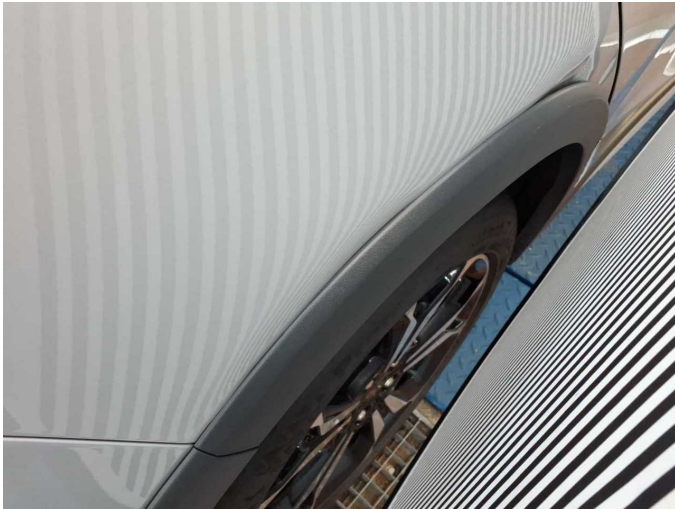
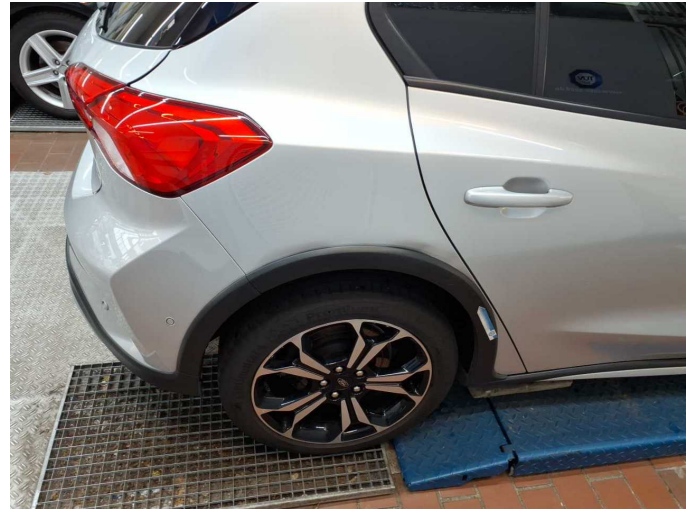
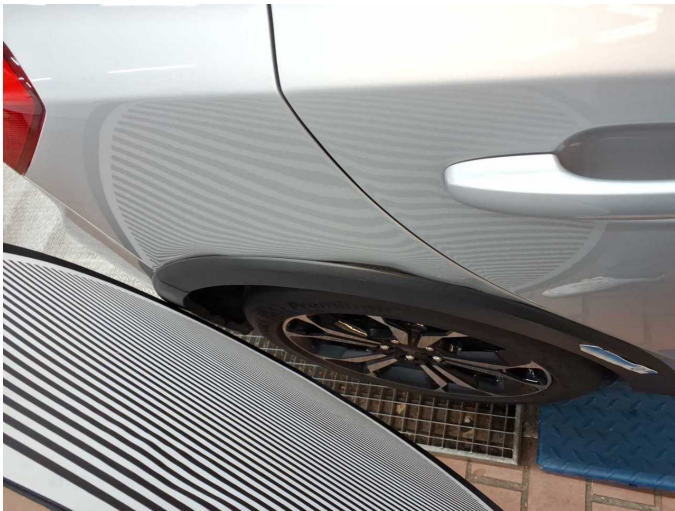
- Side right

Non-repaired previous damages were found at the vehicle. The necessary repair costs are listed in the expert report or if necessary, are listed in detail in a separately enclosed repair cost calculation.

**Accident 1:** Side right

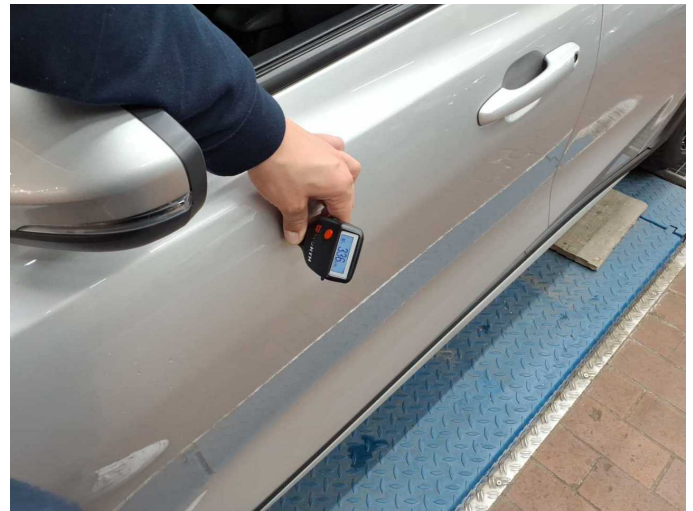
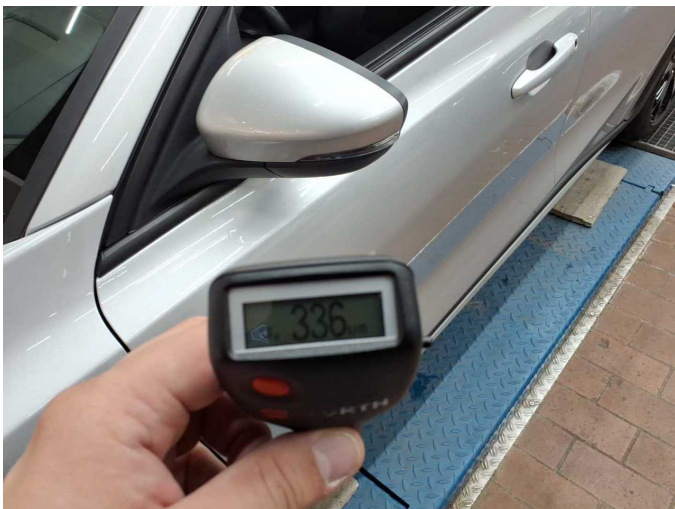
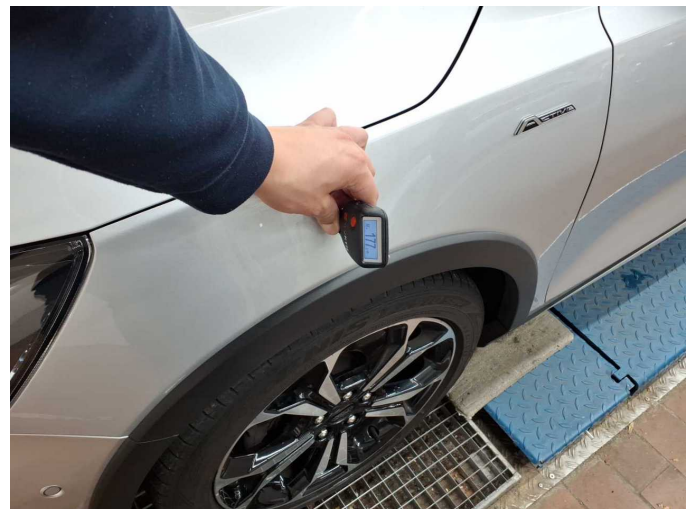
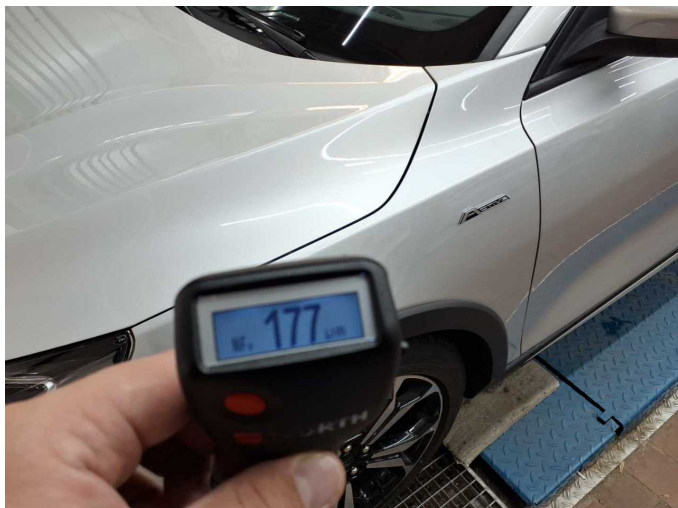
- Mudguard - left side, Door - front left side, Professionally carried out, Invoice of repair done Non-existent

| Mudguard - left side | 177 µm | Door - front left side | 336 µm |

**Repainting 1: Mudguard - left side, Door - front left side**
