Expertise

Protocol number: 39815120
Order No. / Reference: 24784556
Inspection date: 20 May 2025

Manufacturer: Ford

Model: Focus 1.0 EcoBoost Start-Stopp-System COOL&CONNECT

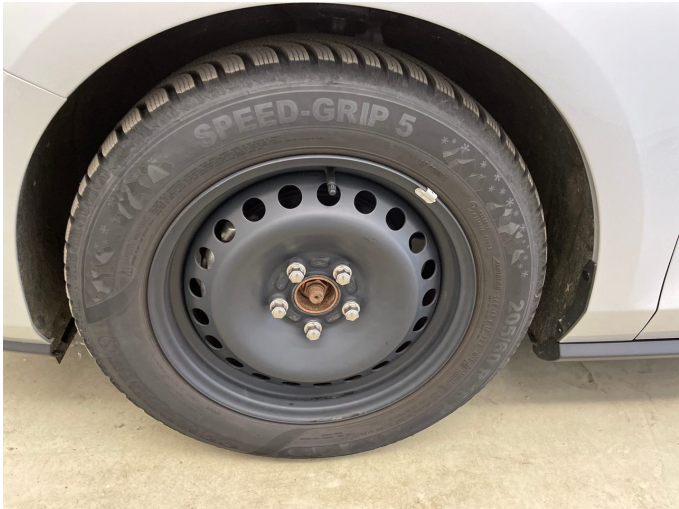
#	Tyre size	Type of tyre	Manufacturer	Tread depth
1)	205/60 R16 92H	Winter tyres on Steel	Semperit	5mm / 5mm
2)	205/60 R16 92H	Winter tyres on Steel	Semperit	6mm / 6mm

Figure 12: Mounted tyres

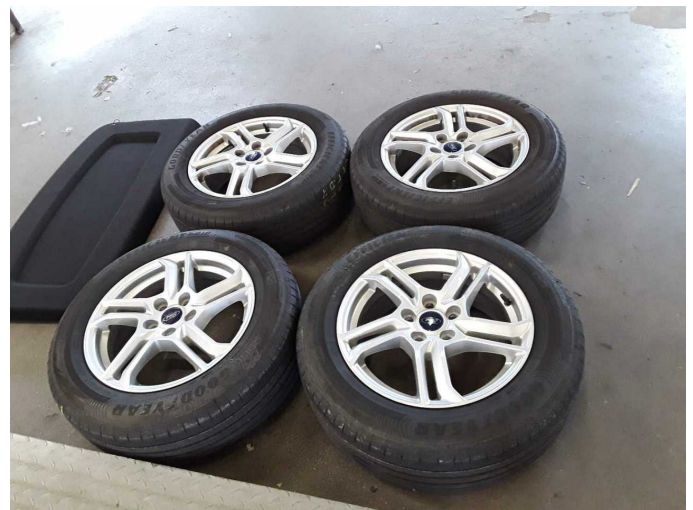
#	Tyre size	Type of tyre	Manufacturer	Tread depth
1)	205/60 R16 92V	Summer tyres on Light alloy	Goodyear	5mm / 5mm
2)	205/60 R16 92V	Summer tyres on Light alloy	Goodyear	5mm / 5mm

Figure 16: Additional tyres

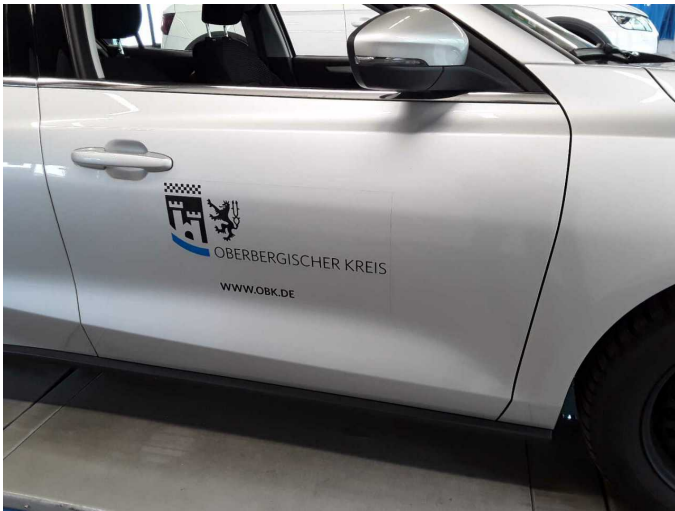
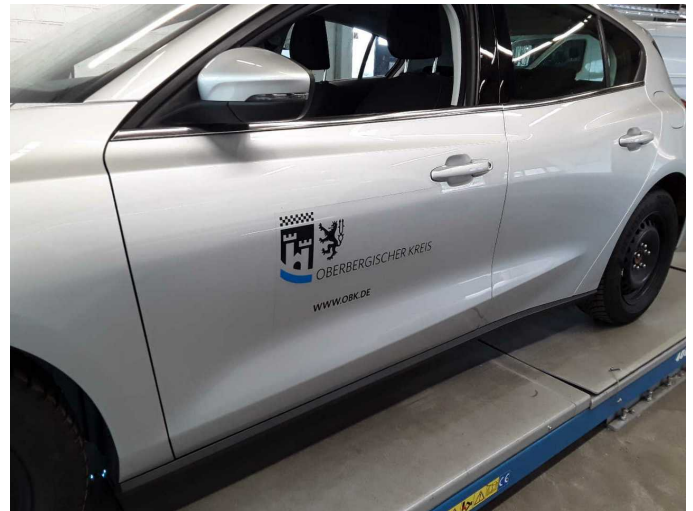
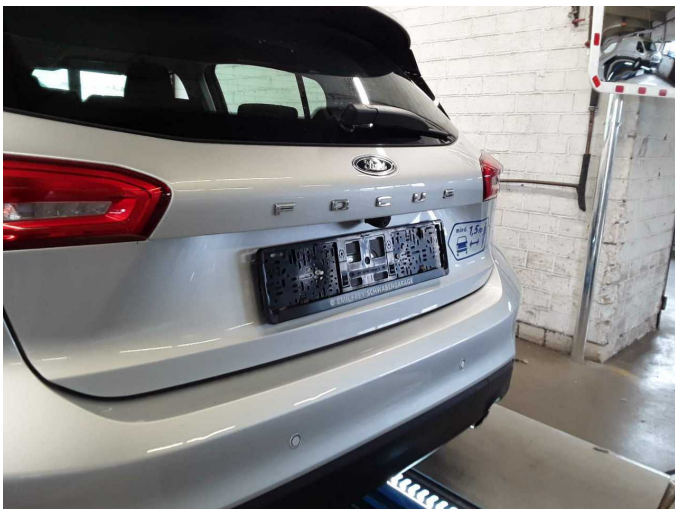
Damage 1: Body: Body - Glued / labelled - De-glue / neutralise

No.	Component group	Description
1	Body	Body - Glued / labelled - De-glue / neutralise

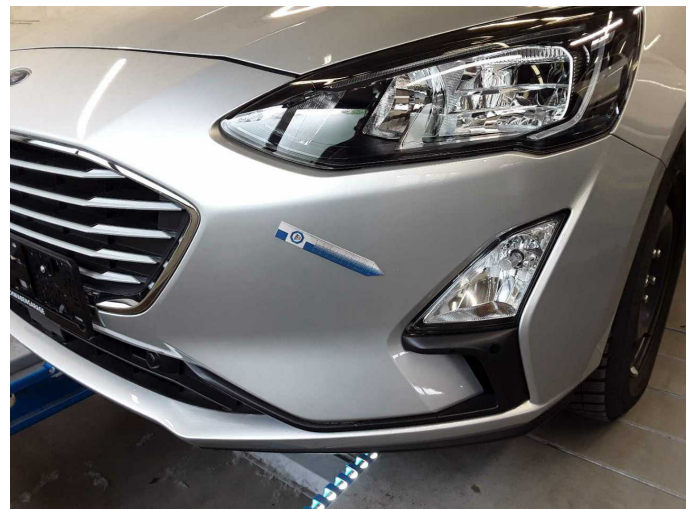
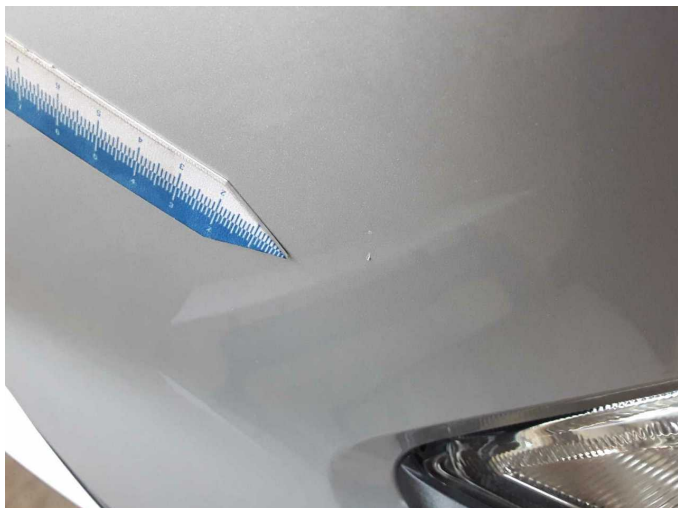
Wear and tear 1: Front bumper: Front bumper - Stone chips - No deduction

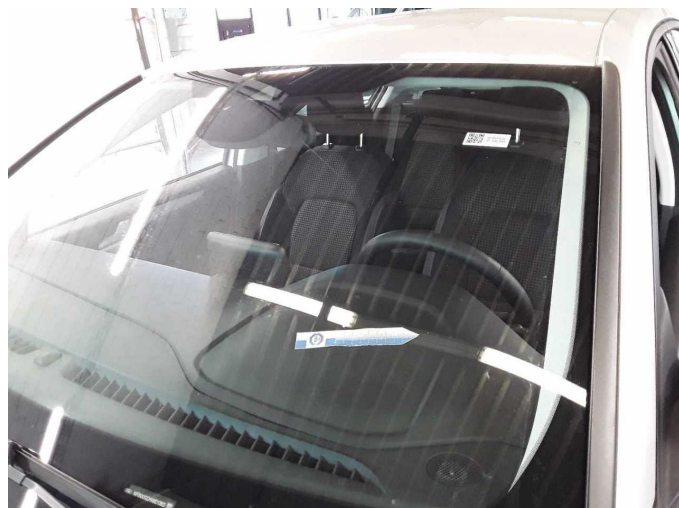
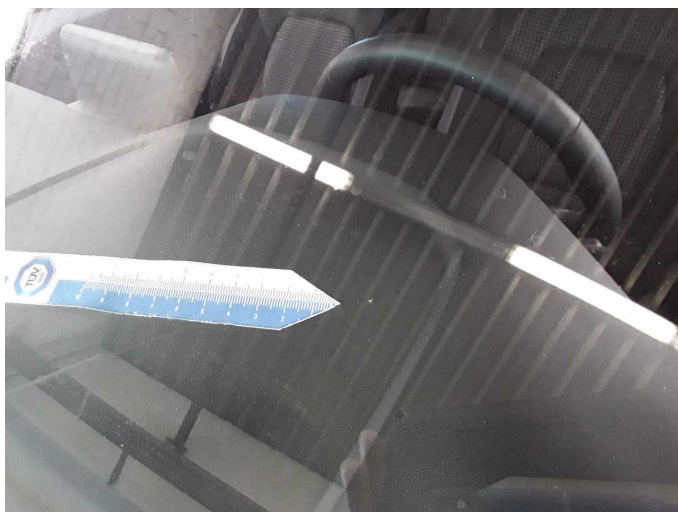
Wear and tear 2: Vehicle glazing: Windscreen - Stone chips - No deduction
