Expertise

Protocol number: 39433472
Order No. / Reference: 24586795
Inspection date: 22 Apr 2025

Manufacturer: Ford	Model: Focus 1.0 EcoBoost Hybrid TITANIUM STYLE
VIN: WF0NXXGCHNPK50035

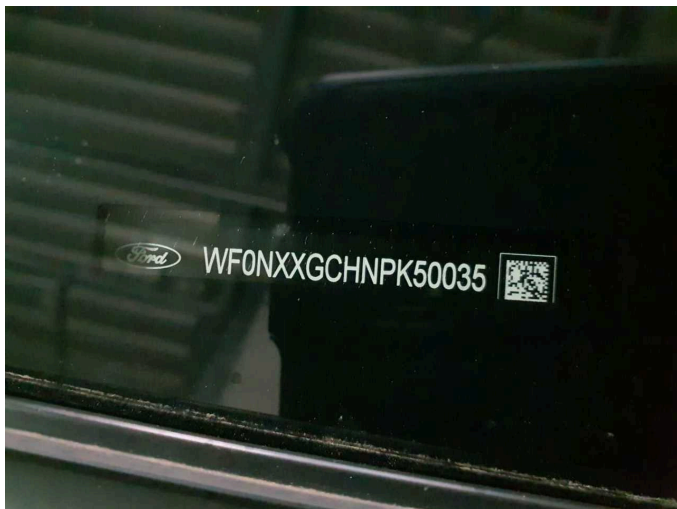
Figure 11: VIN

Documents submitted	At the time of the inspection, the registration certificate part 2 (letter) was available, but the registration certificate part 1 (certificate) was not available. (Copy)
VIN comparison	The vehicle identification number (VIN) was read and the undersigned verified that it matched the documents submitted during the inspection.
Inspection	The inspection conditions were sufficient to assess the vehicle. The inspection was carried out using the lighting conditions provided by the photo system included in the report. Lifting equipment and a pit were available for examining the vehicle.
Test drive	No test drive/maneuvering was carried out during the inspection of the vehicle.
Engine function test	An engine test run was performed.

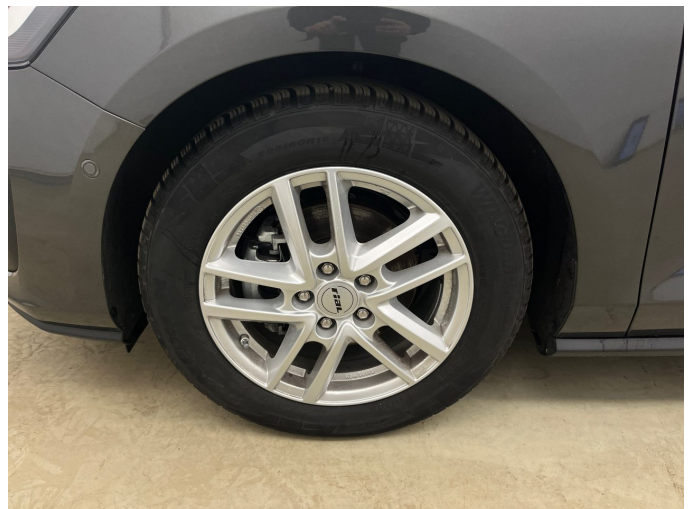
Figure 12: Mounted tyres

#	Tyre size	Type of tyre	Manufacturer	Tread depth
1)	205/60 R16 92H	Winter tyres on Light alloy	Nexen	7mm / 7mm
2)	205/60 R16 92H	Winter tyres on Light alloy	Nexen	7mm / 7mm

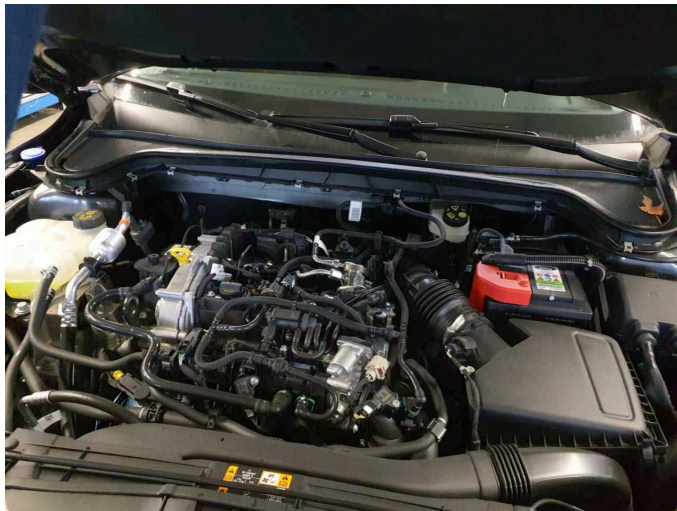
Damage 1: Engine: Engine cover - top / cover - Missing - Replace

No.	Component group	Description
1	Engine	Engine cover - top / cover - Missing - Replace
2	Misc.	Inspection / maintenance - Due - Perform

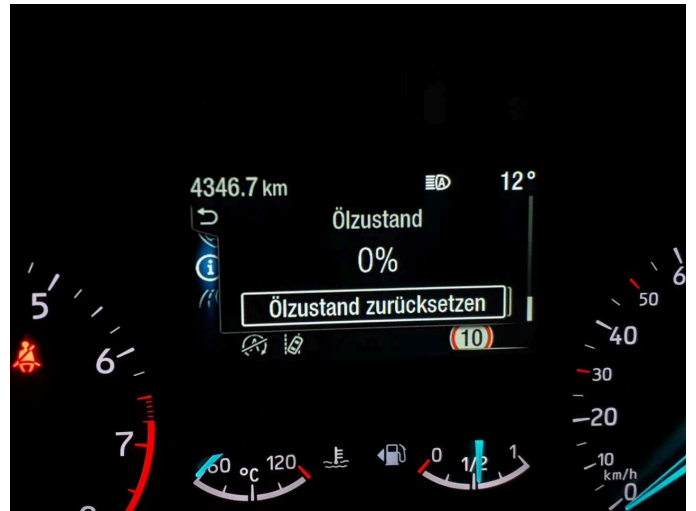
Damage 2: Misc.: Inspection / maintenance - Due - Perform
