Expertise

Protocol number: 41739661  
Order number / reference: 25235667  
Inspection date: 25 Sept 2025

Manufacturer: Ford

Model: Focus 1.0 EcoBoost Start-Stopp-System TITANIUM

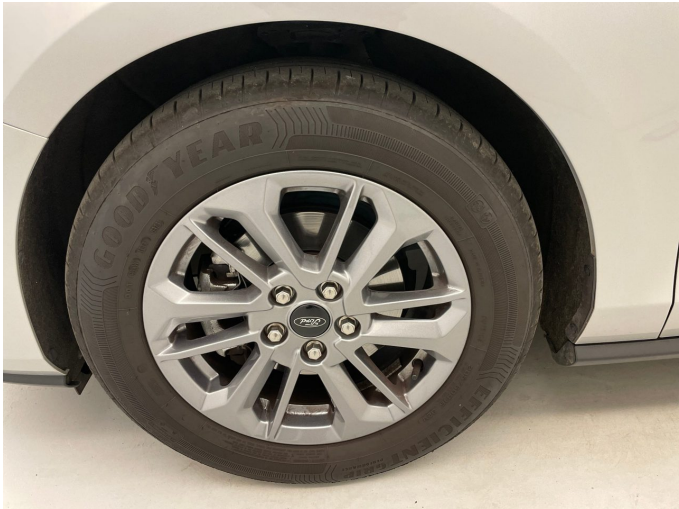
Figure 12: Mounted tyres

#	Tyre size	Type of tyre	Manufacturer	Tread depth
1)	205/60 R16 92V	Summer tyres on Light alloy	Goodyear	5mm / 5mm
2)	205/60 R16 92V	Summer tyres on Light alloy	Goodyear	6mm / 6mm

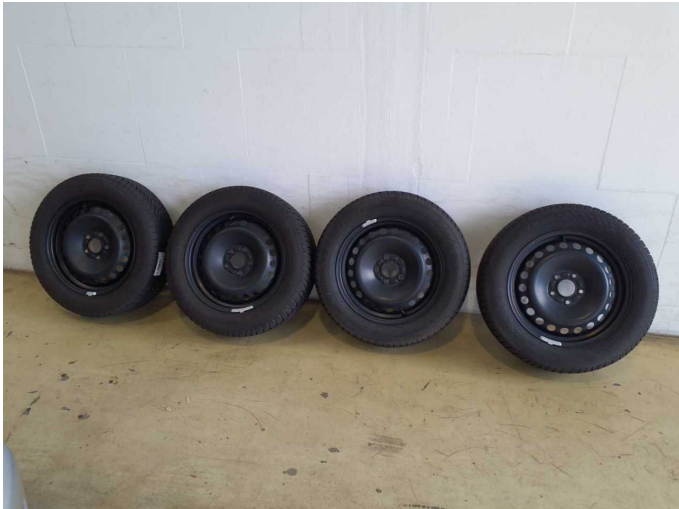
Figure 16: Additional tyres

#	Tyre size	Type of tyre	Manufacturer	Tread depth
1)	205/60 R16 96H	Winter tyres on Steel	Nokian	7mm / 7mm
2)	205/60 R16 96H	Winter tyres on Steel	Nokian	8mm / 8mm

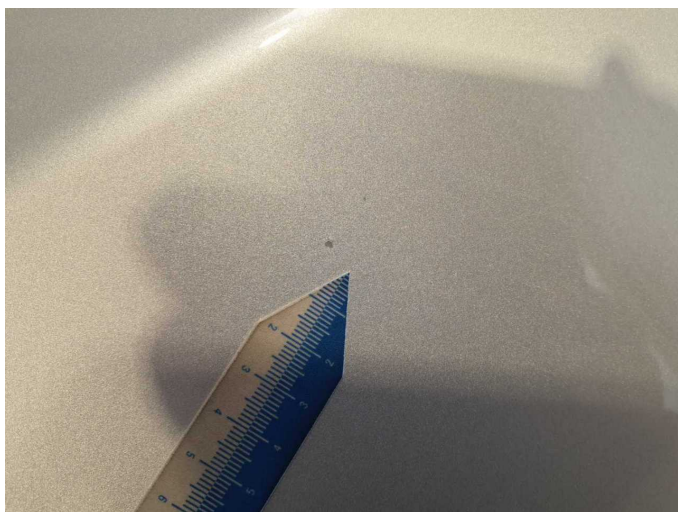
No.	Component group	Description
1	Bonnet	Bonnet - Stone chips - No deduction
2	Rear bumper	Rear bumper (Oberflächlich) - Scratch(es) - No deduction

**Wear and tear 1:** Bonnet: Bonnet - Stone chips - No deduction

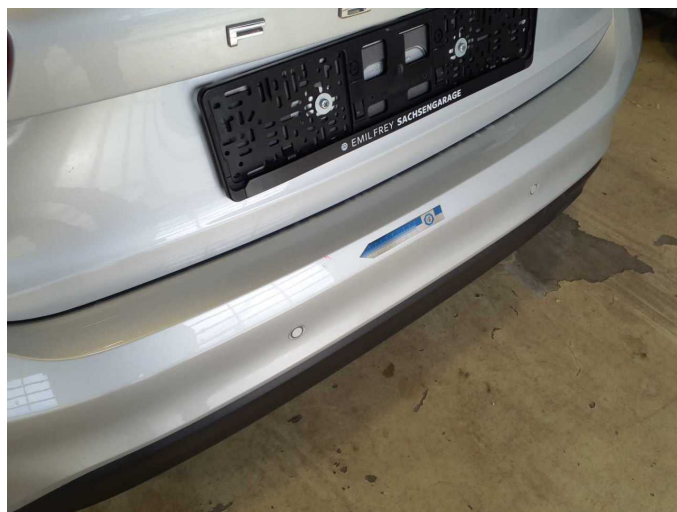
**Wear and tear 2:** Rear bumper: Rear bumper (Oberflächlich) - Scratch(es) - No deduction
