Expertise

Protocol number: 41491029
Order No. / Reference: 25173967
Inspection date: 11 Sept 2025

Manufacturer: Ford

Model: Focus 1.0 EcoBoost Start-Stopp-System TITANIUM

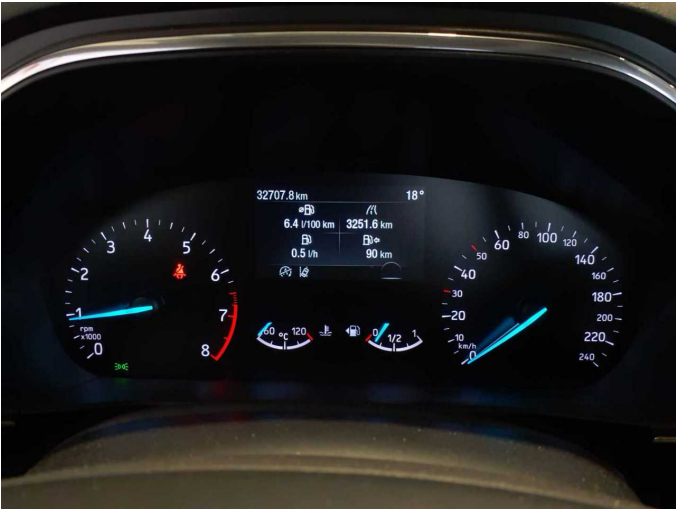
Figure 7: Instrument cluster

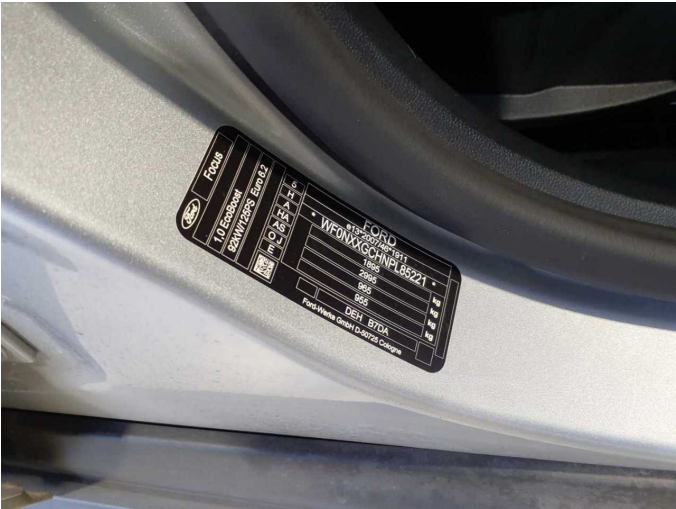
Figure 11: VIN

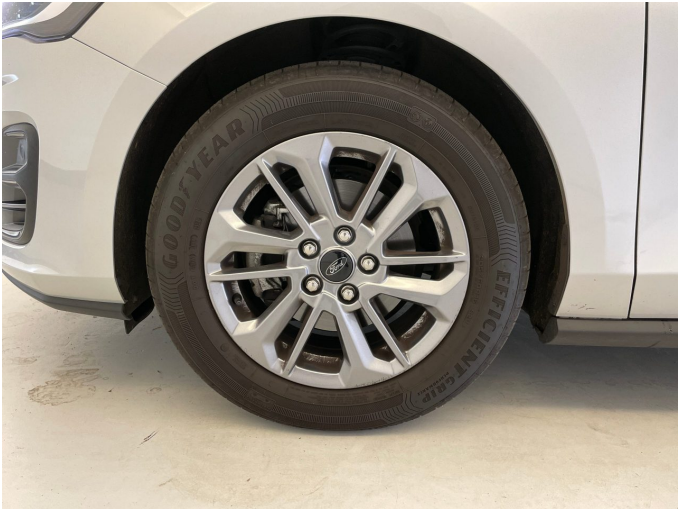
#	Tyre size	Type of tyre	Manufacturer	Tread depth
1)	205/60 R16 92V	Summer tyres on Light alloy	Goodyear	5mm / 5mm
2)	205/60 R16 92V	Summer tyres on Light alloy	Goodyear	6mm / 6mm

Figure 12: Mounted tyres

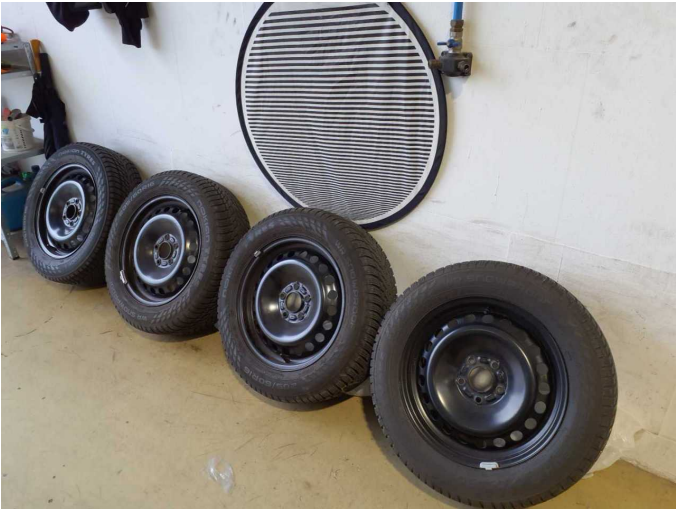
#	Tyre size	Type of tyre	Manufacturer	Tread depth
1)	205/60 R16 96H	Winter tyres on Steel	Nokian	7mm / 7mm
2)	205/60 R16 96H	Winter tyres on Steel	Nokian	7mm / 7mm

Figure 17: Additional tyres

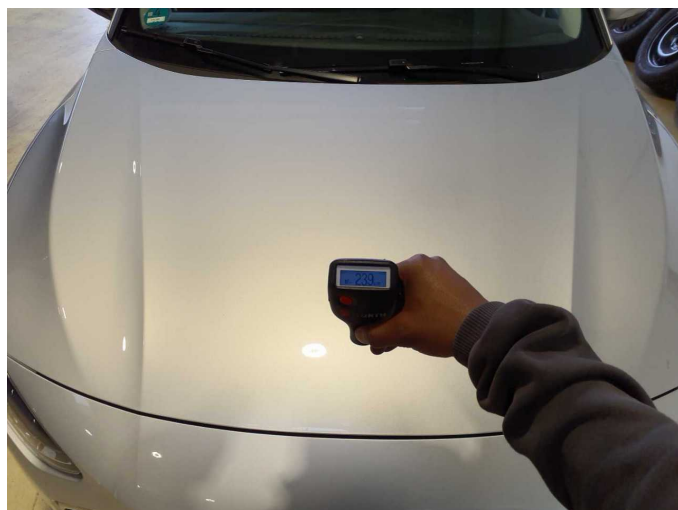
- 1 Bonnet, Professionally carried out, Invoice of repair done Non-existent

Bonnet	239 µm
--------	--------

Repainting 1: Bonnet

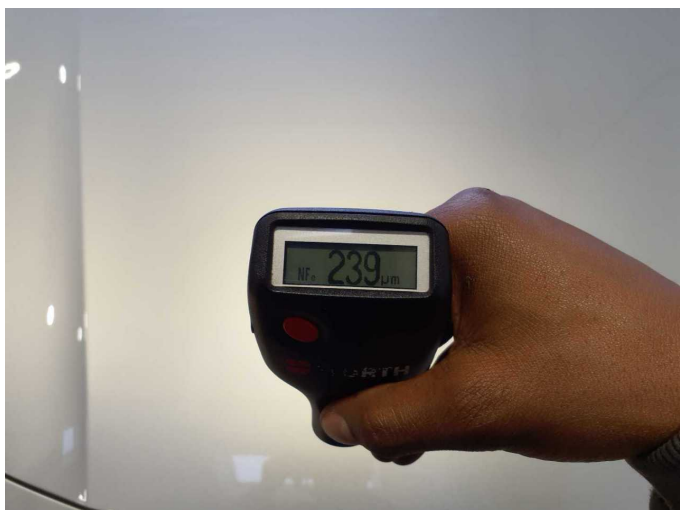
Repainting 1: Bonnet
