Expertise

Protocol number: 41409842  
Order No. / Reference: 25167378  
Inspection date: 8 Sept 2025

Manufacturer: Ford

Model: Focus Turnier 1.5 EcoBlue Start-Stopp-System  
COOL&CONNECT

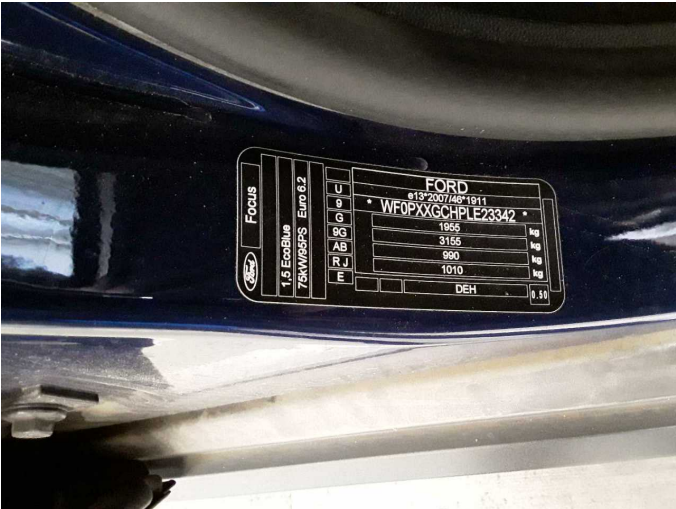
Figure 11: VIN

Documents submitted	At the time of the inspection, the registration certificate Part 2 (letter) was available, but the registration certificate Part 1 (certificate) was not. (Copy)
VIN comparison	The vehicle identification number (VIN) was read from the vehicle and its conformity with the submitted documents was verified during the inspection by the undersigned.
Inspection	The inspection conditions were sufficient for the assessment of the vehicle. Lifting equipment and a pit were available for examining the vehicle.
Test drive	No test drive/maneuvering was carried out during the inspection of the vehicle.
Engine function test	An engine test run was performed.

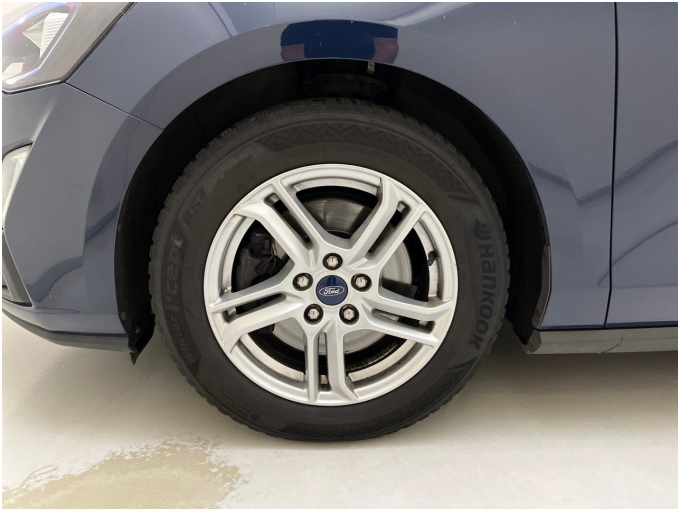
Figure 12: Mounted tyres

#	Tyre size	Type of tyre	Manufacturer	Tread depth
1)	205/60 R16 92H	Winter tyres on Light alloy	Hankook	6mm / 5mm
2)	205/60 R16 92H	Winter tyres on Light alloy	Hankook	7mm / 6mm

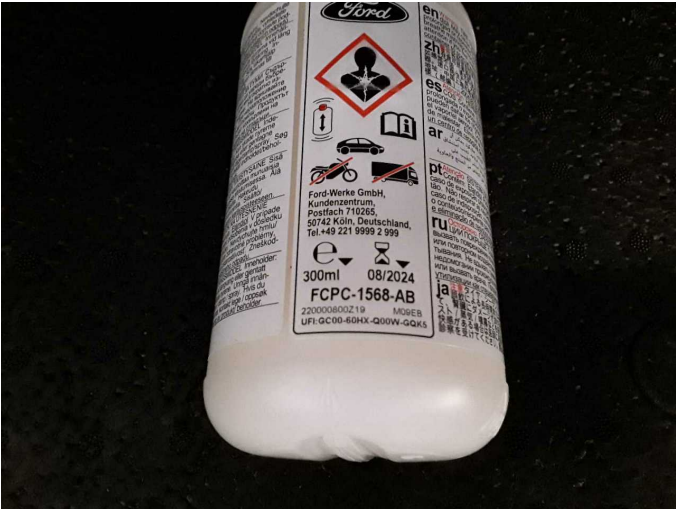
Damage 1: Equipment: Tirefit filler - Expired - Replace

No.	Component group	Description
1	Equipment	Tirefit filler - Expired - Replace
2	Sill - right side	Sill - dent(s) - Smart repair
3	Front bumper	Front bumper - Scratched - Paint
4	Vehicle glazing	Windscreen with lane departure assistant - Stone chips - Replace

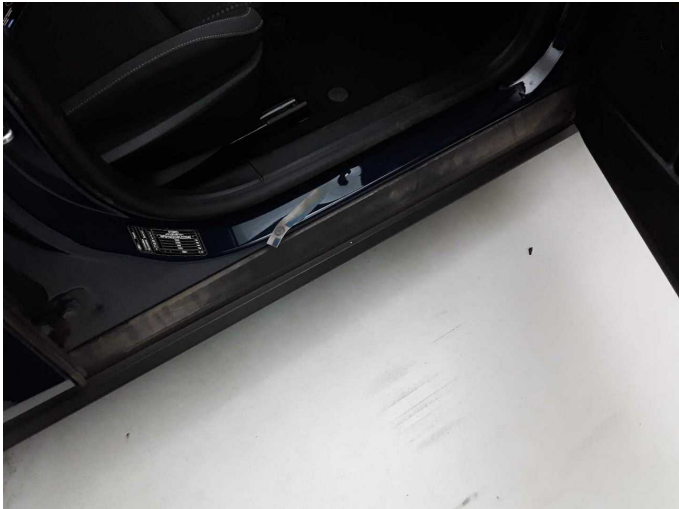
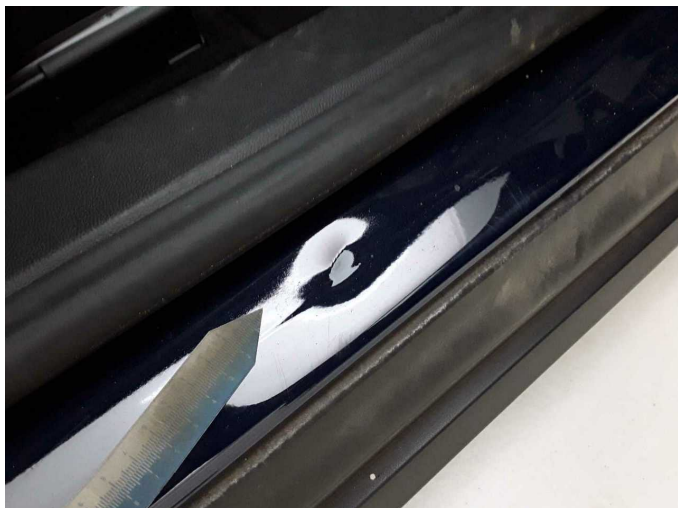
Damage 2: Sill - right side: Sill - dent(s) - Smart repair

**Damage 2:** Sill - right side: Sill - dent(s) - Smart repair

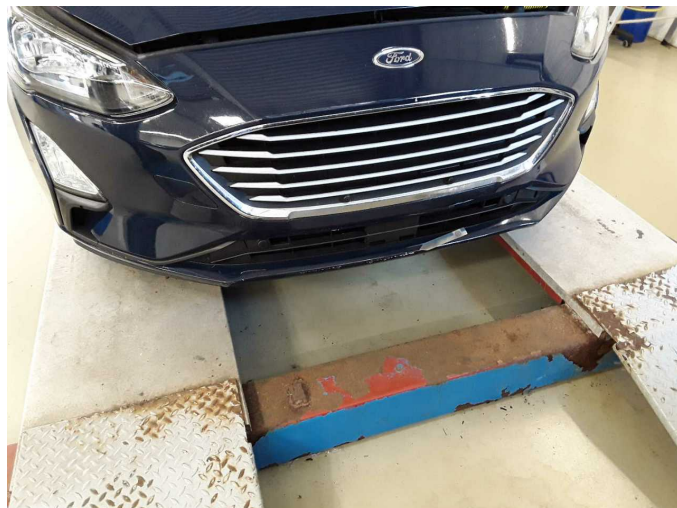
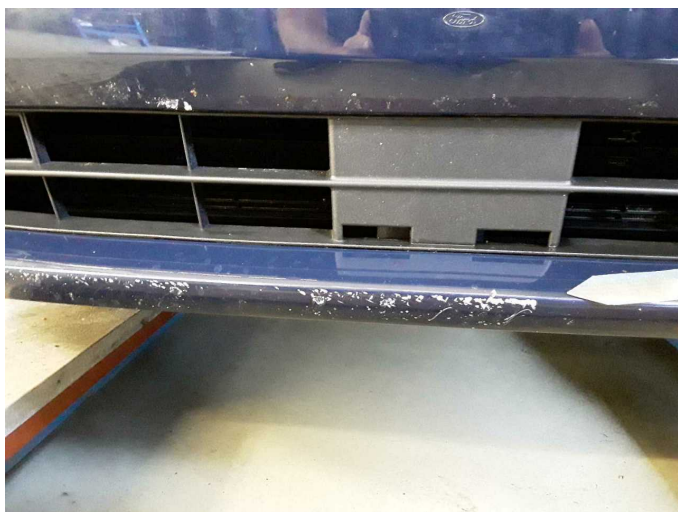
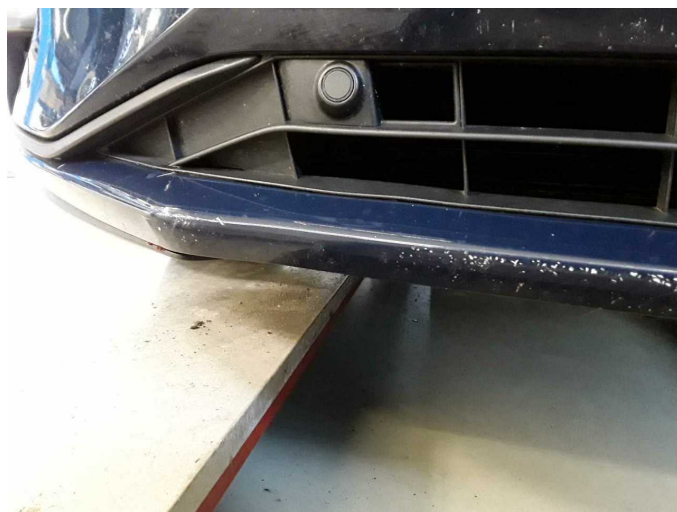
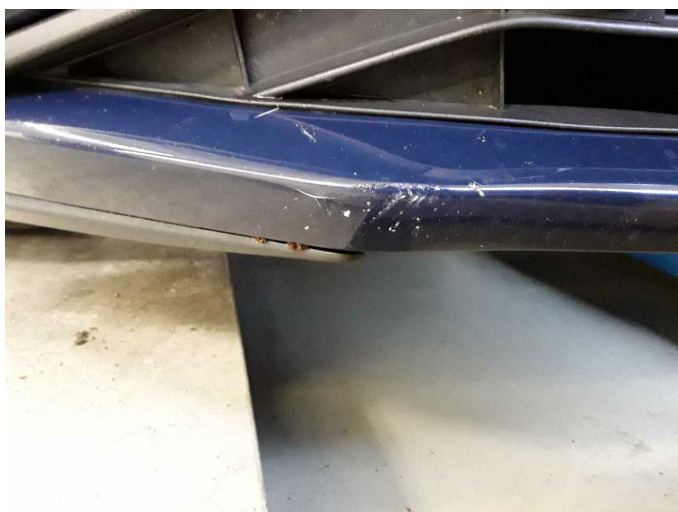
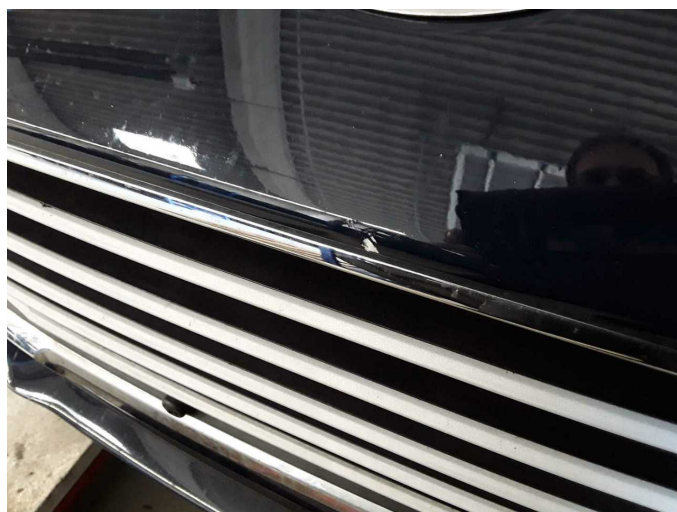
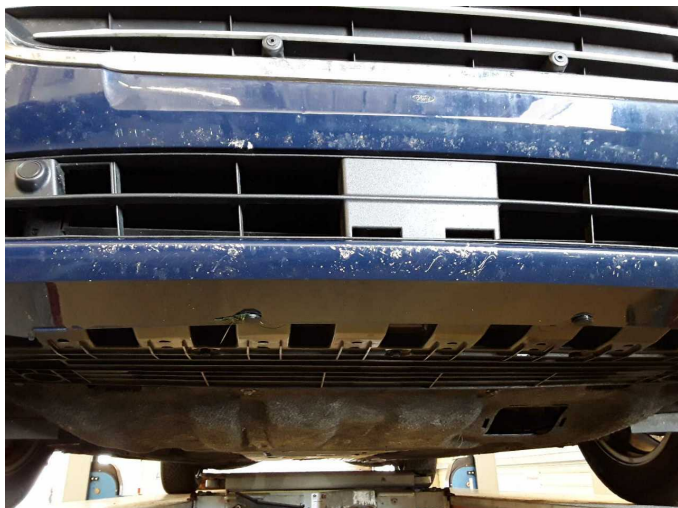
**Damage 3:** Front bumper: Front bumper - Scratched - Paint

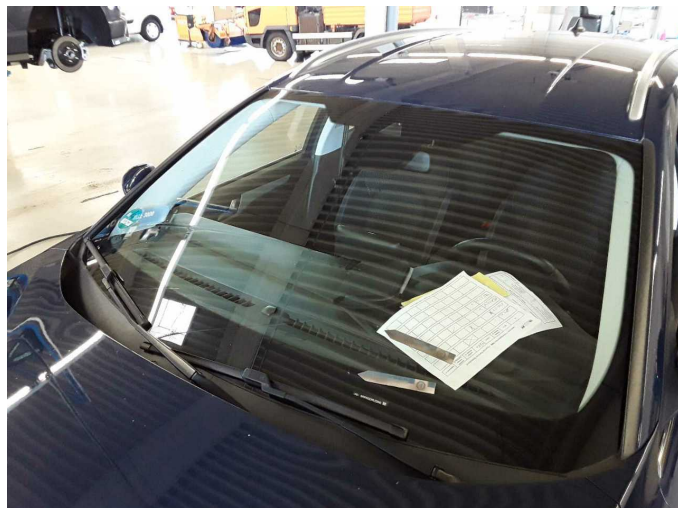
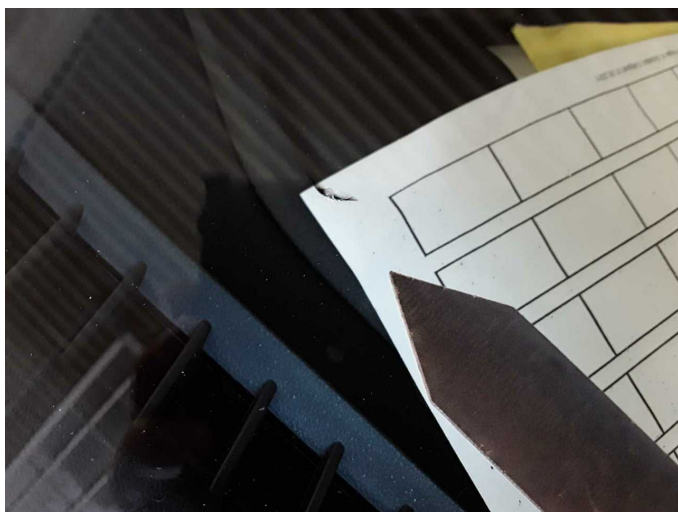
**Damage 4:** Vehicle glazing: Windscreen with lane departure assistant - Stone chips - Replace
