Expertise

Protocol number: 39884779  
Order No. / Reference: 24680185  
Inspection date: 23 May 2025

Manufacturer: Ford

Model: Focus Turnier 1.5 EcoBlue Start-Stopp-System TITANIUM

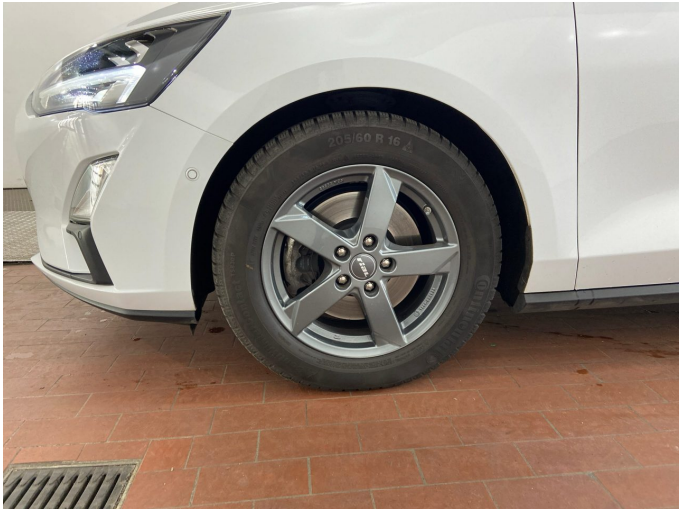
Figure 12: Mounted tyres

#	Tyre size	Type of tyre	Manufacturer	Tread depth
1)	205/60 R16 96H	Winter tyres on Light alloy	Continental	5mm / 5mm
2)	205/60 R16 96H	Winter tyres on Light alloy	Continental	6mm / 6mm

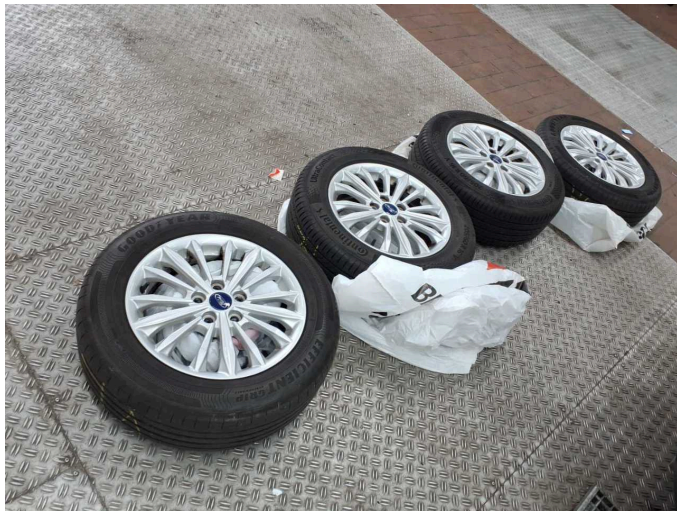
Figure 19: Additional tyres

#	Tyre size	Type of tyre	Manufacturer	Tread depth
1)	205/60 R16 92V	Summer tyres on Light alloy	Goodyear	4mm / 4mm
2)	205/60 R16 92V	Summer tyres on Light alloy	Goodyear	4mm / 4mm

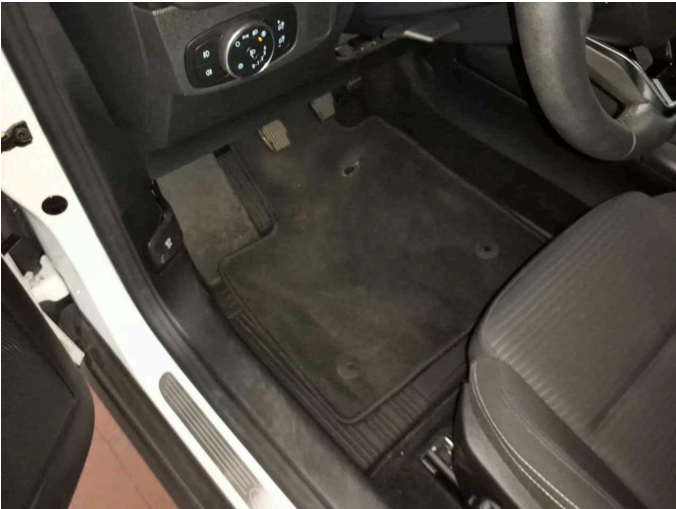
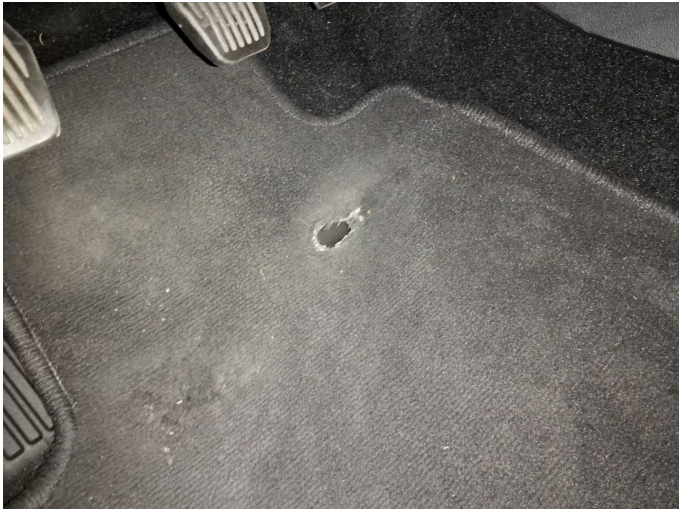
Damage 1: Trim / covers: Floor mats (Vorne links) - Holes - Replace

No.	Component group	Description
1	Trim / covers	Floor mats (Vorne links) - Holes - Replace
2	Equipment	Tirefit filler - Expired - Replace

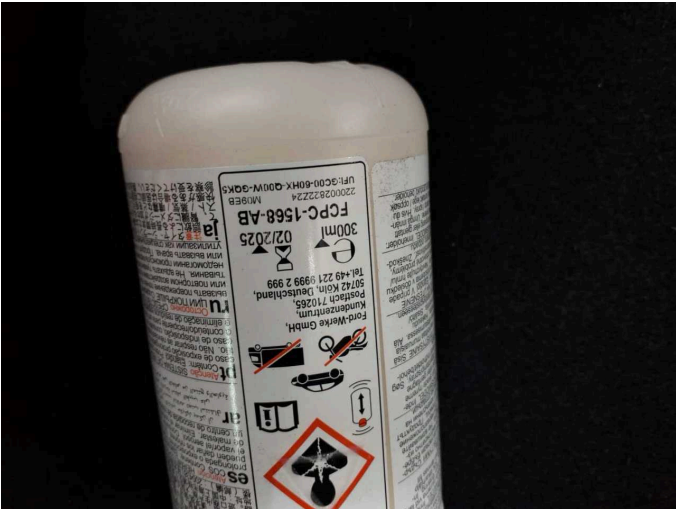
Damage 2: Equipment: Tirefit filler - Expired - Replace

Typ	Tyre size	Type of tyre	Manufacturer	Tread depth
	Tirefit	Expiration date 02/2025

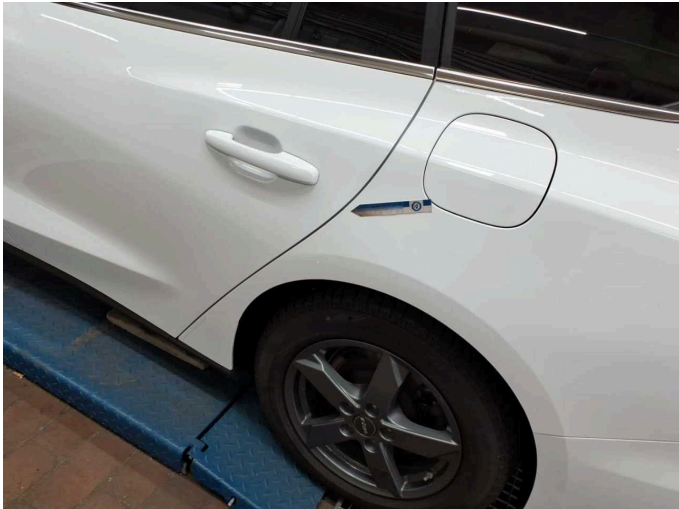
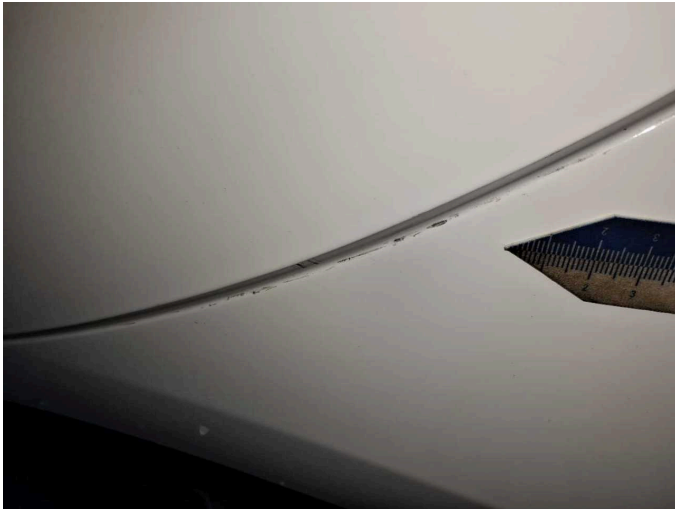
Damage 3: Side panel - rear left side: Side panel - Scratch(es) - Smart repair

**Damage 3:** Side panel - rear left side: Side panel - Scratch(es) - Smart repair

No.	Component group	Description
3	Side panel - rear left side	Side panel - Scratch(es) - Smart repair
4	Front bumper	Front bumper - Scratched - Smart repair
5	Vehicle glazing	Windscreen - Broken / torn - Replace
6	Bonnet	Bonnet - Dent / paintcoat damage - Paint

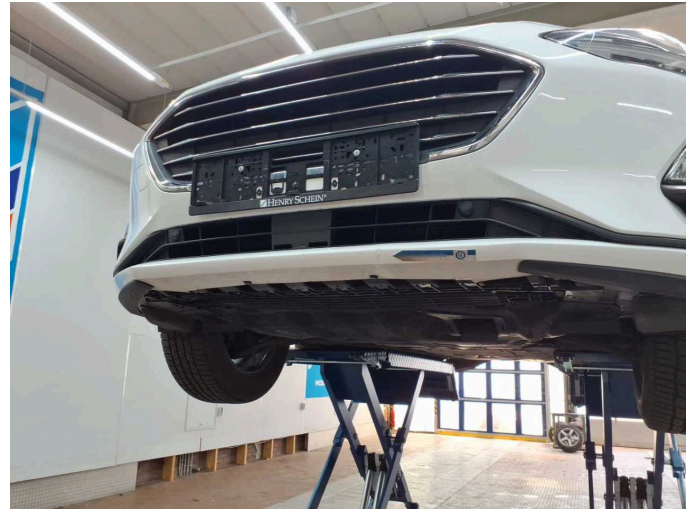
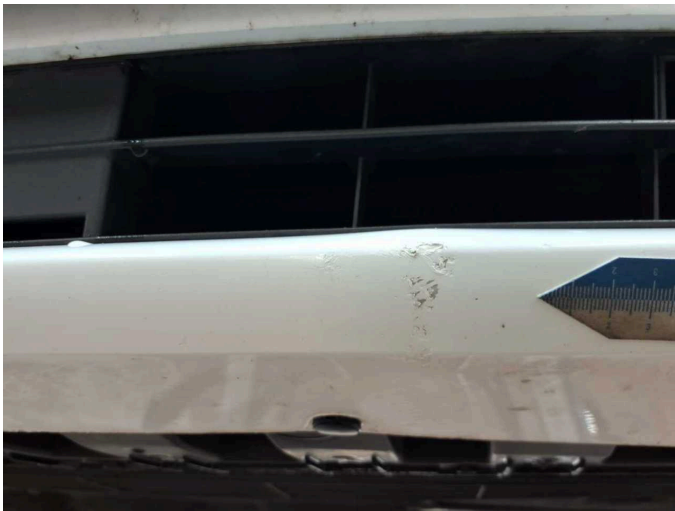
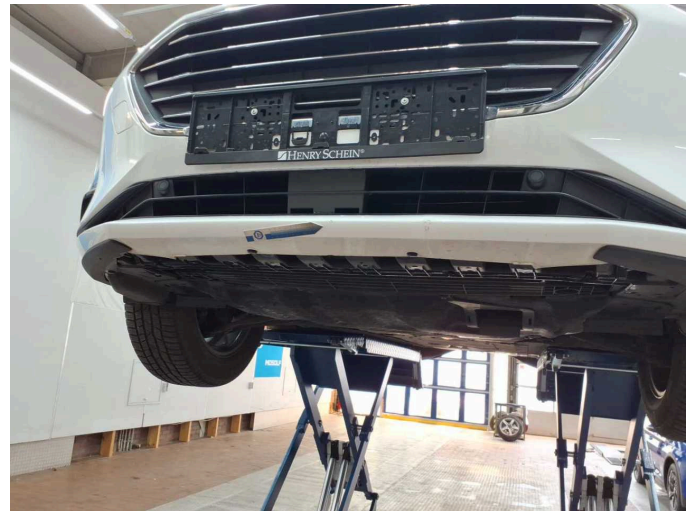
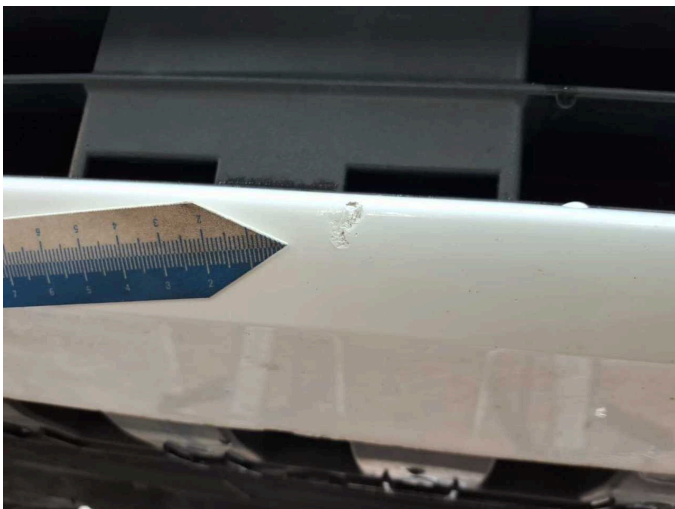
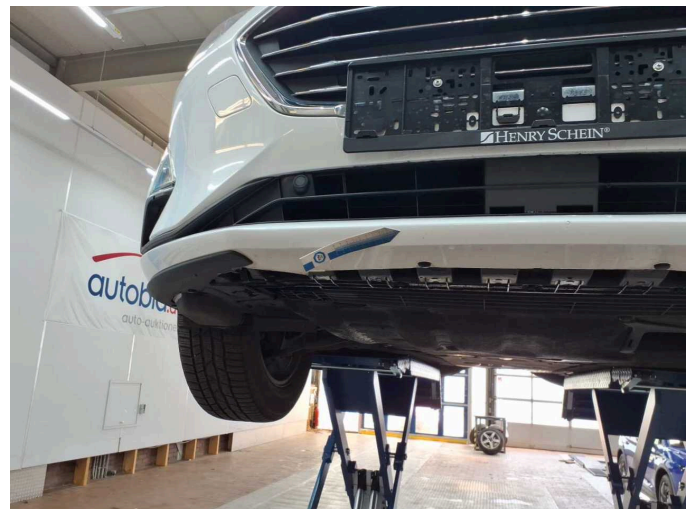
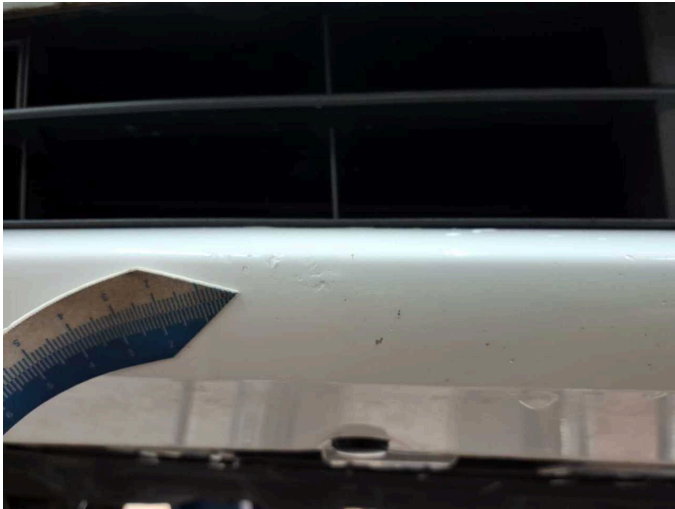
**Damage 4:** Front bumper: Front bumper - Scratched - Smart repair

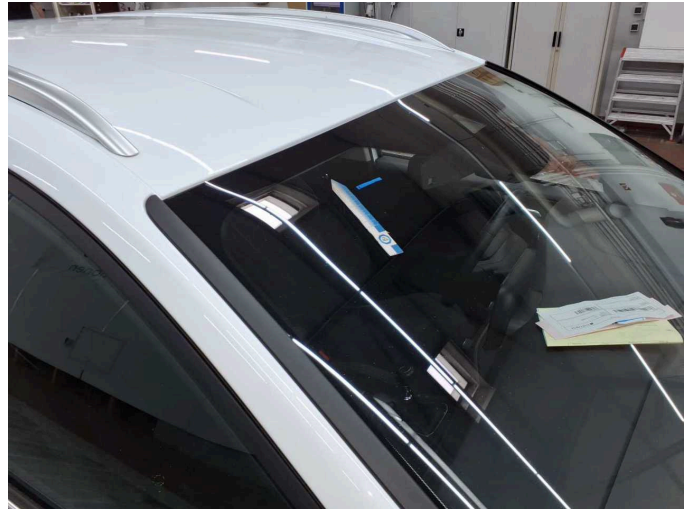
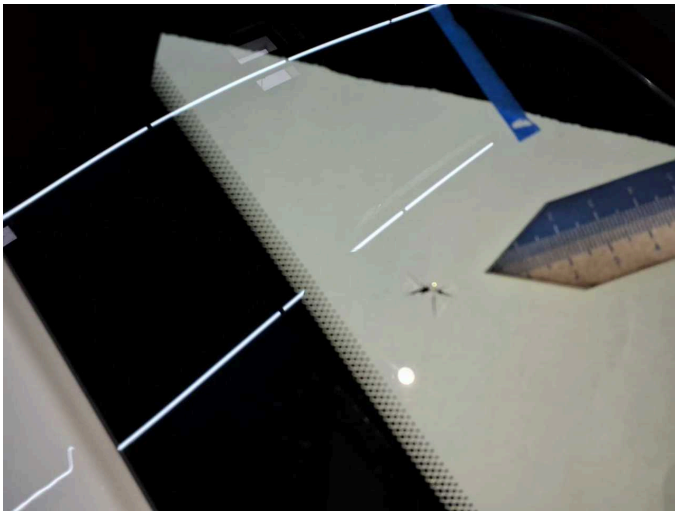
**Damage 5:** Vehicle glazing: Windscreen - Broken / torn - Replace

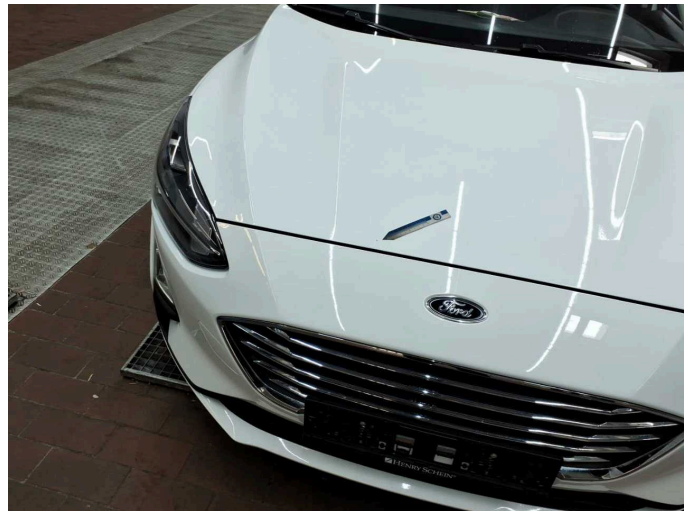
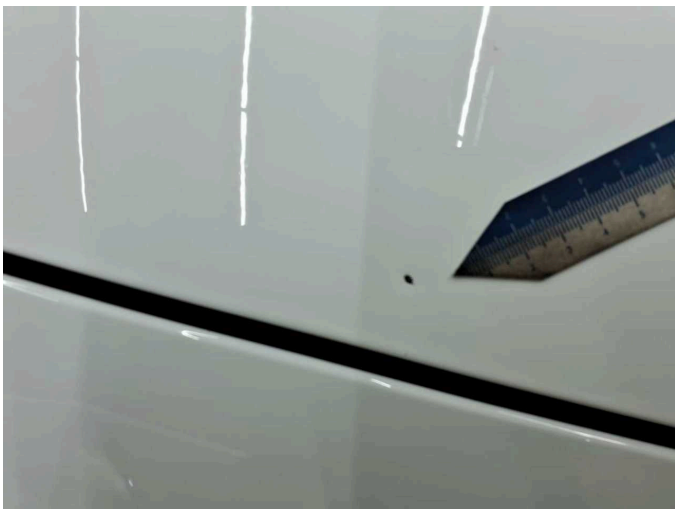
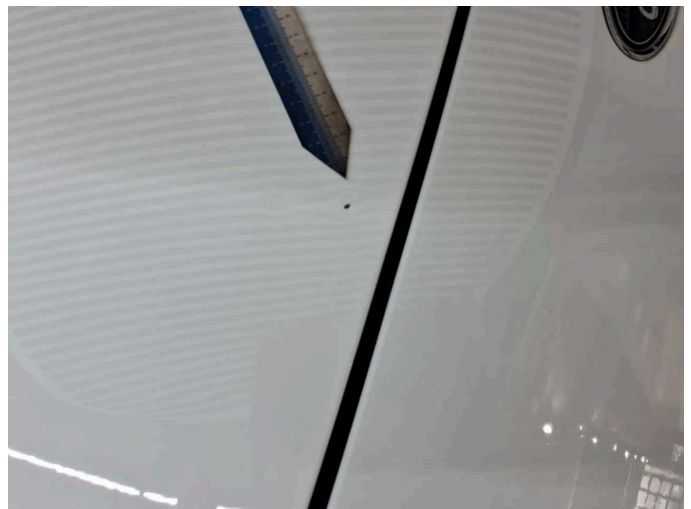
**Damage 6:** Bonnet: Bonnet - Dent / paintcoat damage - Paint

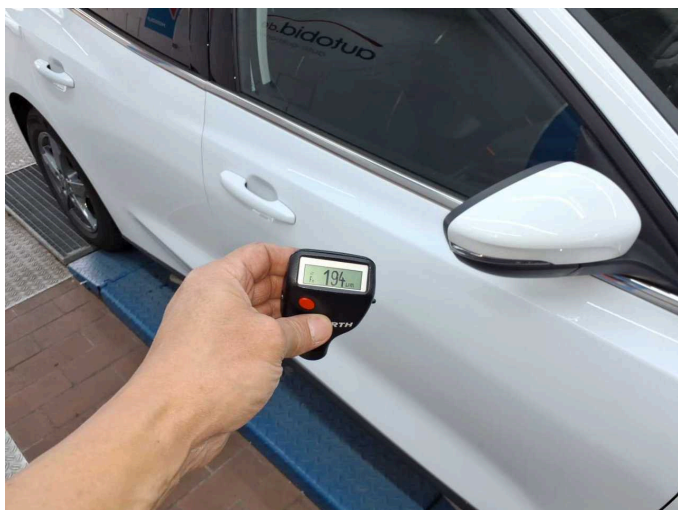
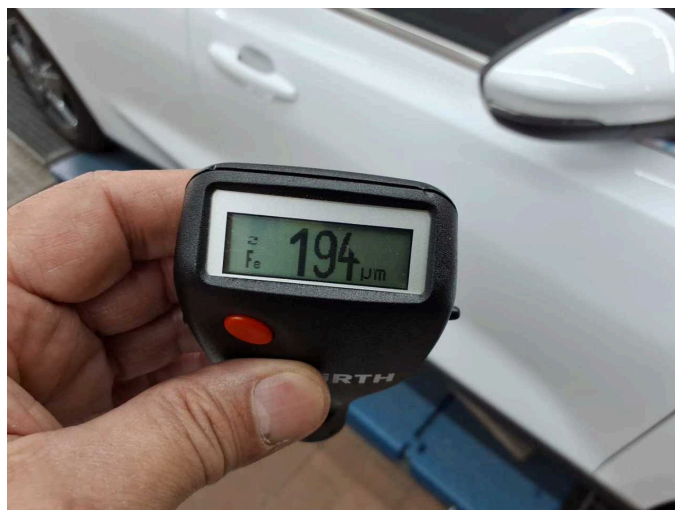
No.	Repainting
1	Door - front right side

Door - front right side	194 µm
-------------------------	--------

**Repainting 1:** Door - front right side
