Expertise

Protocol number: 41250814  
Order No. / Reference: 25069585  
Inspection date: 26 Aug 2025

| Manufacturer: Ford | Model: Focus Turnier 1.5 EcoBlue Start-Stopp-System Aut.<br>COOL&CONNECT |

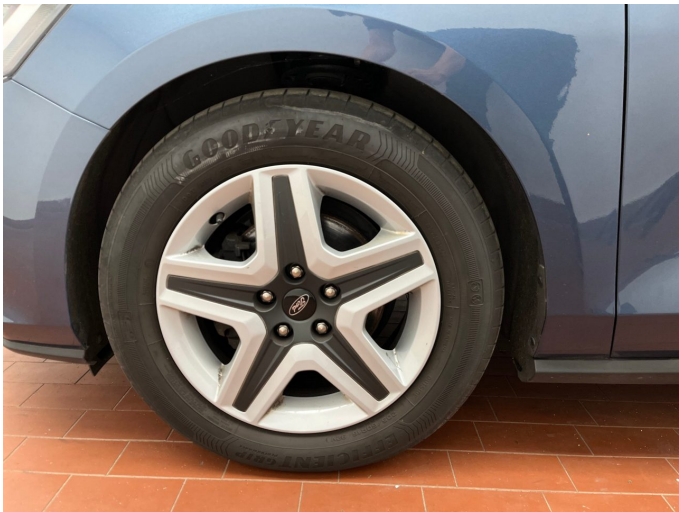
Figure 12: Mounted tyres

| # | Tyre size | Type of tyre | Manufacturer | Tread depth |
|---|---|---|---|---|
| 1) | 205/60 R16 92V | Summer tyres on Steel rim with wheel cover | Goodyear | 3mm / 3mm |
| 2) | 205/60 R16 92V | Summer tyres on Steel rim with wheel cover | Goodyear | 5mm / 5mm |

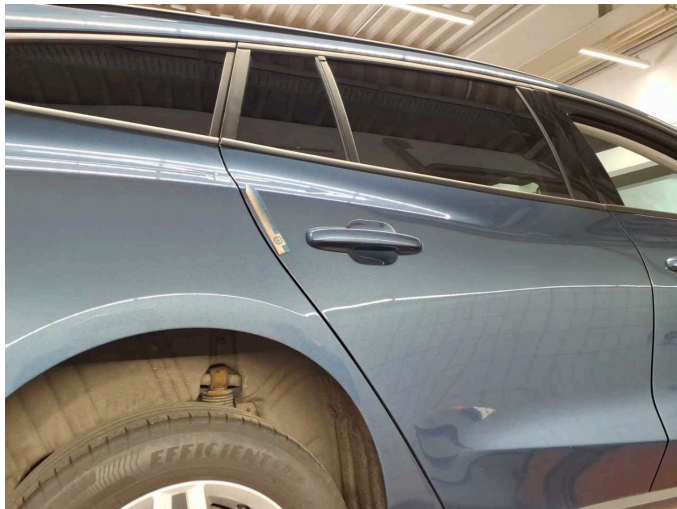
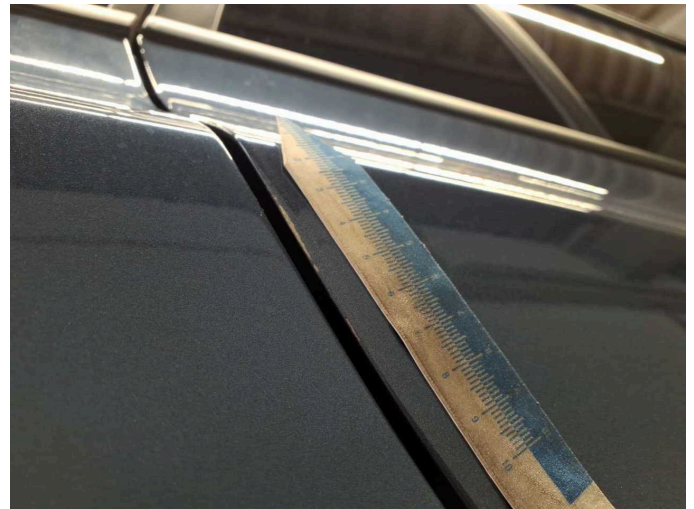
| No. | Component group | Description |
|---|---|---|
| 1 | Door - rear right side | Door edge - Scratch(es) - Smart repair |

**Damage 1:** Door - rear right side: Door edge - Scratch(es) - Smart repair

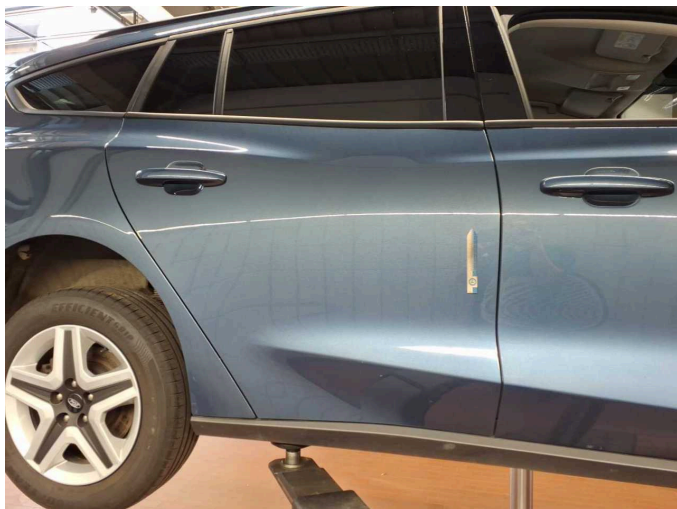
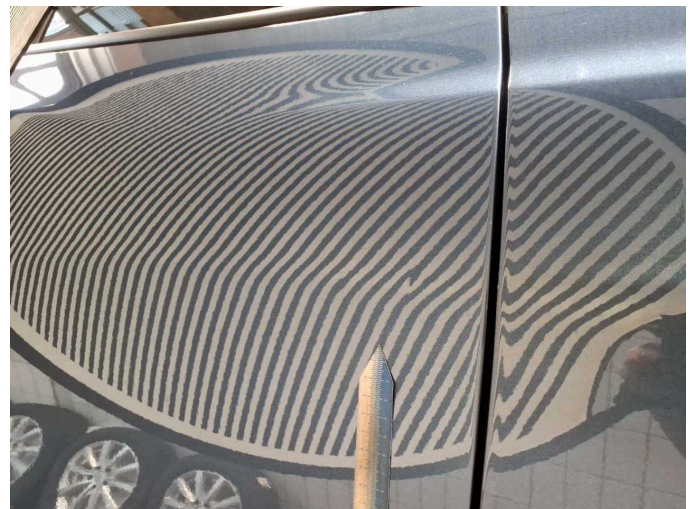
| No. | Component group | Description |
|---|---|---|
| 2 | Door - rear right side | Door (2 Dellen) - dent(s) - Smart repair |

**Damage 2:** Door - rear right side: Door (2 Dellen) - dent(s) - Smart repair

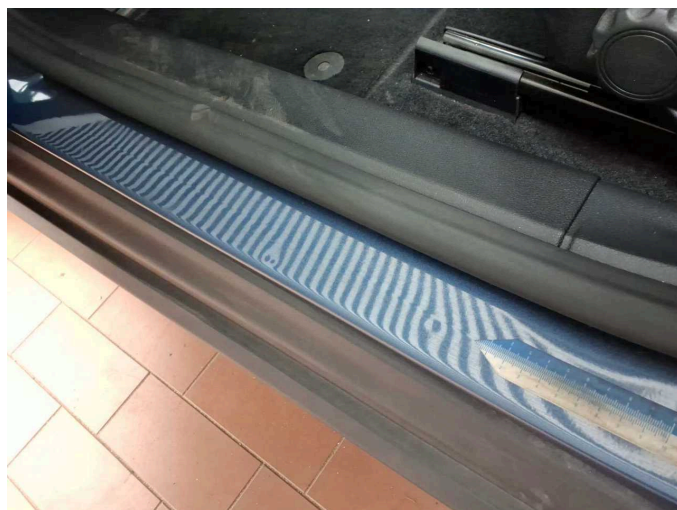
| No. | Component group | Description |
|---|---|---|
| 3 | Sill - left side | Sill (2 Dellen) - dent(s) - Smart repair |

**Damage 3:** Sill - left side: Sill (2 Dellen) - dent(s) - Smart repair

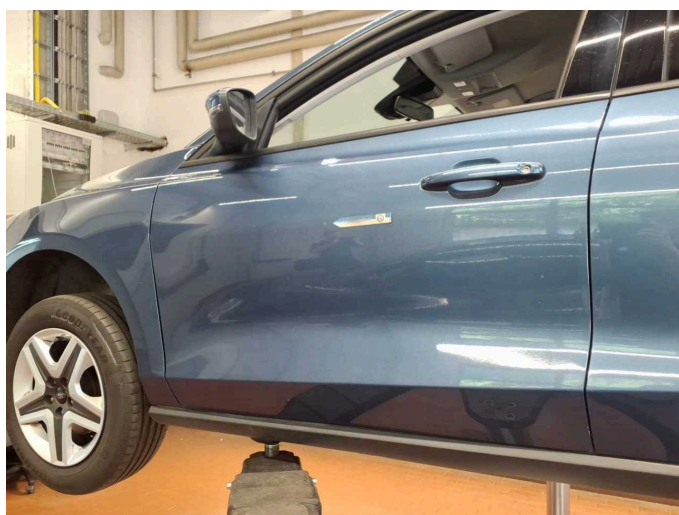
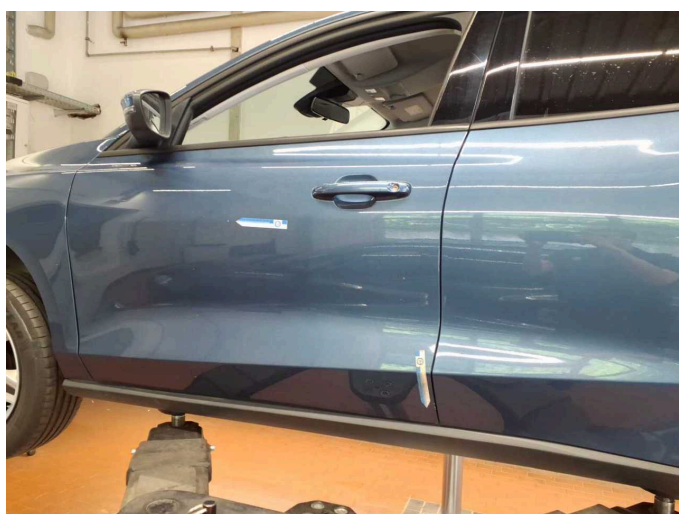
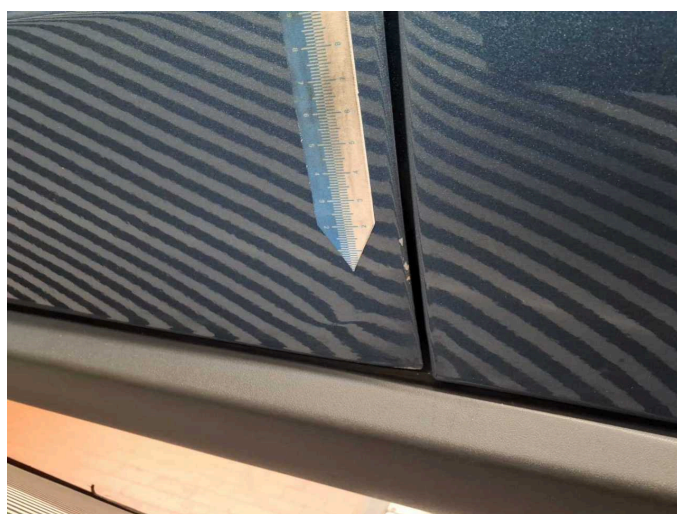
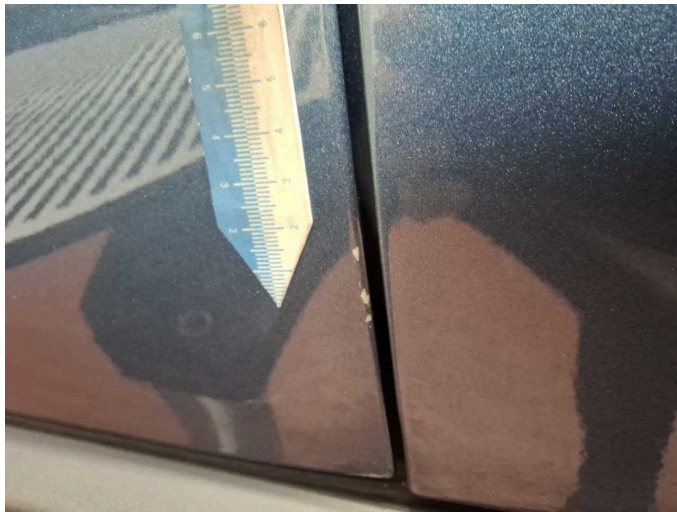
| No. | Component group | Description |
|---|---|---|
| 4 | Door - front left side | Door - Scratch(es) - Smart repair |

**Damage 4:** Door - front left side: Door - Scratch(es) - Smart repair

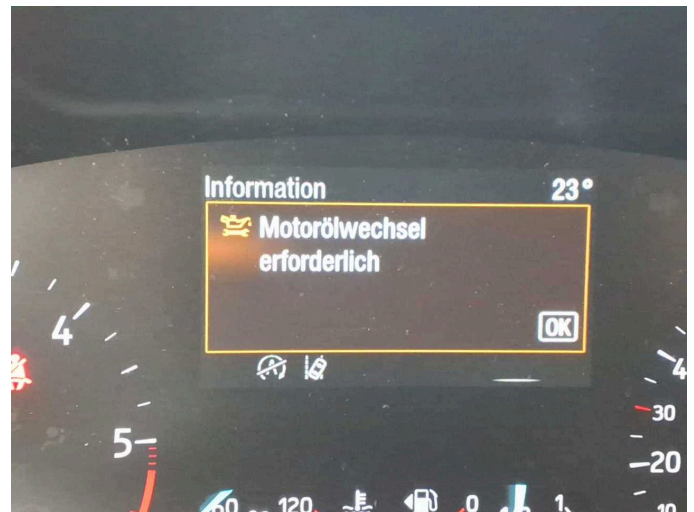
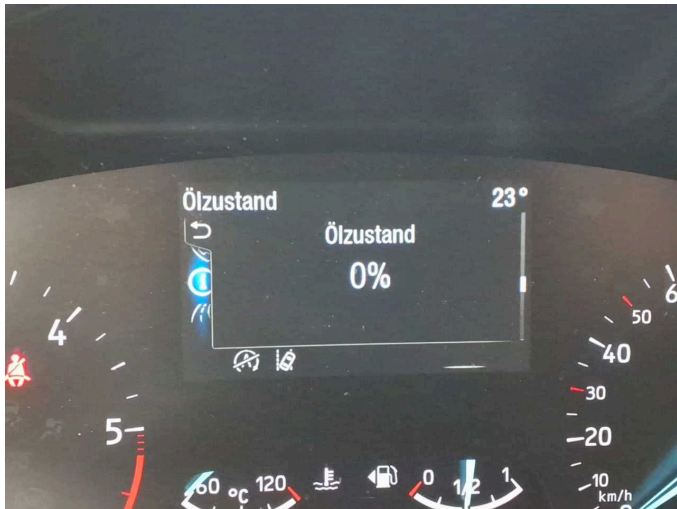
| No. | Component group | Description |
|---|---|---|
| 5 | Misc. | Inspection / maintenance - Due - Perform |

**Damage 5:** Misc.: Inspection / maintenance - Due - Perform

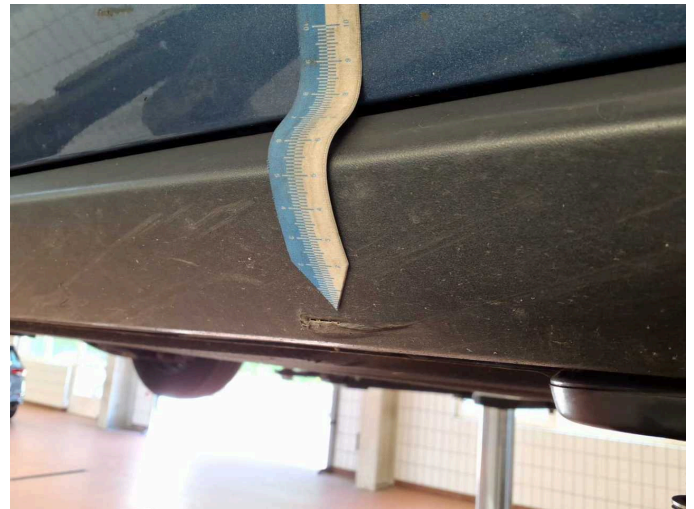
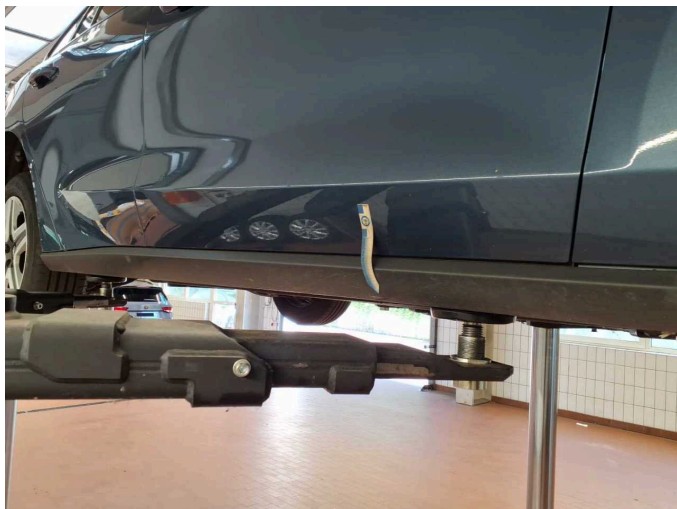
| No. | Component group | Description |
|---|---|---|
| 6 | Sill - right side | Trim - Broken / torn - Replace |

**Damage 6:** Sill - right side: Trim - Broken / torn - Replace

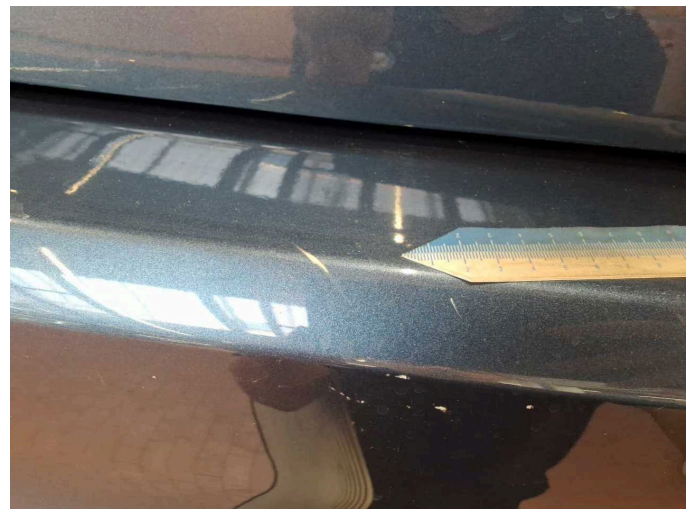
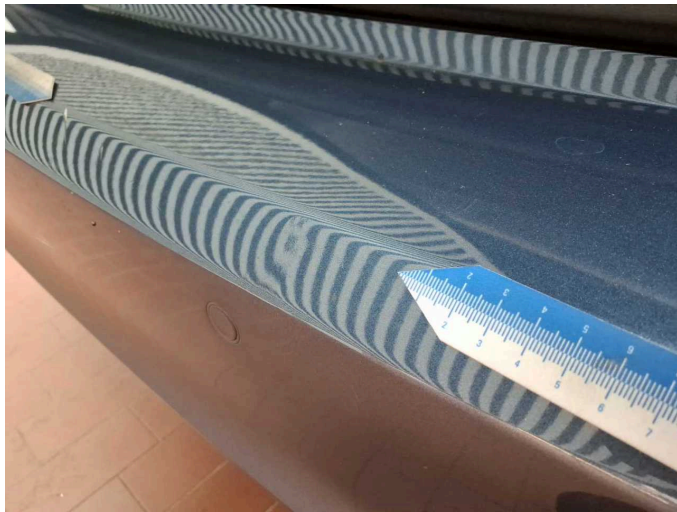
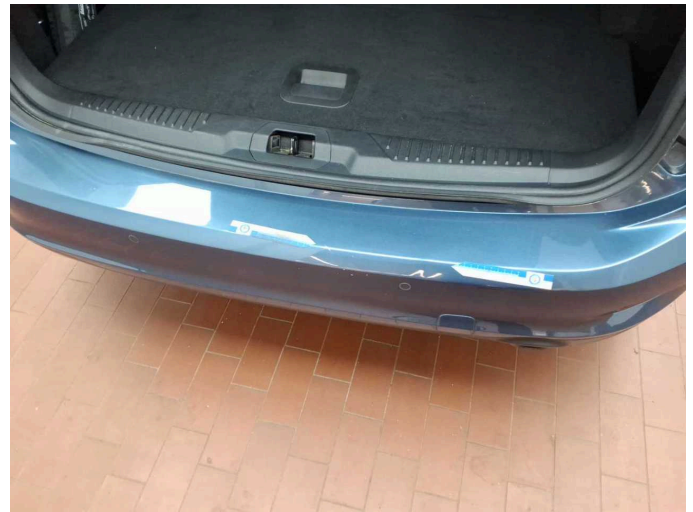
| No. | Component group | Description |
|---|---|---|
| 7 | Rear bumper | Rear bumper (gestaucht) - Scratch(es) - Repair and paint |

**Damage 7:** Rear bumper: Rear bumper (gestaucht) - Scratch(es) - Repair and paint

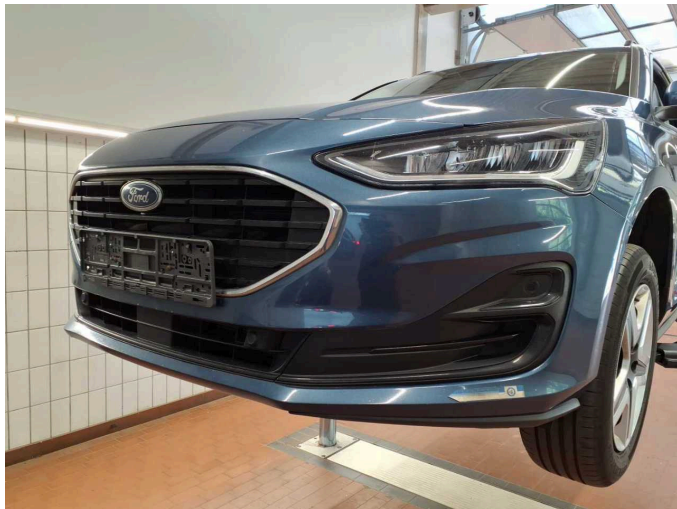
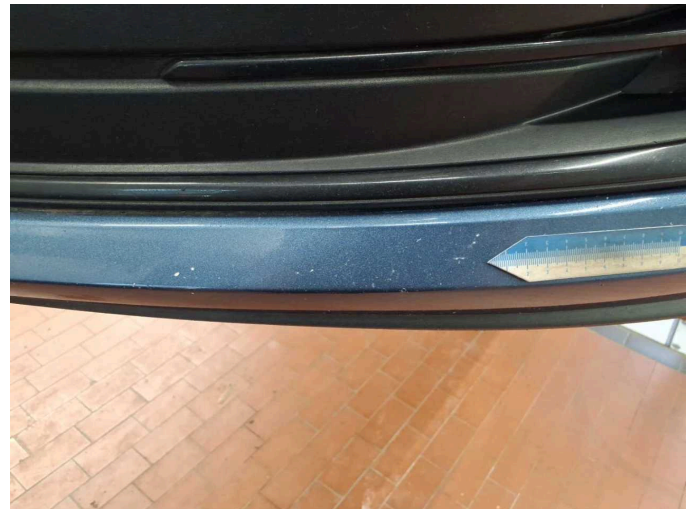
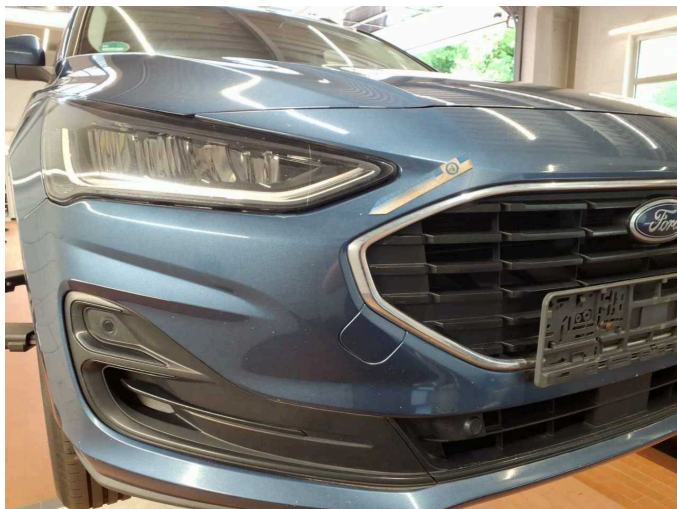
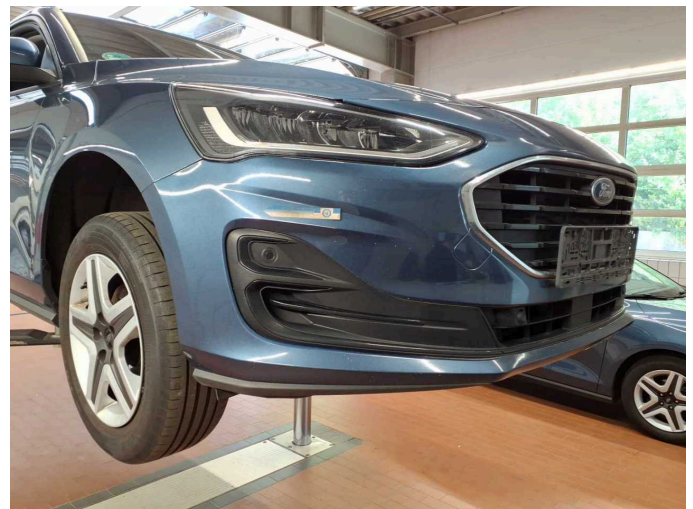
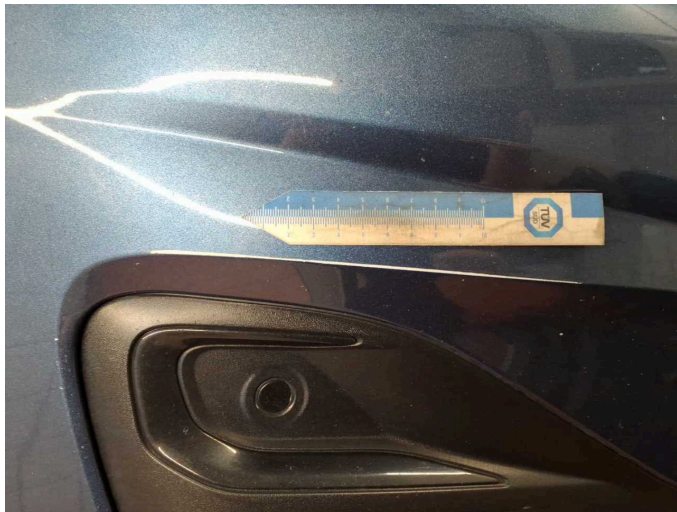
| No. | Component group | Description |
|---|---|---|
| 8 | Front bumper | Front bumper - Scratched - Paint |

**Damage 8:** Front bumper: Front bumper - Scratched - Paint

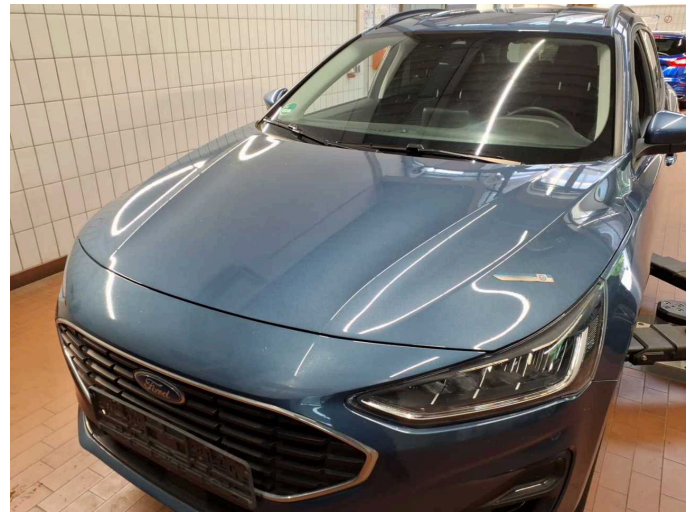
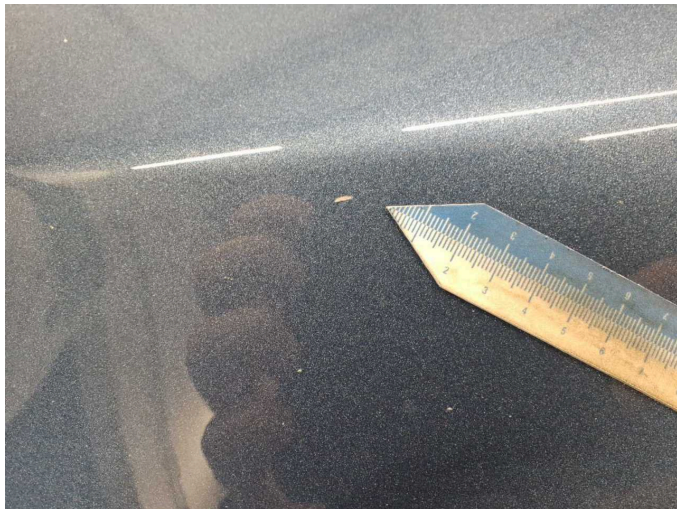
| No. | Component group | Description |
|---|---|---|
| 9 | Bonnet | Bonnet (mit Rostbildung) - Scratch(es) - Repair and paint |

**Damage 9:** Bonnet: Bonnet (mit Rostbildung) - Scratch(es) - Repair and paint

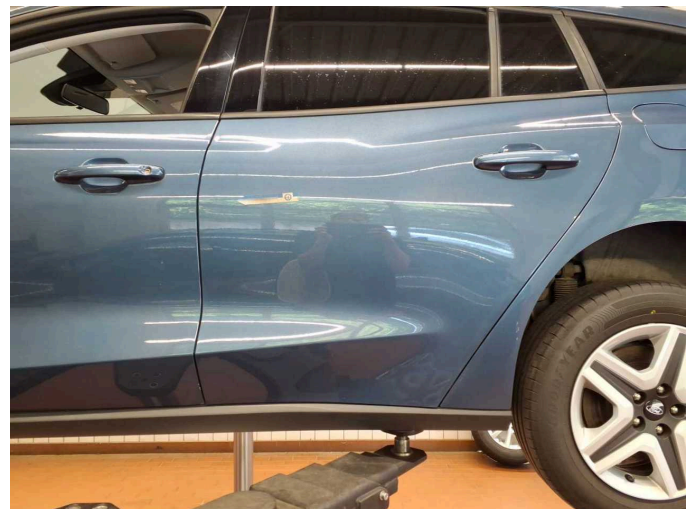
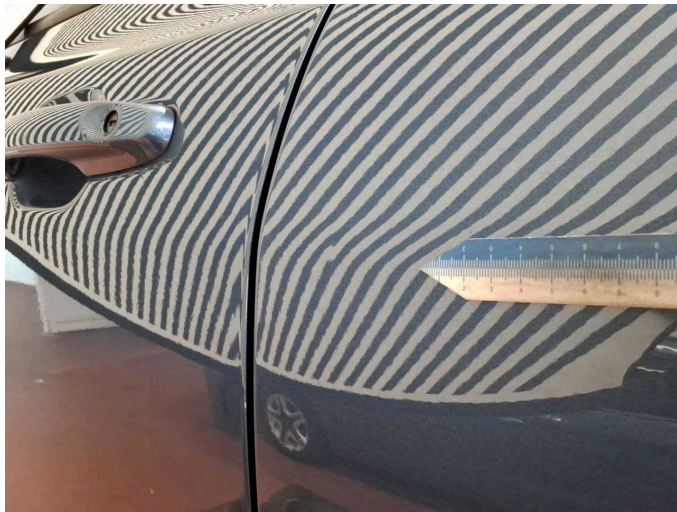
| No. | Component group | Description |
|---|---|---|
| 6 | Door - rear left side | Door - dent(s) - Smooth repair work |

**Wear and tear 6:** Door - rear left side: Door - dent(s) - Smooth repair work
