Expertise

Protocol number: 41525592  
Order No. / Reference: 24922309  
Inspection date: 5 Sept 2025

Manufacturer: Ford

Model: Focus Turnier 1.5 EcoBlue Start-Stopp-System Aut. TITANIUM  
STYLE

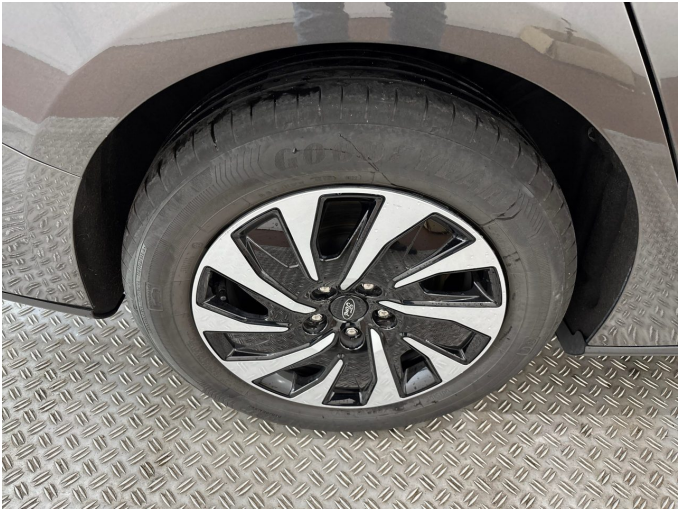
Figure 12: Mounted tyres

#	Tyre size	Type of tyre	Manufacturer	Tread depth
1)	205/60 R16 92V	Summer tyres on Steel rim with wheel cover	Pirelli	7mm / 7mm
2)	205/60 R16 92V	Summer tyres on Steel rim with wheel cover	Pirelli	5mm / 5mm

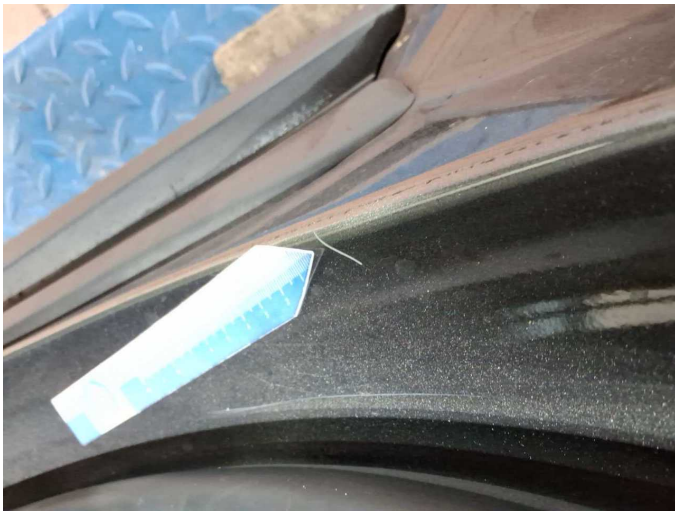
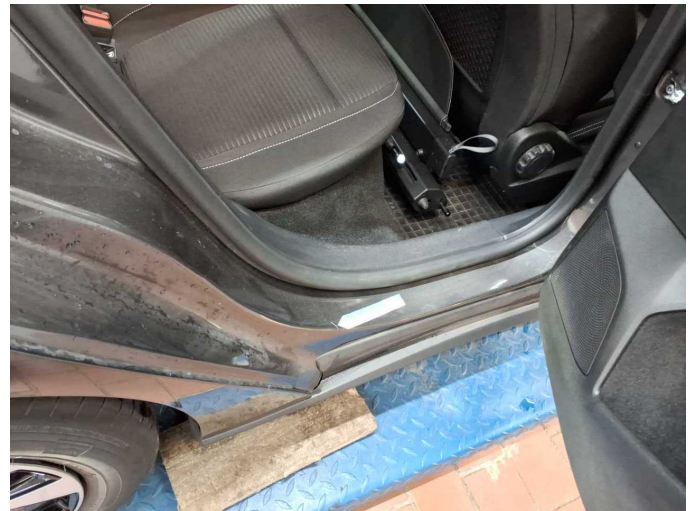
No.	Component group	Description
1	Side panel - rear right side	Sill - Scratch(es) - Smart repair
2	Front bumper	Front bumper - Stone chips - Paint

**Damage 1:** Side panel - rear right side: Sill - Scratch(es) - Smart repair

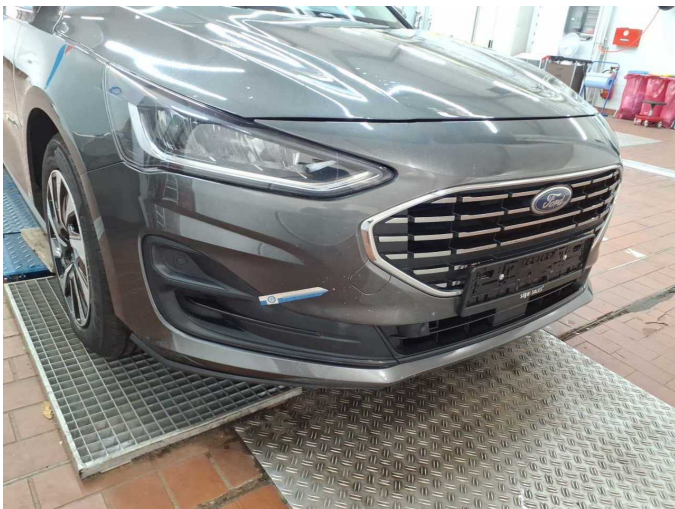
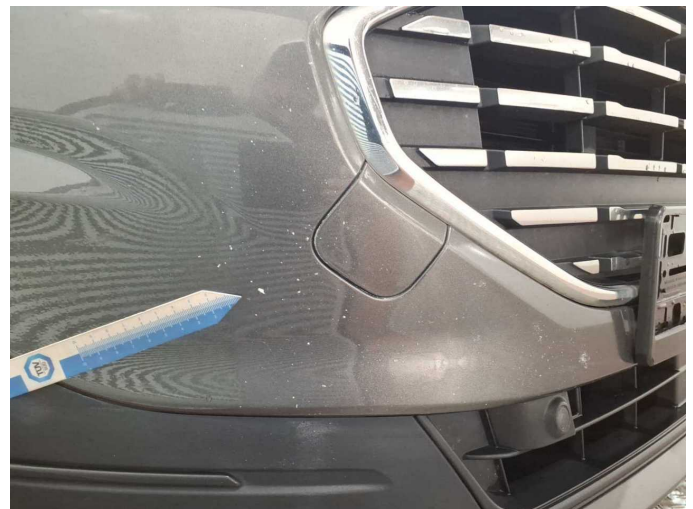
**Damage 2:** Front bumper: Front bumper - Stone chips - Paint

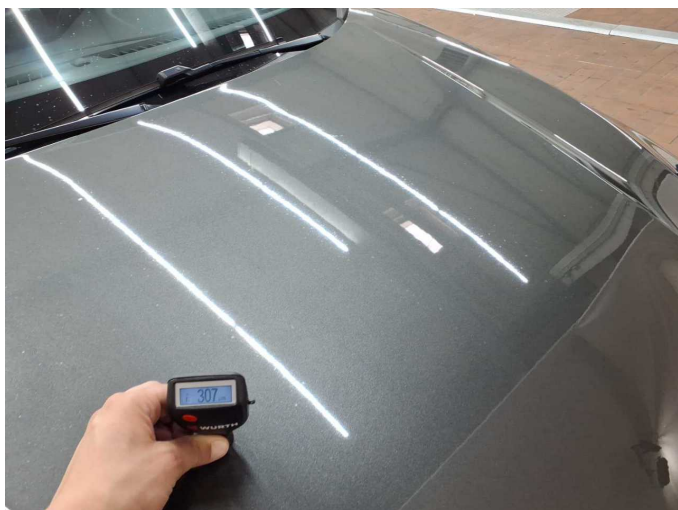
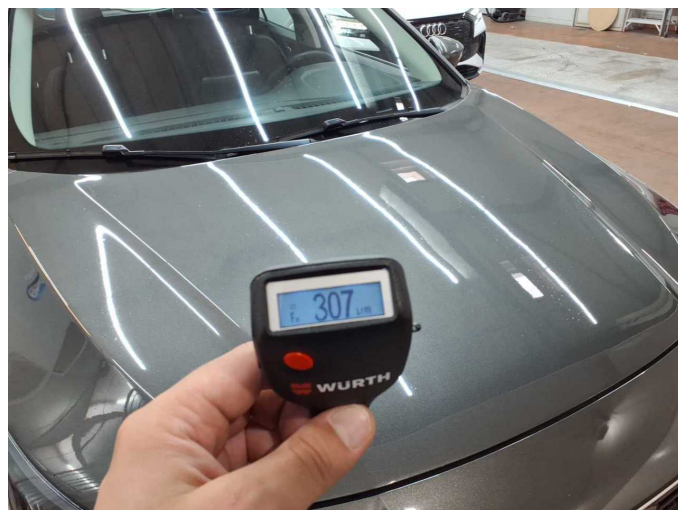
No.	Repainting
1	Mudguard - right side, Bonnet, Professionally carried out, Invoice of repair done Non-existent

Mudguard - right side	333 µm	Bonnet	307 µm
-----------------------	--------	--------	--------

**Repainting 1:** Mudguard - right side, Bonnet
