Expertise

Protocol number: 41172785  
Order No. / Reference: 25113901  
Inspection date: 21 Aug 2025

Manufacturer: Ford

Model: Focus Turnier 1.5 EcoBlue Start-Stopp-System TITANIUM

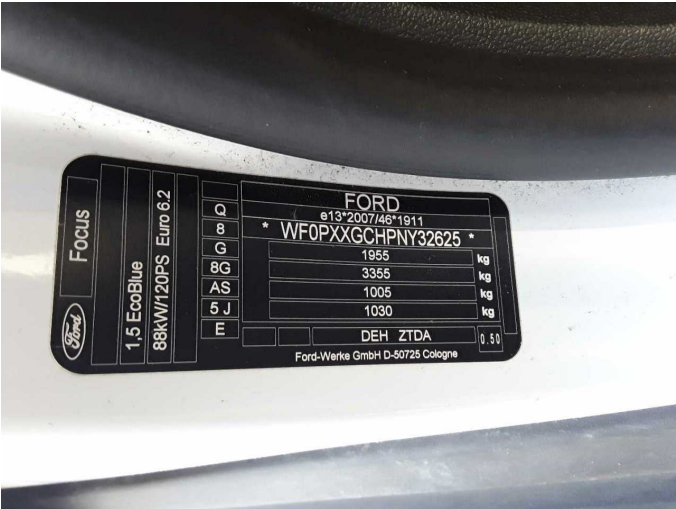
Figure 11: VIN

Documents submitted	At the time of the inspection, the registration certificate Part 2 (letter) was available, but the registration certificate Part 1 (certificate) was not. (Copy)
VIN comparison	The vehicle identification number (VIN) was read from the vehicle and its conformity with the submitted documents was verified during the inspection by the undersigned.
Inspection	The inspection conditions were sufficient for the assessment of the vehicle. Lifting equipment and a pit were available for examining the vehicle.
Test drive	No test drive/maneuvering was carried out during the inspection of the vehicle.
Engine function test	An engine test run was performed.

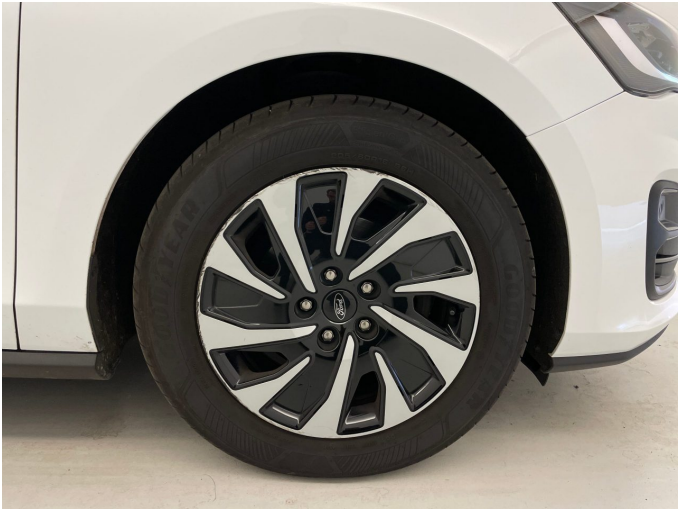
Figure 12: Mounted tyres

#	Tyre size	Type of tyre	Manufacturer	Tread depth
1)	205/60 R16 96H	Summer tyres on Light alloy	Goodyear	6mm / 6mm
2)	205/60 R16 96H	Summer tyres on Light alloy	Goodyear	7mm / 7mm

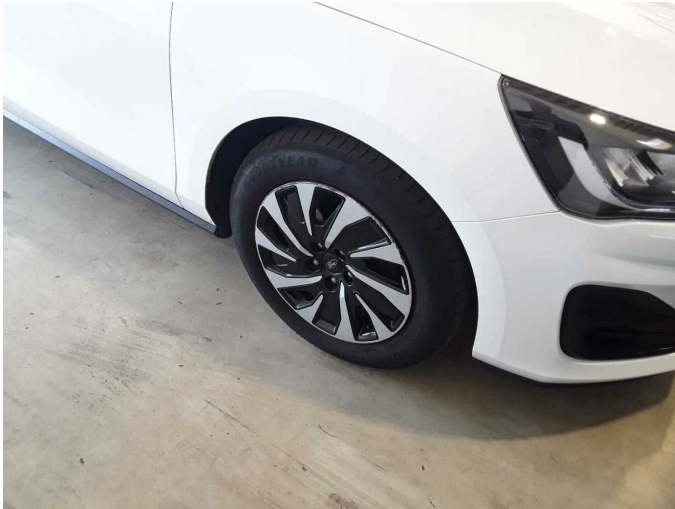
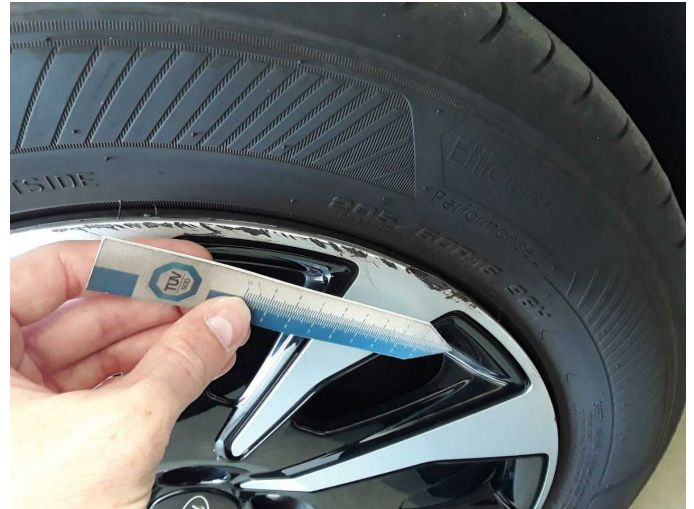
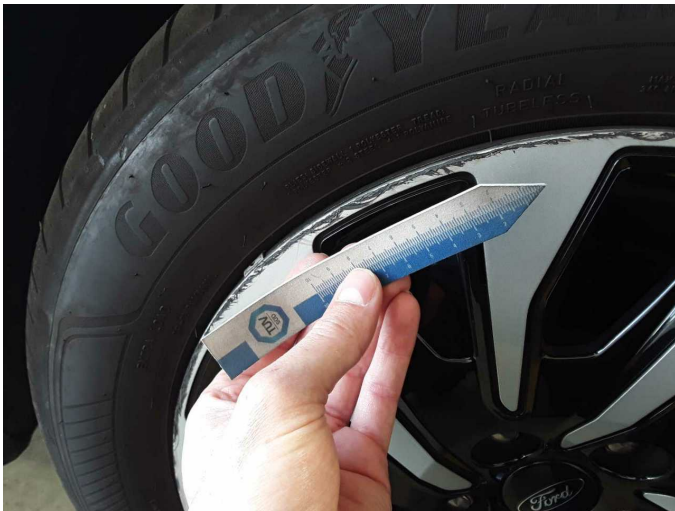
**Damage 2:** Wheel / tyres: Wheel cover - front right side - Scratched - Replace

No.	Component group	Description
1	Misc.	Inspection / maintenance - No evidence - No deduction
2	Wheel / tyres	Wheel cover - front right side - Scratched - Replace
3	Trim / covers	Door trim - rear left side - Scratched - Replace
4	Front bumper	Front bumper - Scratched - Paint

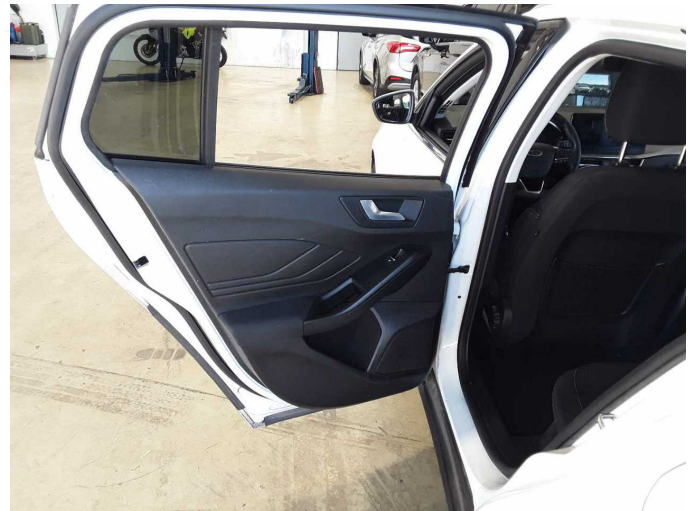
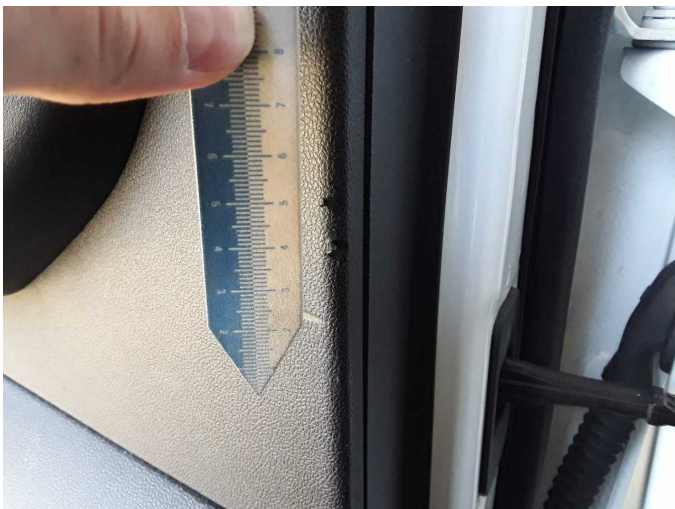
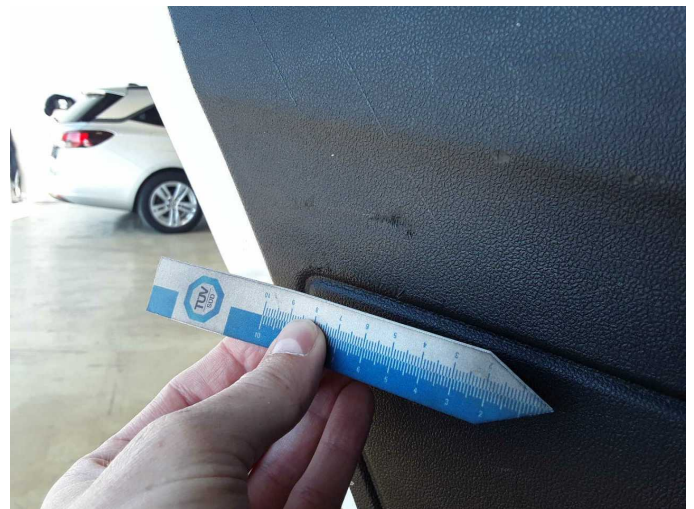
**Damage 3:** Trim / covers: Door trim - rear left side - Scratched - Replace

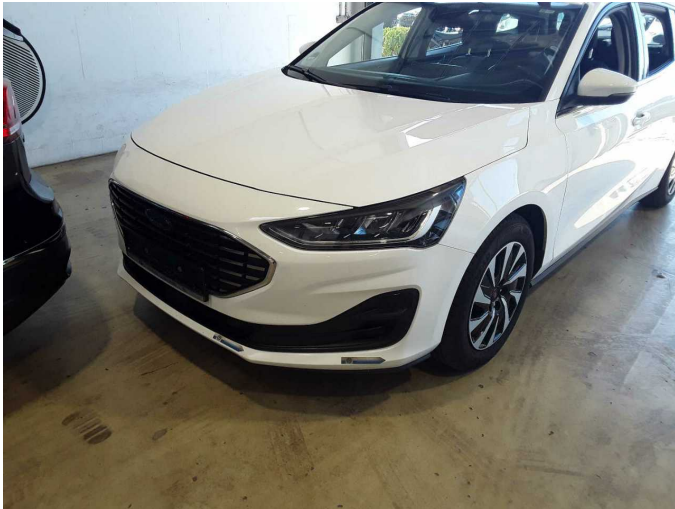
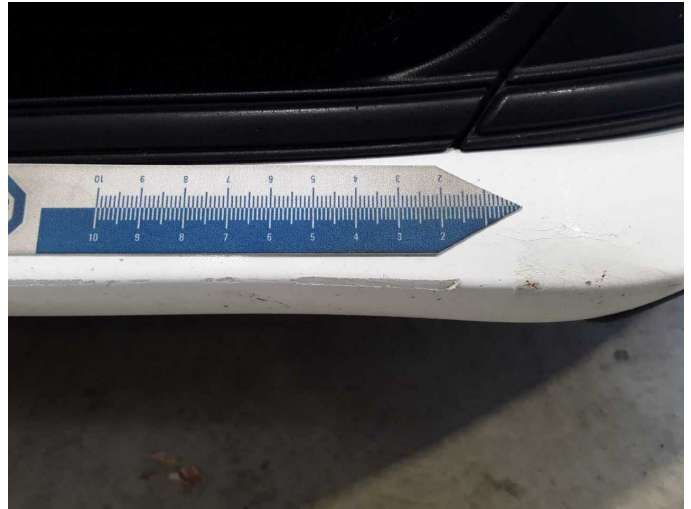
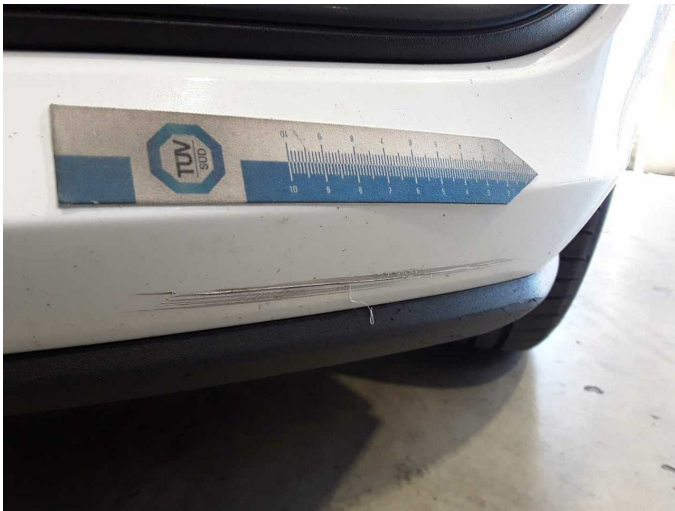
**Damage 4:** Front bumper: Front bumper - Scratched - Paint

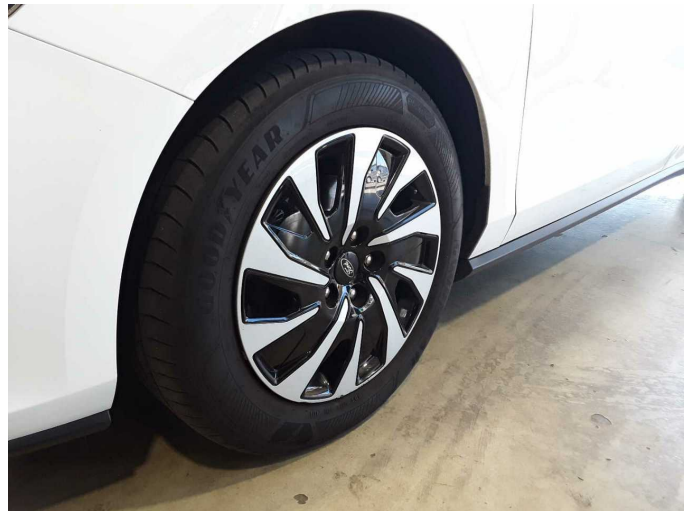
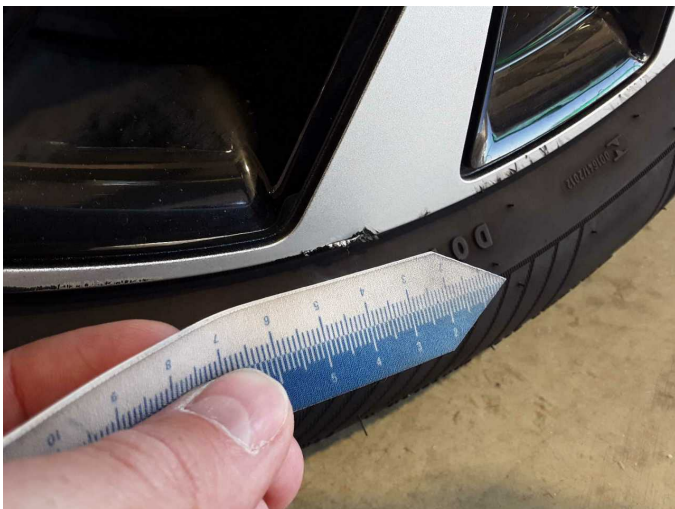
**Wear and tear 2:** Wheel / tyres: Wheel cover - front left side - Scratched - No deduction

No.	Component group	Description
1	Roof	Roof - Stone chips - No deduction
2	Wheel / tyres	Wheel cover - front left side - Scratched - No deduction
3	Side panel - rear right side	Side panel - dent(s) - No deduction
4	Side panel - rear left side	Sill - Dent / paintcoat damage - No deduction
5	Trim / covers	Roof lining - Soiled - No deduction
6	Side panel - rear left side	Side panel - dent(s) - No deduction
