Expertise

Protocol number: 39810053
Order No. / Reference: 24714967
Inspection date: 20 May 2025

Manufacturer: Ford

Model: Focus Turnier 1.5 EcoBlue Start-Stopp-System Aut. TITANIUM

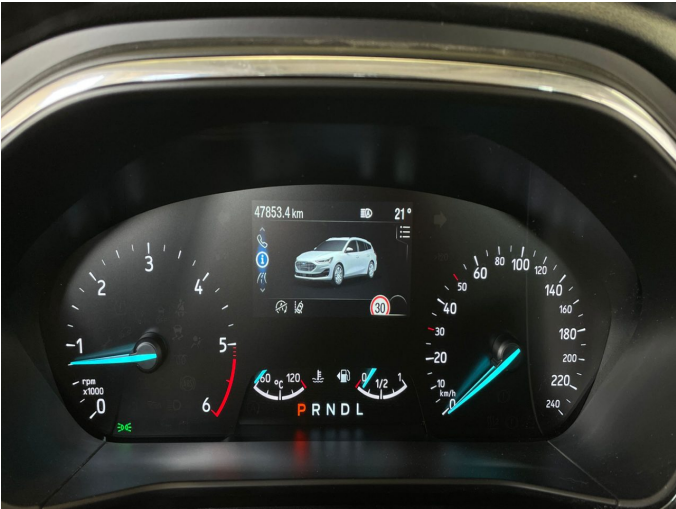
Maintenance booklet / proof	digital proof / complete	Next maintenance in	74 %
Last maintenance on / at	01/2025 at 43,726 km		
Key is / should be	1 / 2	FZG documents	ZB#2 (B) was available (copy), ZB#1 (S) was not available
		Letter No.	GT891271
Previous damage / Accident	None detectable	Repainting	None detectable
Inspection conditions	Sufficient	Lifting equipment / pit	yes
Test drive	Not performed	Engine function test	Performed
Manufacturer key number/ type code number	8566 / BYE 00002		
Emission standard	EURO6;WLTP;AP;PI/CI; M, N1 I	Fine dust sticker	
Permitted total weight	2,035 kg	Empty weight

Figure 7: Instrument cluster

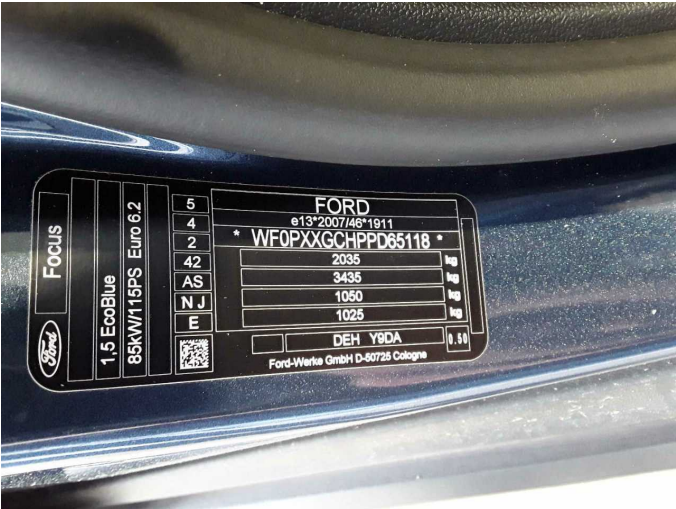
Figure 11: VIN

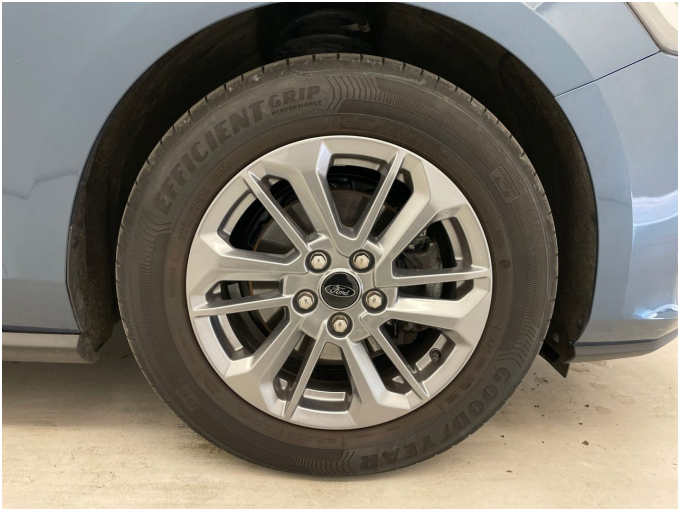
#	Tyre size	Type of tyre	Manufacturer	Tread depth
1)	205/60 R16 92V	Summer tyres on Light alloy	Goodyear	5mm / 5mm
2)	205/60 R16 92V	Summer tyres on Light alloy	Goodyear	5mm / 5mm

Figure 12: Mounted tyres

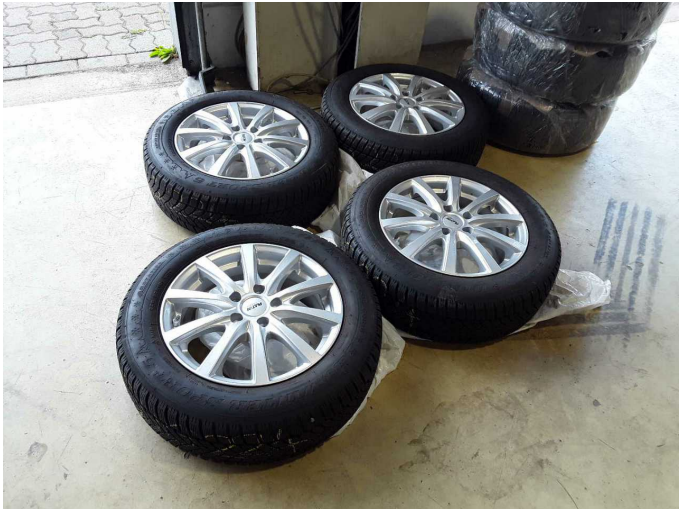
#	Tyre size	Type of tyre	Manufacturer	Tread depth
1)	205/60 R16 92H	Winter tyres on Light alloy	Dunlop	8mm / 8mm
2)	205/60 R16 92H	Winter tyres on Light alloy	Dunlop	8mm / 8mm

Figure 16: Additional tyres

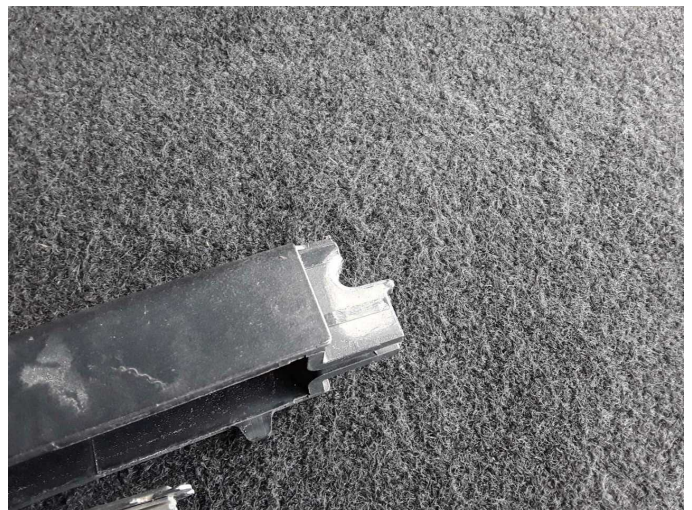
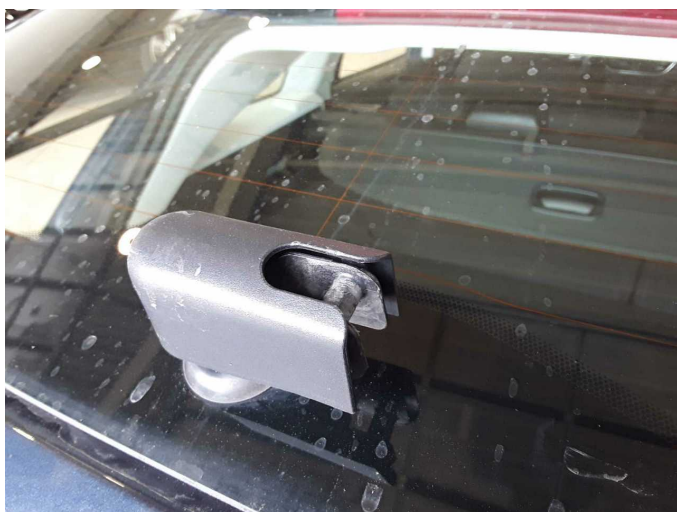
Damage 1: Screen cleaning: Wiper arm - rear - Broken / torn - Replace

No.	Component group	Description
1	Screen cleaning	Wiper arm - rear - Broken / torn - Replace
2	Boot lid / rear door	Boot lid - dent(s) - Smooth repair work
3	Roof	Roof rail - right side - dent(s) - Smart repair
4	Rear bumper	Rear bumper - Scratched - Paint
5	Front bumper	Front bumper - Scratched - Paint

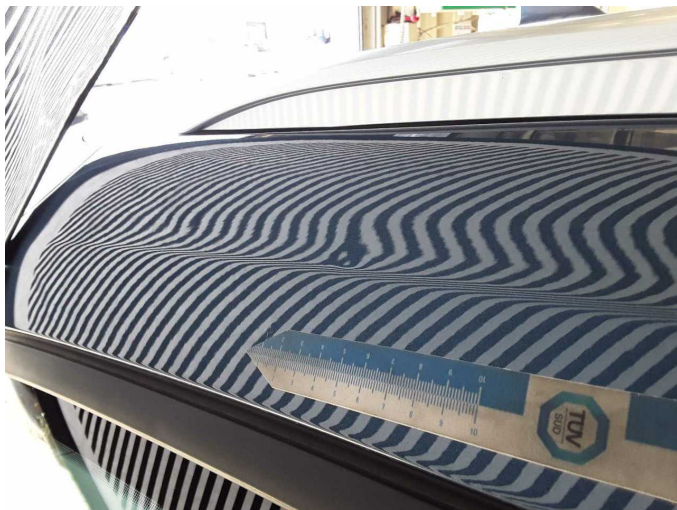
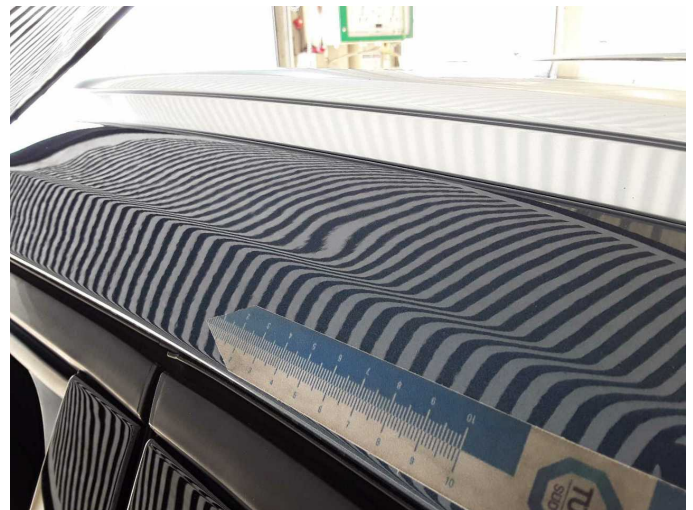
Damage 3: Roof: Roof rail - right side - dent(s) - Smart repair

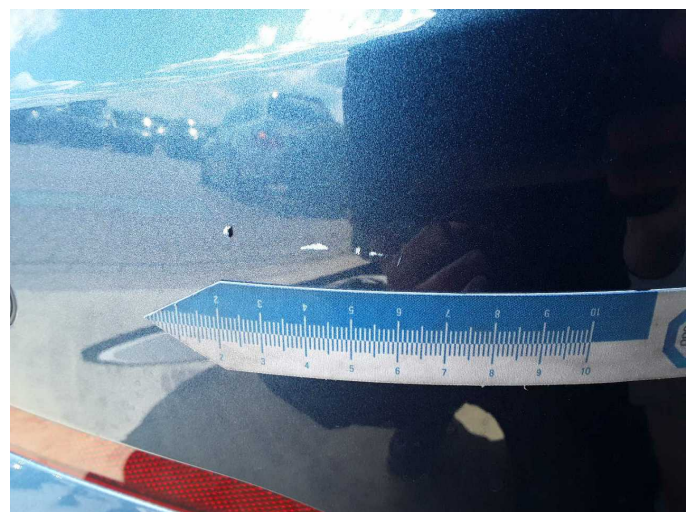
Damage 4: Rear bumper: Rear bumper - Scratched - Paint

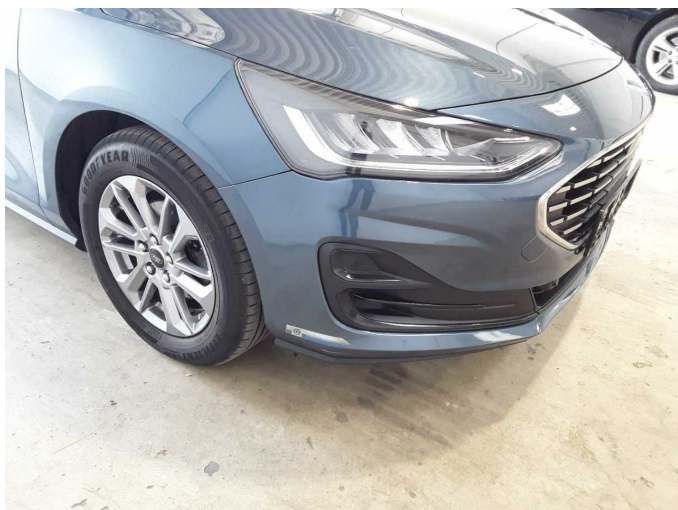
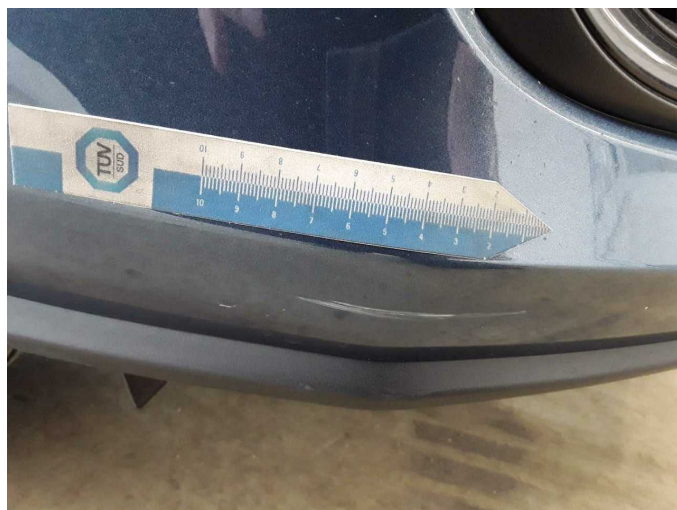
Damage 5: Front bumper: Front bumper - Scratched - Paint

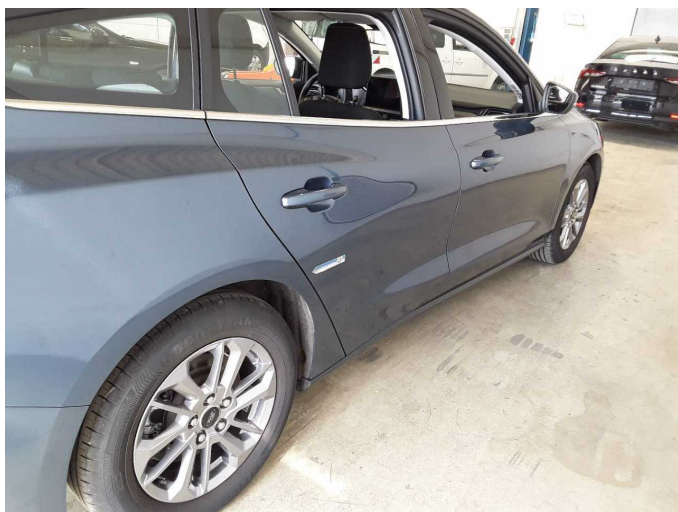
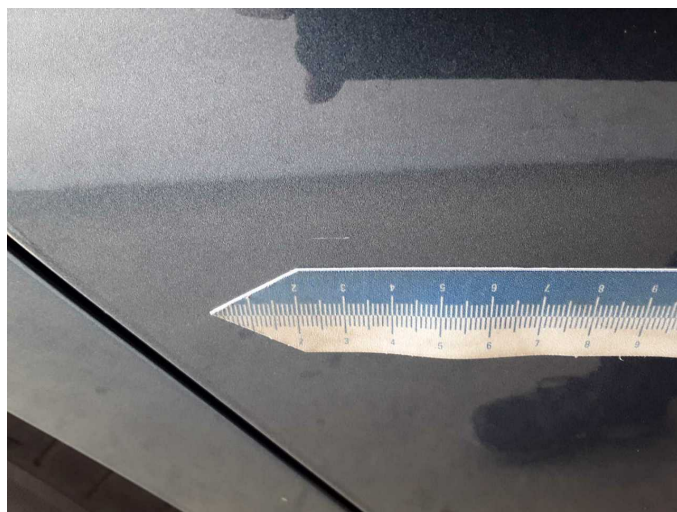
Wear and tear 2: Door - rear right side: Door - Scratch(es) - No deduction

No.	Component group	Description
1	Roof	Roof - dent(s) - No deduction
2	Door - rear right side	Door - Scratch(es) - No deduction
