Expertise

Protocol number: 41615466
Order No. / Reference: 25117931
Inspection date: 17 Sept 2025

Manufacturer: Ford	Model: Focus Turnier 1.5 EcoBlue Start-Stopp-System Aut. TITANIUM
VIN: WF0PXXGCHPPL02226

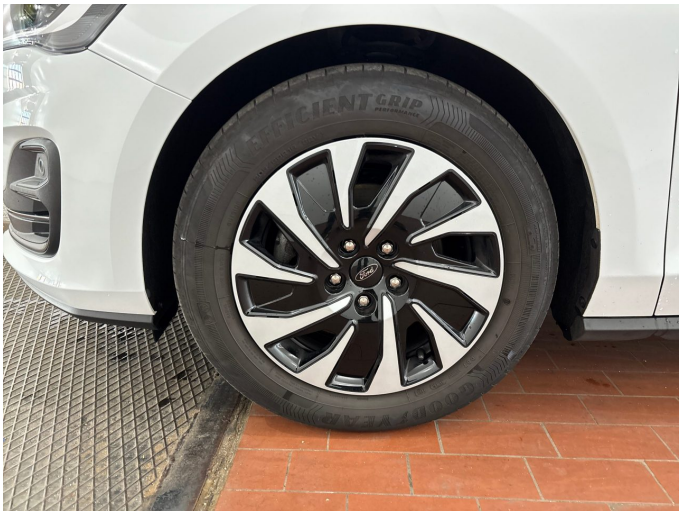
Figure 12: Mounted tyres

#	Tyre size	Type of tyre	Manufacturer	Tread depth
1)	205/60 R16 92V	Summer tyres on Light alloy	Goodyear	4mm / 4mm
2)	205/60 R16 92V	Summer tyres on Light alloy	Goodyear	4mm / 4mm

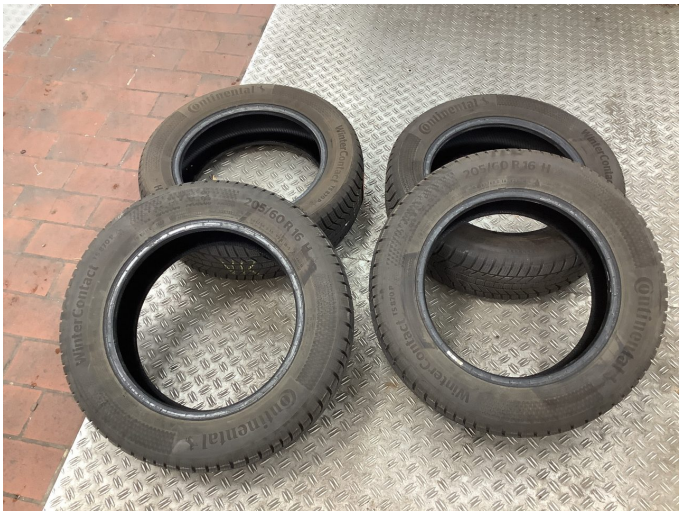
Figure 14: Additional tyres

#	Tyre size	Type of tyre	Manufacturer	Tread depth
1)	205/60 R16 92H	Winter tyres (Without wheel rim)	Continental	7mm / 7mm
2)	205/60 R16 92H	Winter tyres (Without wheel rim)	Continental	7mm / 7mm

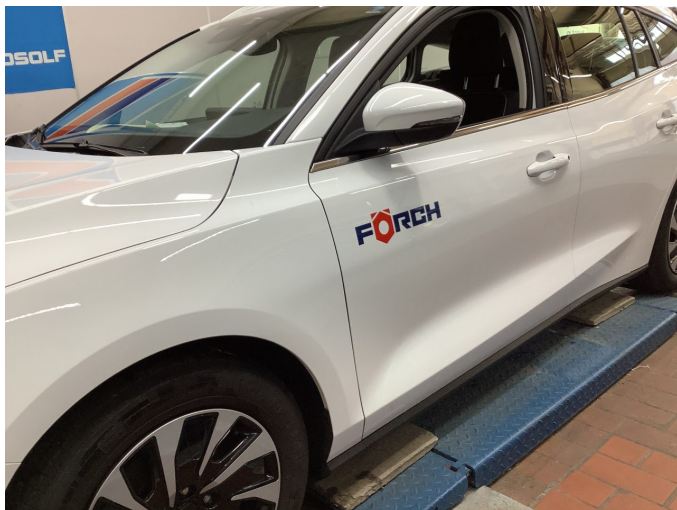
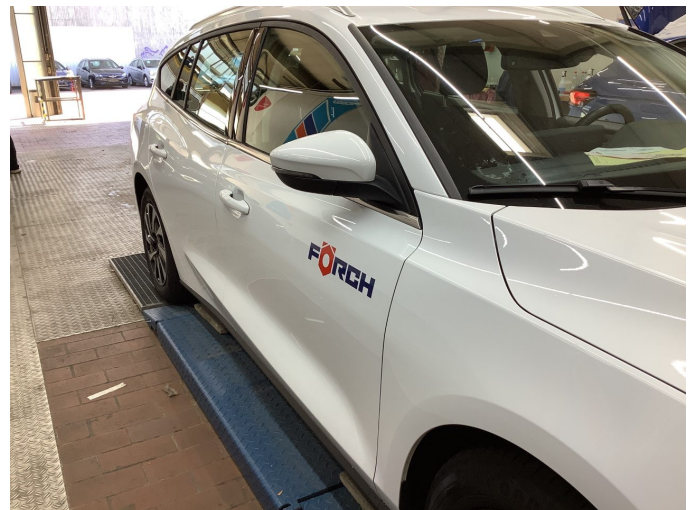
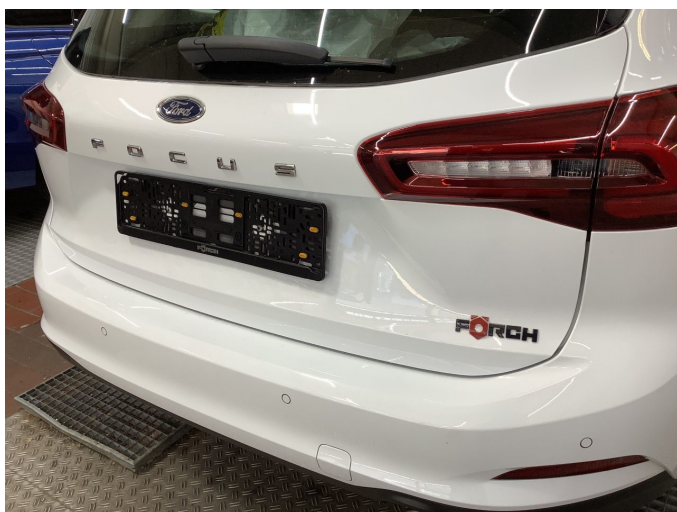
Damage 1: Body: Body - Glued / labelled - De-glue / neutralise

No.	Component group	Description
1	Body	Body - Glued / labelled - De-glue / neutralise
2	Side panel - rear left side	Side panel - dent(s) - Smart repair
3	Body	Body (Flugrost) - Soiled - Clean
4	Rear bumper	Rear bumper - Scratched - Paint

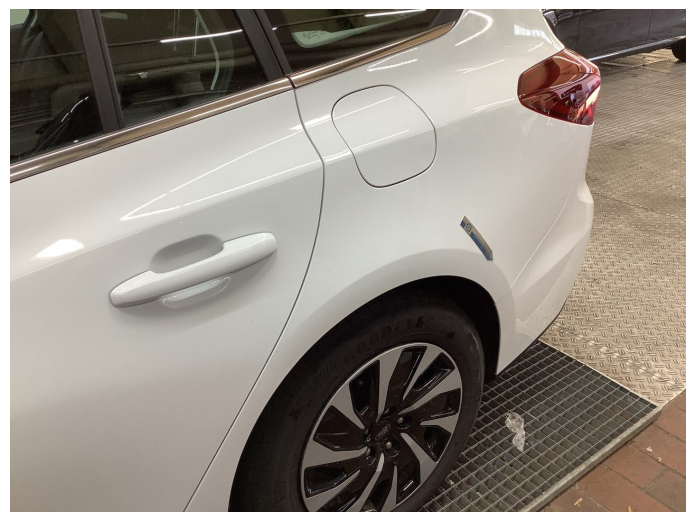
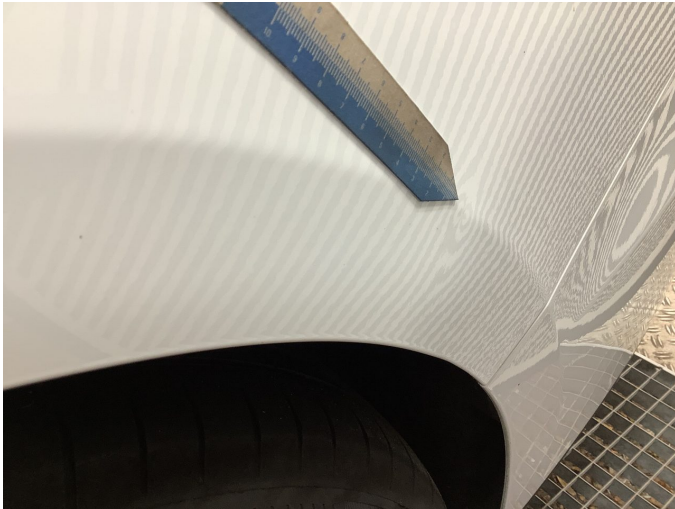
Damage 2: Side panel - rear left side: Side panel - dent(s) - Smart repair

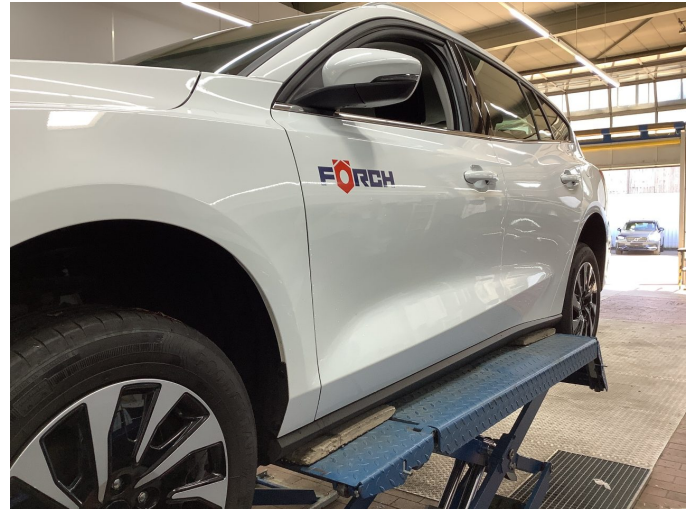
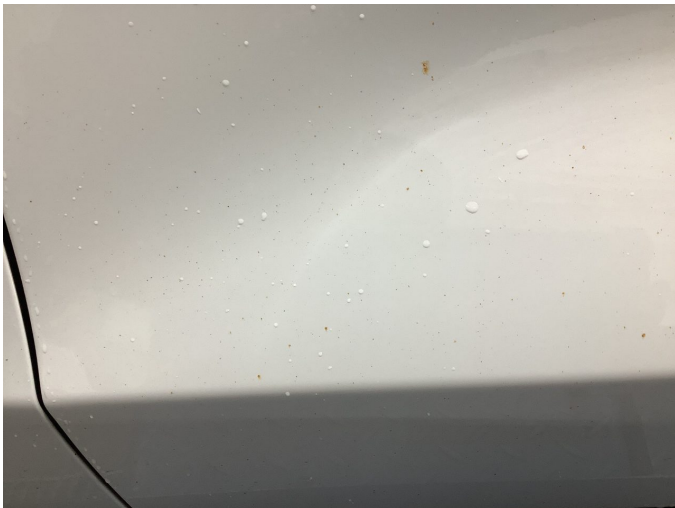
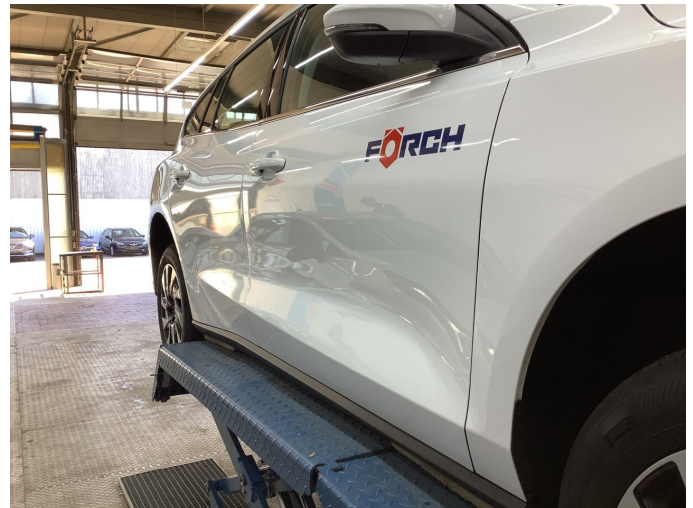
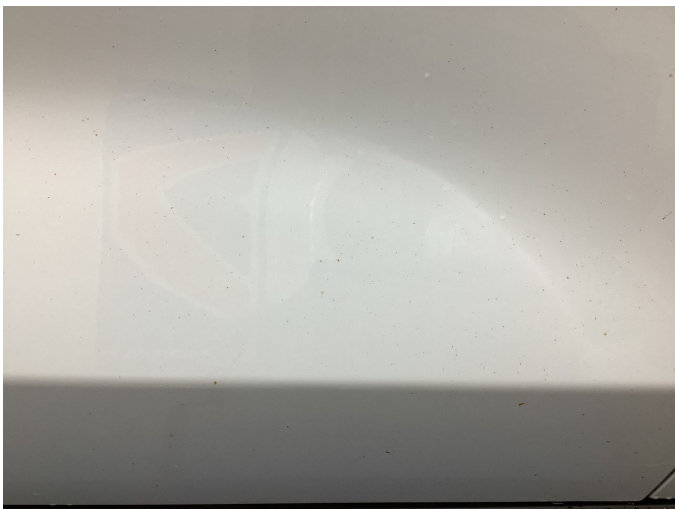
Damage 3: Body: Body (Flugrost) - Soiled - Clean

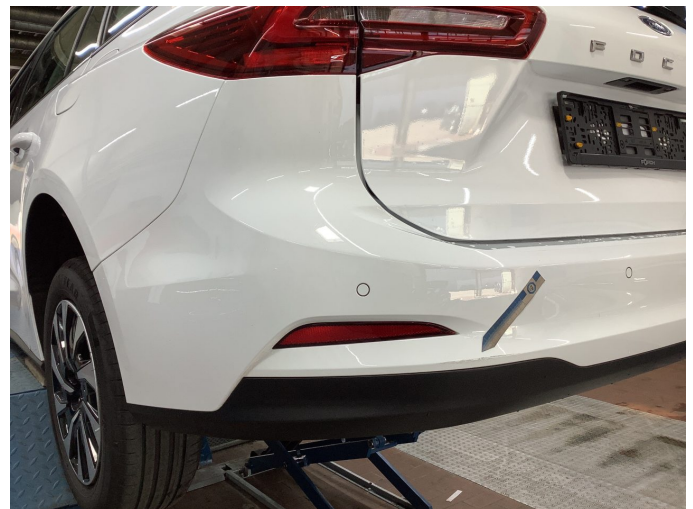
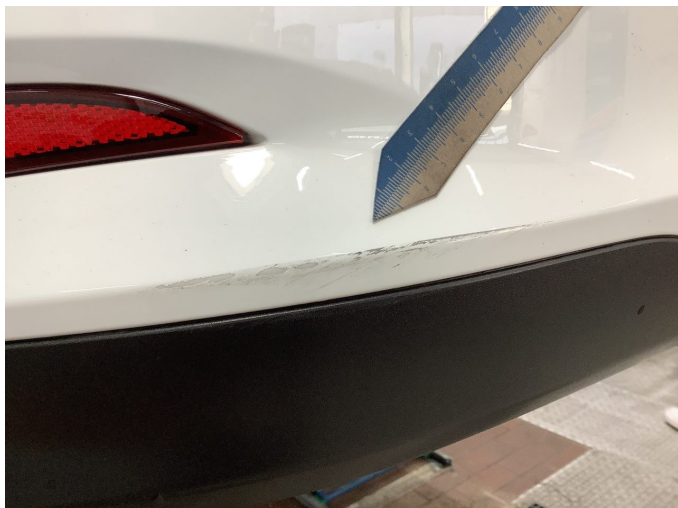
Damage 4: Rear bumper: Rear bumper - Scratched - Paint

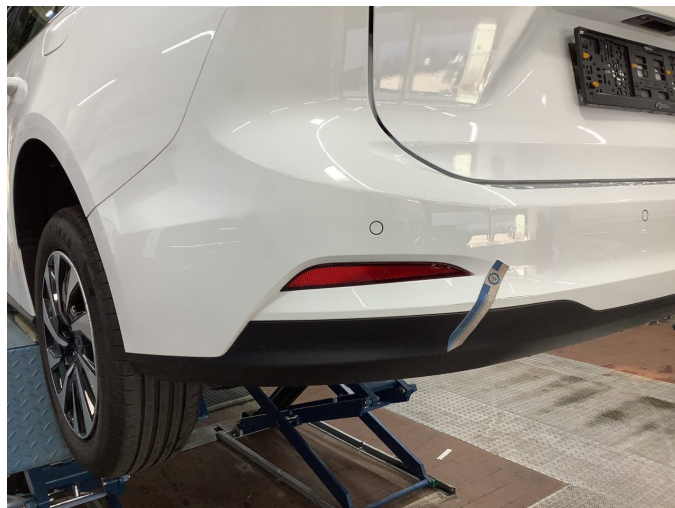
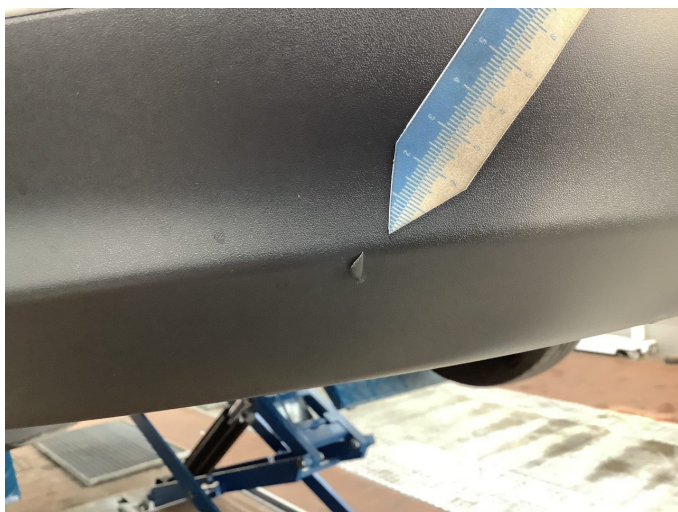
Wear and tear 1: Rear bumper: Spoiler - Scratch(es) - No deduction

No.	Component group	Description
1	Rear bumper	Spoiler - Scratch(es) - No deduction
