Expertise

Protocol number: 41588435
Order No. / Reference: 25155371
Inspection date: 17 Sept 2025

Manufacturer: Ford

Model: Focus Turnier 1.5 EcoBlue Start-Stopp-System Aut. TITANIUM

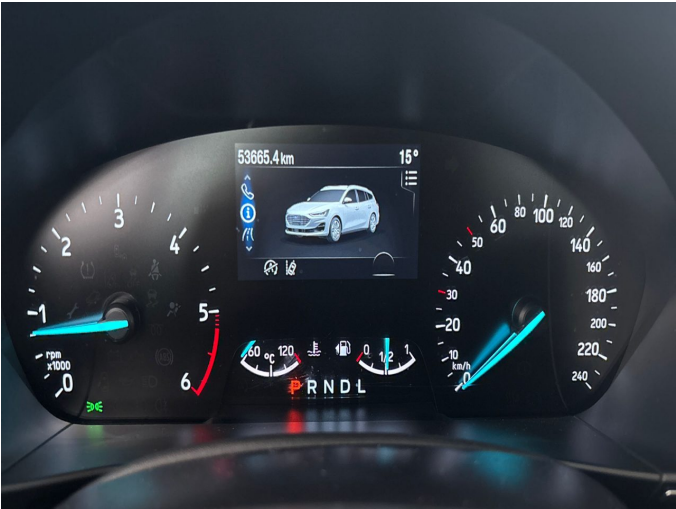
Figure 7: Instrument cluster

Vehicle details	
Manufacturer / Type / Model / Equipment	
Ford Focus Turnier 1.5 EcoBlue Start-Stopp-System Aut. TITANIUM	
Vehicle Identification number	WF0PXXGCHPPL02230
Mileage (Read)	53,665 km
First registration	26 Jul 2023
Number of holders	1
Power / Engine displacement	85 kw / 1,499 ccm
Fuel type / Cylinder	Diesel / 4
Gearbox / Number of gears	Automatic / 8
Type of drive	Front drive
Type of vehicle	Station wagon
Colour / colour code	Frozen White
Doors / Seats	5 / 5
Upholstery type	Cloth
Colour of upholstery	Anthracite-Black
Vehicle with smoke odor	no

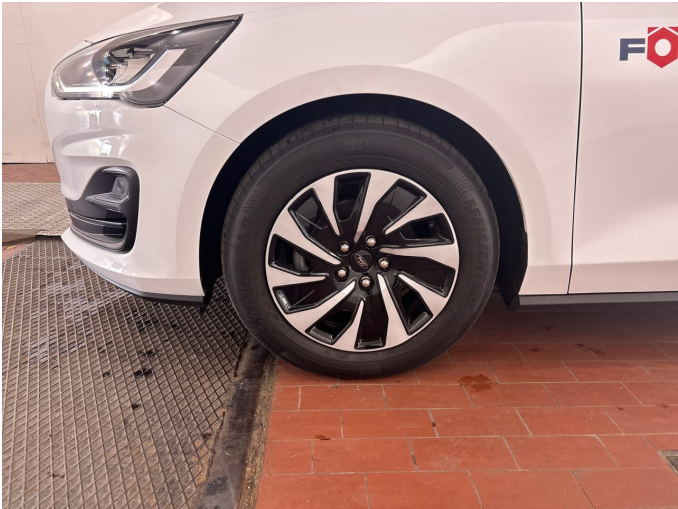
Figure 12: Mounted tyres

#	Tyre size	Type of tyre	Manufacturer	Tread depth
1)	205/60 R16 92V	Summer tyres on Steel rim with wheel cover	Goodyear	3mm / 3mm
2)	205/60 R16 92V	Summer tyres on Steel rim with wheel cover	Goodyear	5mm / 5mm

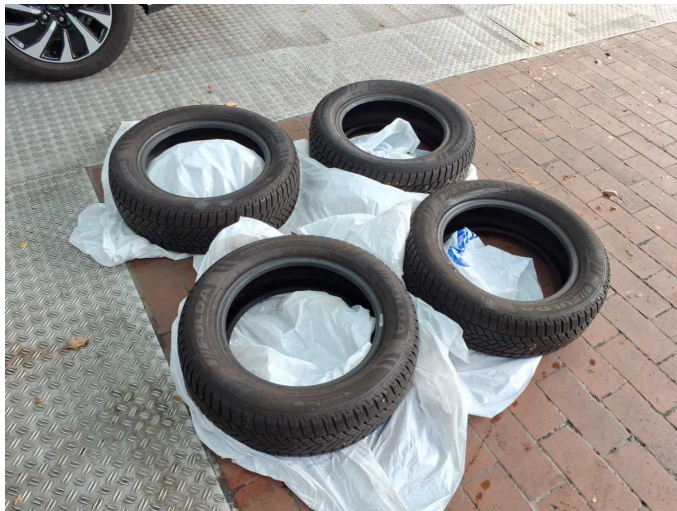
Figure 15: Additional tyres

#	Tyre size	Type of tyre	Manufacturer	Tread depth
1)	205/60 R16 92H	Winter tyres (Without wheel rim)	Fulda	7mm / 7mm
2)	205/60 R16 92H	Winter tyres (Without wheel rim)	Fulda	7mm / 7mm

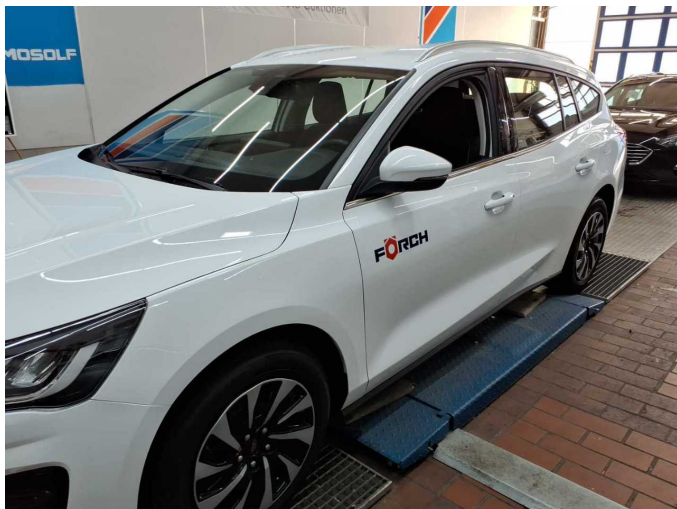
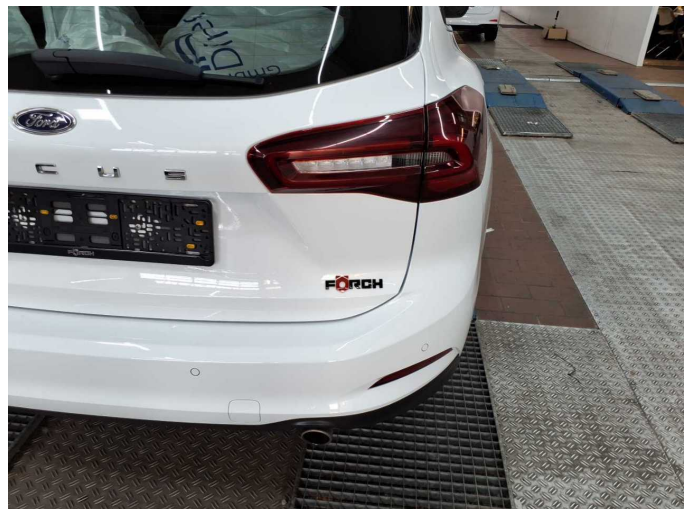
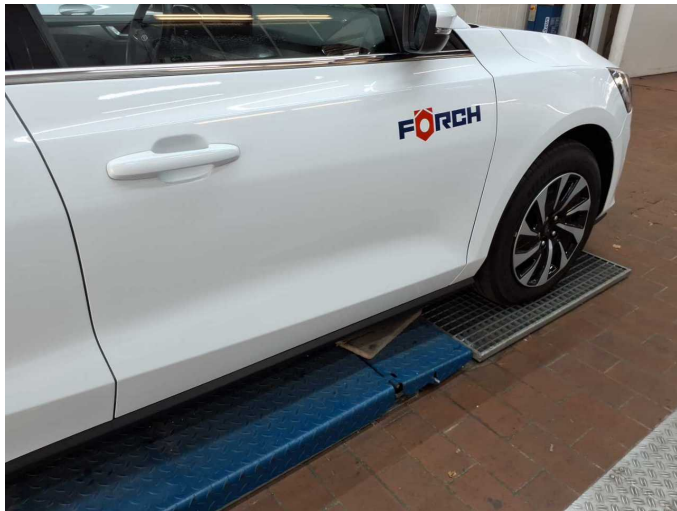
Damage 1: Body: Body - Glued / labelled - De-glue / neutralise

No.	Component group	Description
1	Body	Body - Glued / labelled - De-glue / neutralise
2	Front bumper	Front bumper - Scratched - Smart repair
3	Side panel - rear right side	Side panel (Kante) - dent(s) - Smart repair
4	Rear bumper	Rear bumper (Kante) - dent(s) - Repair and paint

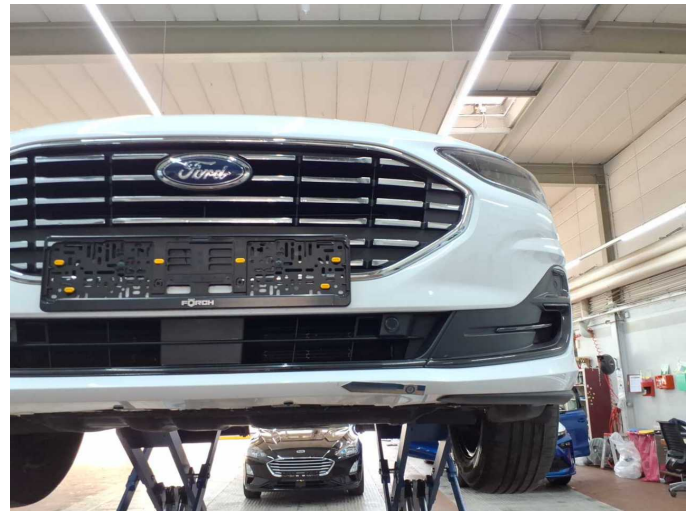
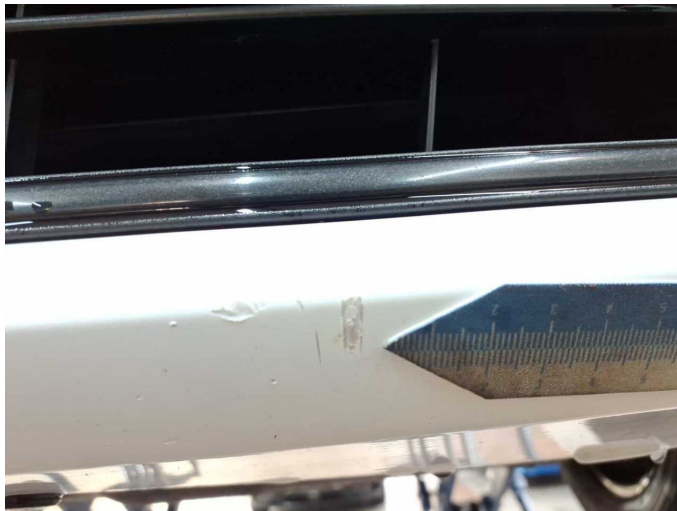
Damage 2: Front bumper: Front bumper - Scratched - Smart repair

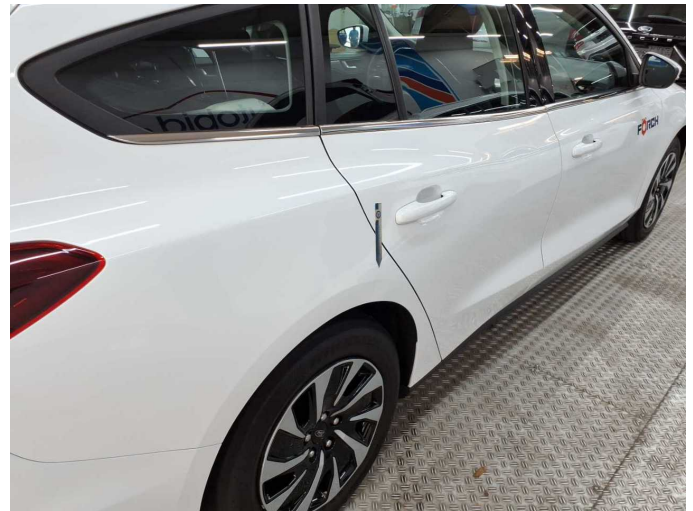
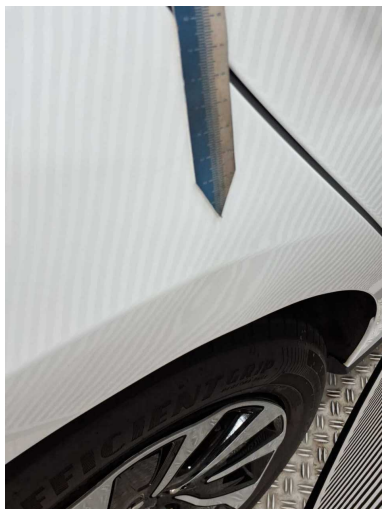
Damage 3: Side panel - rear right side: Side panel (Kante) - dent(s) - Smart repair

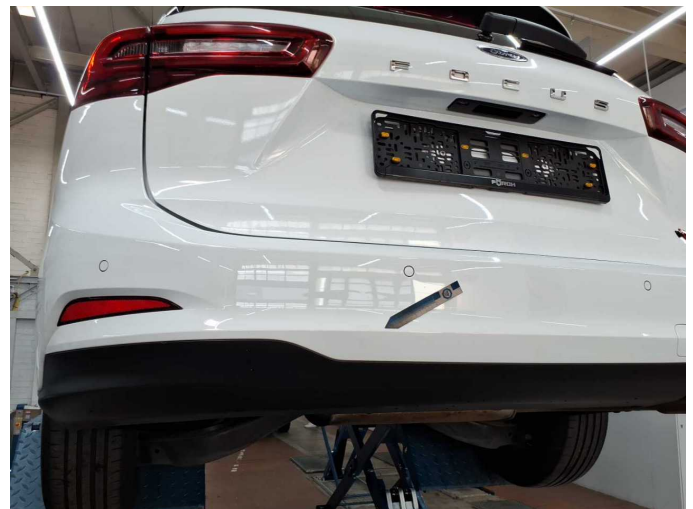
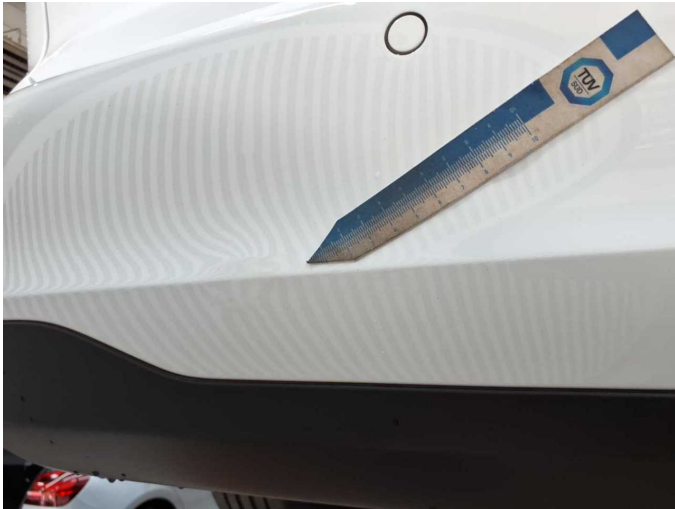
Damage 4: Rear bumper: Rear bumper (Kante) - dent(s) - Repair and paint

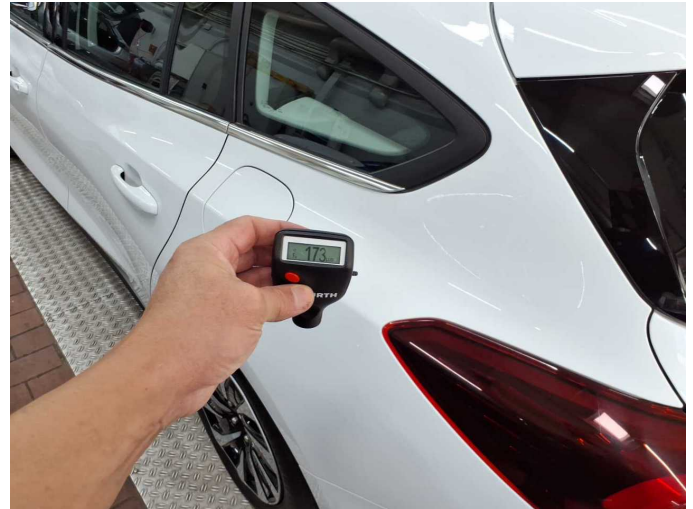
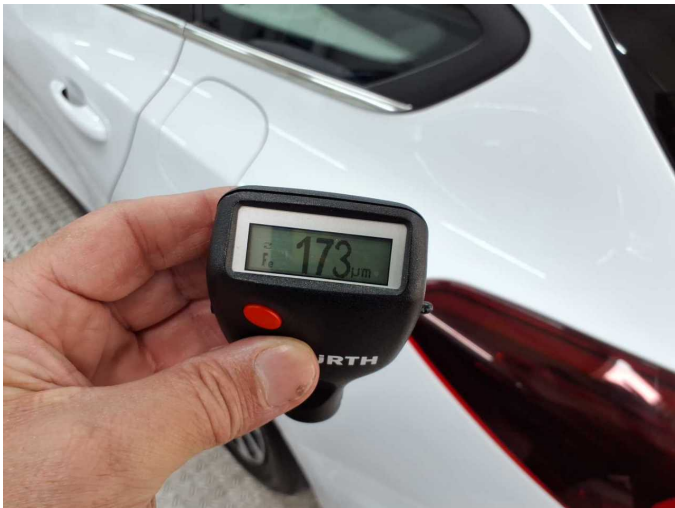
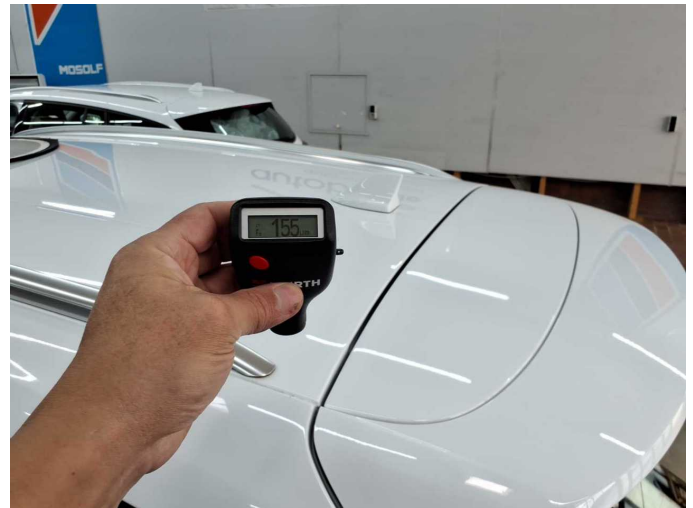
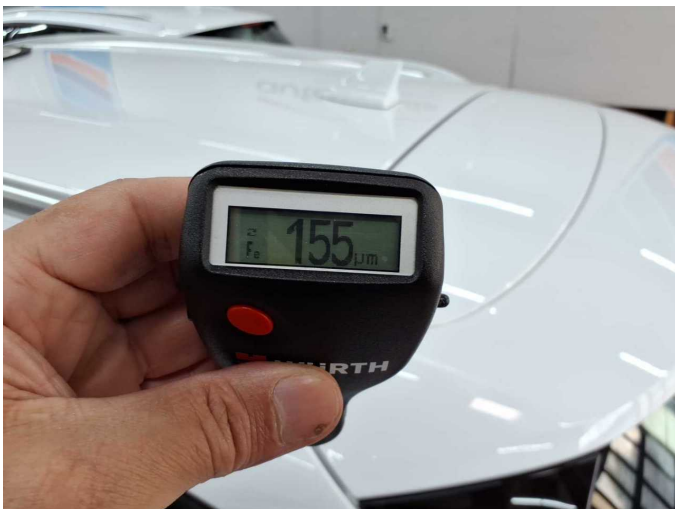
Repainting 1: Roof, Side panel - rear left side

| 1 | Roof, Side panel - rear left side, Professionally carried out, Invoice of repair done Non-existent |

Roof	155 µm	Side panel - rear left side	173 µm
------	--------	-----------------------------	--------
