Expertise

Protocol number: 41088914
Order No. / Reference: 25130798
Inspection date: 15 Aug 2025

Manufacturer: Ford

Model: Transit Connect 220 L2 Trend

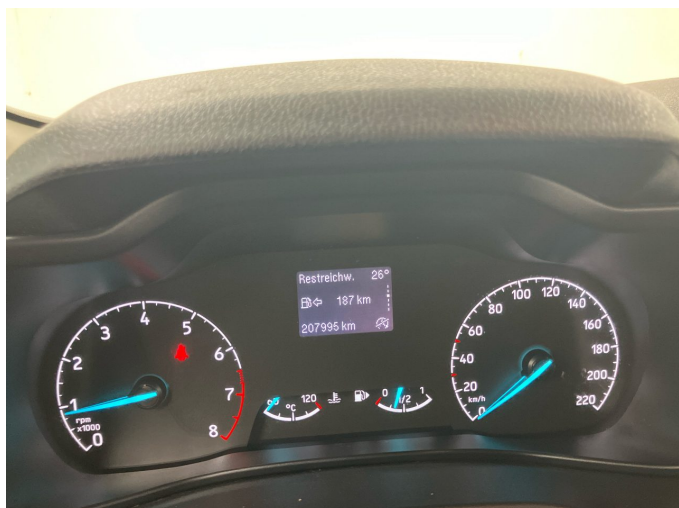
Figure 7: Instrument cluster

Maintenance booklet / proof	digital proof / complete	Next maintenance in	6 %
Last maintenance on / at	09/2024 at 179,795 km		
Key is / should be	1 / 2	FZG documents	ZB#2 (B) was available (copy), ZB#1 (S) was not available
		Letter No.	GH407984
Previous damage / Accident	None detectable	Repainting	None detectable
Inspection conditions	sufficient	Lifting equipment / pit	yes
Test drive	Not performed	Engine function test	Performed
Driving readiness	Roadworthy		
Manufacturer key number/ type code number	8566 / BHA 00534		
Emission standard	EURO6;WLTP;AQ;PI/CI; N1 II	Fine dust sticker	
Permitted total weight	2,175 kg	Empty weight

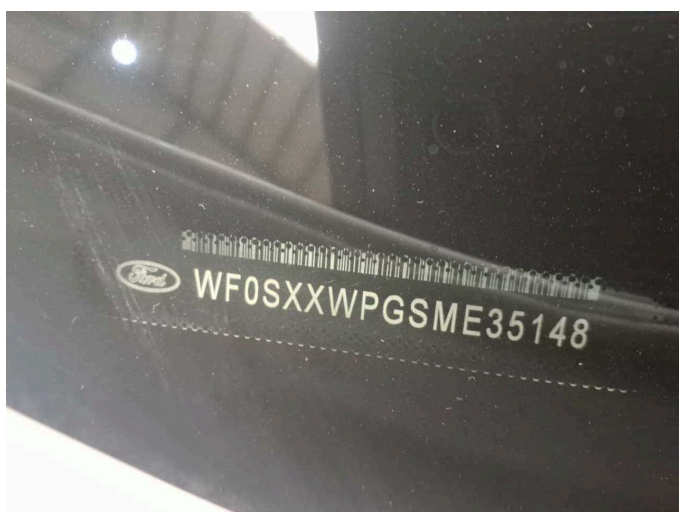
Figure 11: VIN

Documents submitted	At the time of the inspection, the registration certificate Part 2 (letter) was available, but the registration certificate Part 1 (certificate) was not. (Copy)
VIN comparison	The vehicle identification number (VIN) was read and the undersigned verified that it matched the documents submitted during the inspection.
Inspection	The inspection conditions were sufficient for the assessment of the vehicle. Lifting equipment and a pit were available for examining the vehicle.
Test drive	No test drive/maneuvering was carried out during the inspection of the vehicle.
Engine function test	An engine test run was performed.
Driving readiness	The vehicle was drivable at the time of inspection.

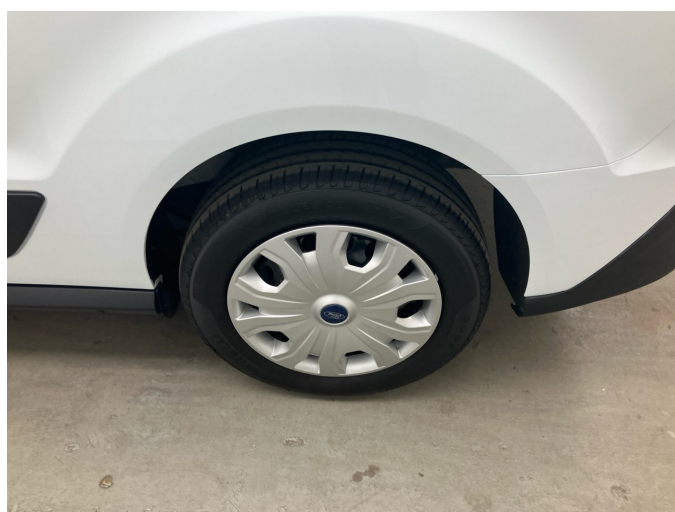
Figure 12: Mounted tyres

#	Tyre size	Type of tyre	Manufacturer	Tread depth
1)	205/60 R16 96V	Summer tyres on Steel rim with wheel cover	Pirelli	5mm / 5mm
2)	205/60 R16 96V	Summer tyres on Steel rim with wheel cover	Pirelli	6mm / 6mm

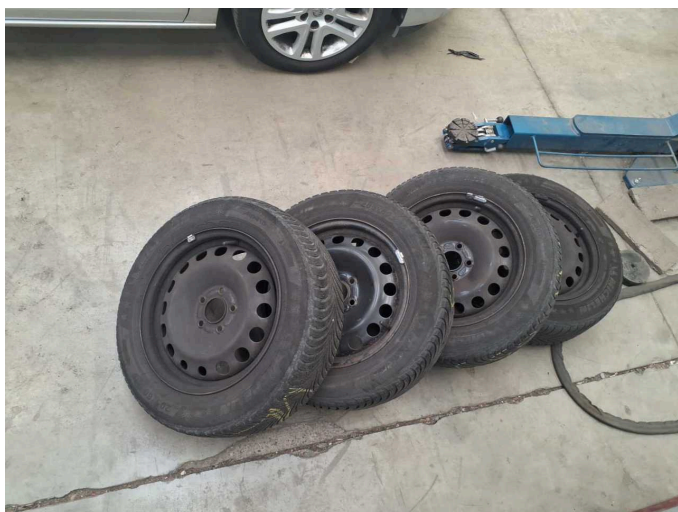
Figure 15: Additional tyres

#	Tyre size	Type of tyre	Manufacturer	Tread depth
1)	205/60 R16 96H	Winter tyres on Steel	Michelin	4mm / 4mm
2)	205/60 R16 96H	Winter tyres on Steel	Michelin	5mm / 6mm

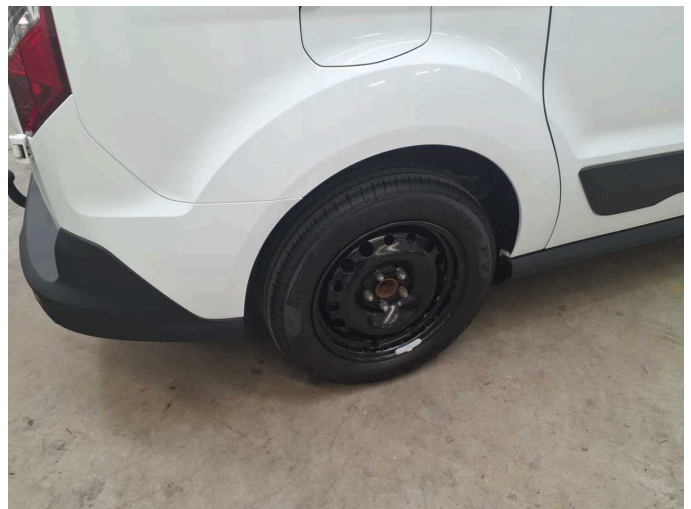
Damage 1: Wheel / tyres: Wheel cover - rear right side (Radkappe Hinten rechts) - Missing - Replace

No.	Component group	Description
1	Wheel / tyres	Wheel cover - rear right side (Radkappe Hinten rechts) - Missing - Replace
