Expertise

Protocol number: 41641808
Order No. / Reference: 25252032
Inspection date: 22 Sept 2025

Model: Transit Custom 280 L1H1 LKW VA Trend

VIN: WF0YXXTTGYLT45293

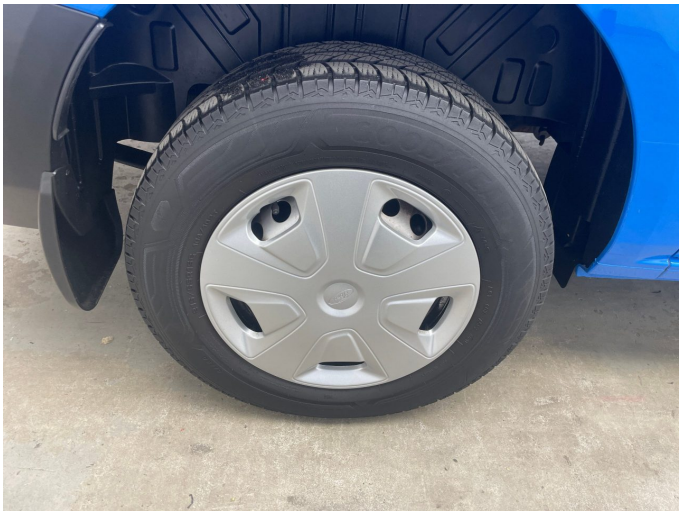
Figure 12: Mounted tyres

Mounted tyres				
#	Tyre size	Type of tyre	Manufacturer	Tread depth
1)	215/65 R15 104T	All-season tyres on Steel rim with wheel cover	Goodyear	3mm / 3mm
2)	215/65 R15 104T	All-season tyres on Steel rim with wheel cover	Goodyear	7mm / 7mm

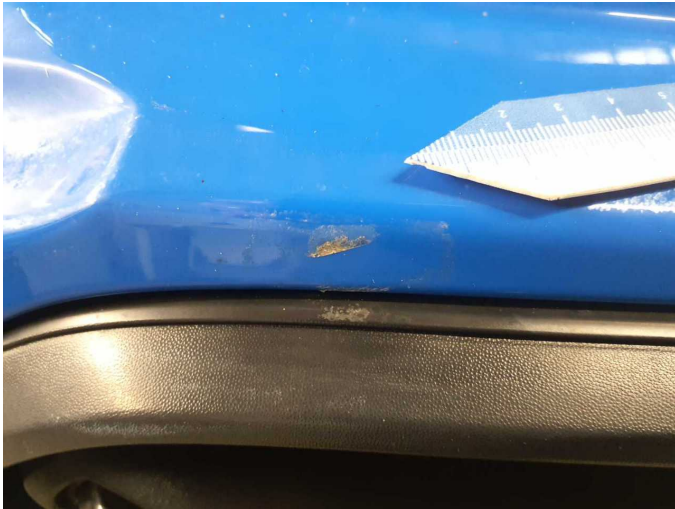
No.	Component group	Description
1	Front bumper	Front bumper - Scratched - Smart repair
2	Boot lid / rear door	Boot lid - Scratched - Smart repair
3	Wheel / tyres	Tyre - front (unter 4mm) - Worn - Replace

Damage 1: Front bumper: Front bumper - Scratched - Smart repair

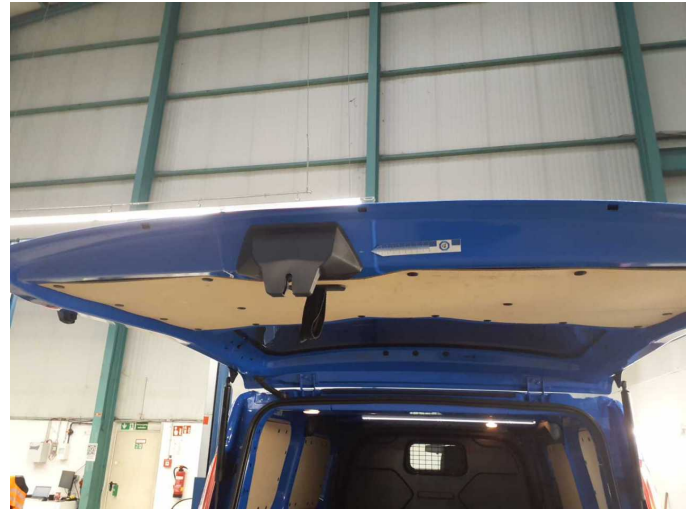
Damage 2: Boot lid / rear door: Boot lid - Scratched - Smart repair

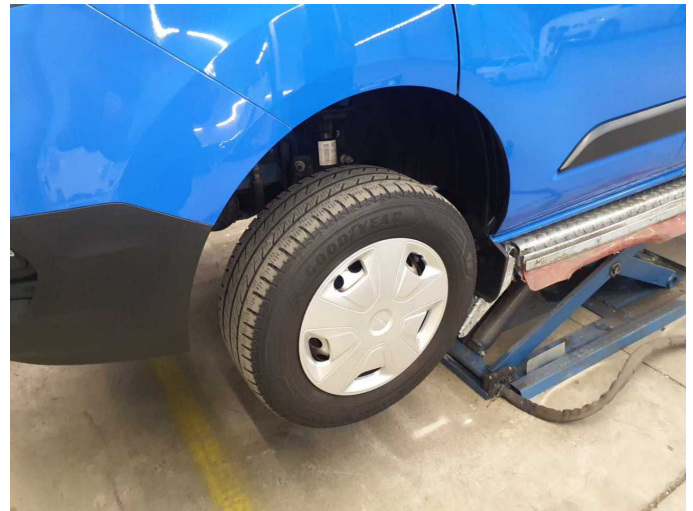
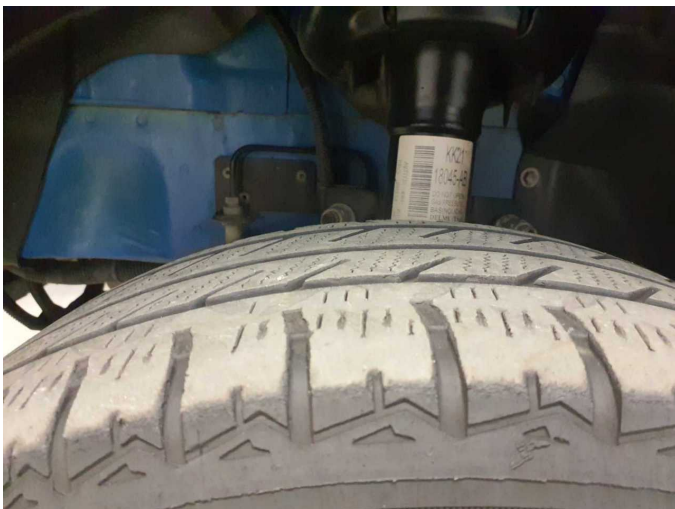
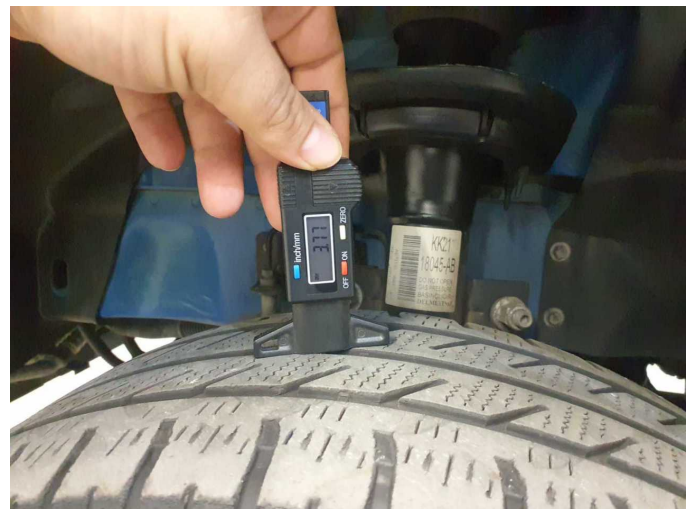
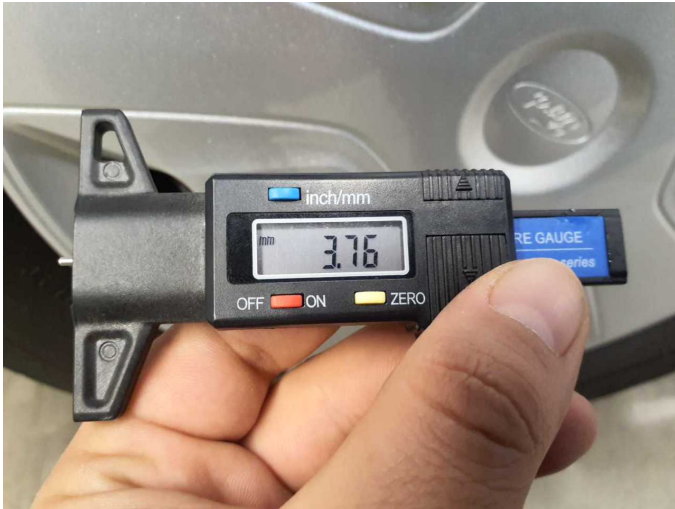
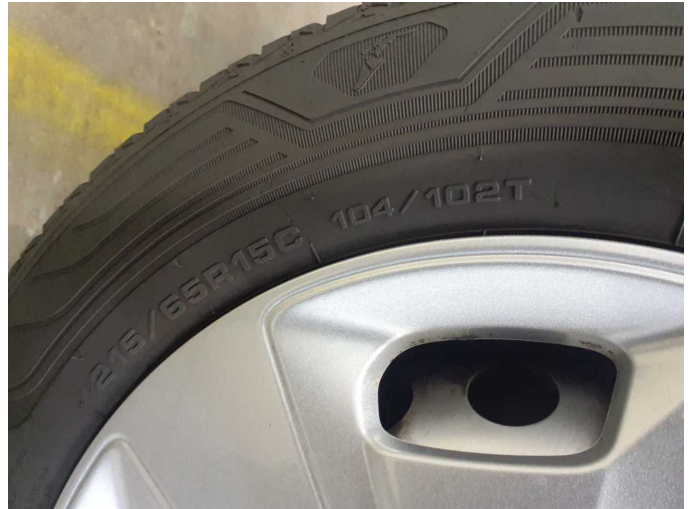
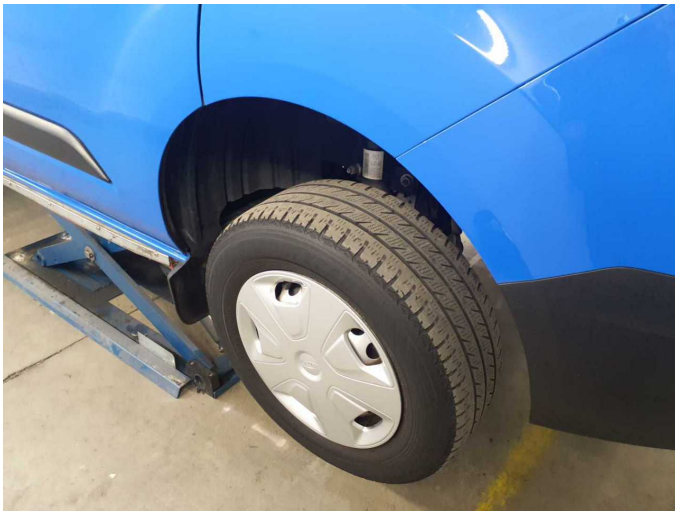
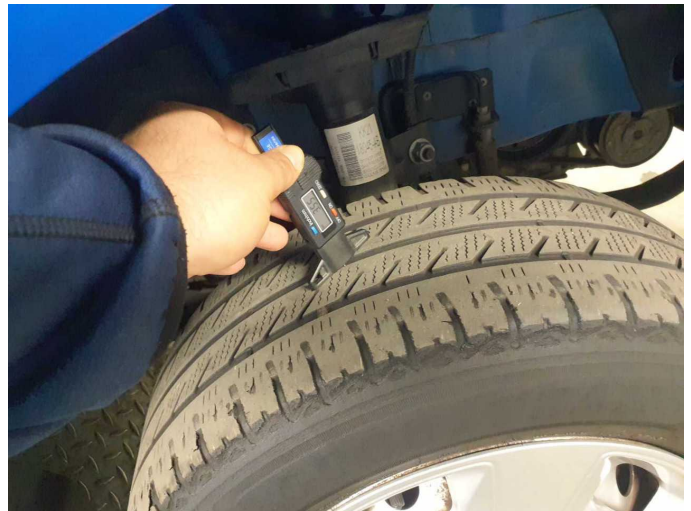
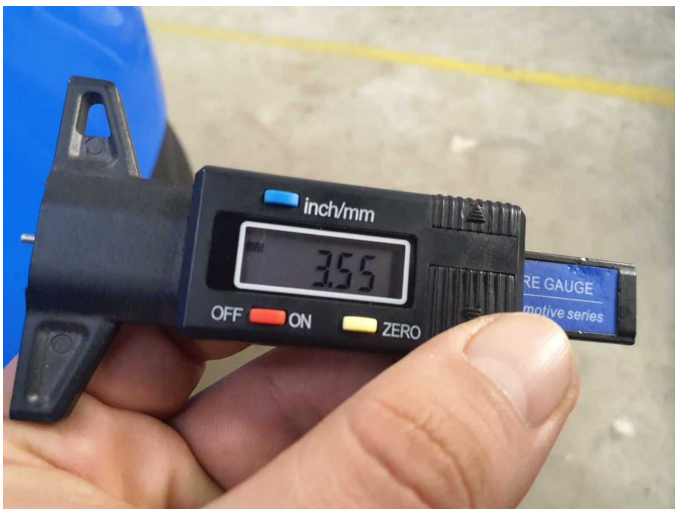
Damage 3: Wheel / tyres: Tyre - front (unter 4mm) - Worn - Replace
