Expertise

Protocol number: 41789959  
Order number / reference: 25209953  
Inspection date: 1 Oct 2025

Manufacturer: Ford

Model: Transit Custom 280 L1H1 LKW VA Trend

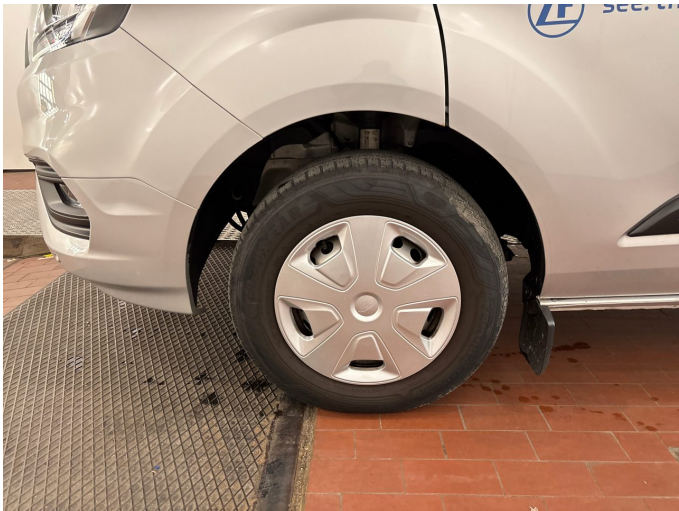
Figure 12: Mounted tyres

#	Tyre size	Type of tyre	Manufacturer	Tread depth
1)	215/65 R15 104T	All-season tyres on Steel rim with wheel cover	Goodyear	4mm / 4mm
2)	215/65 R15 104T	All-season tyres on Steel rim with wheel cover	Goodyear	8mm / 8mm

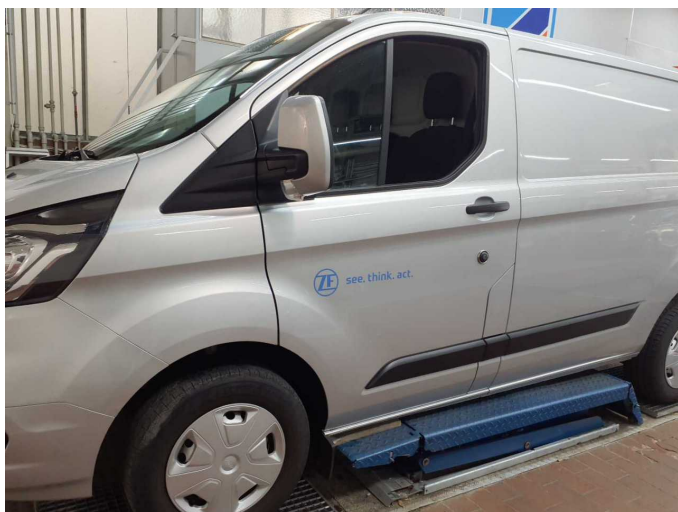
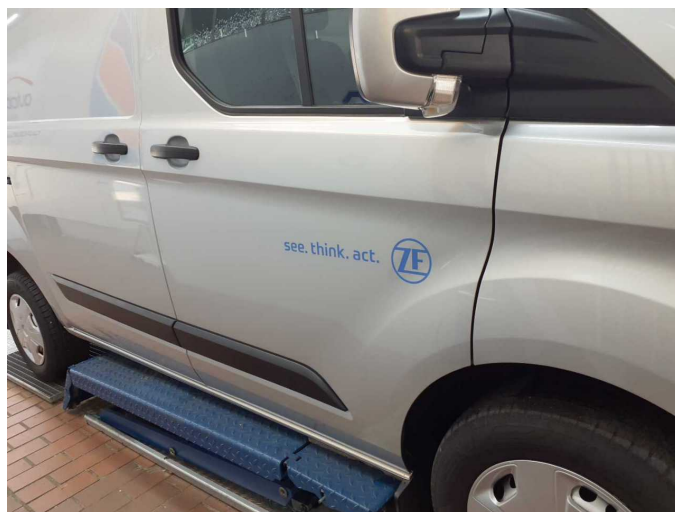
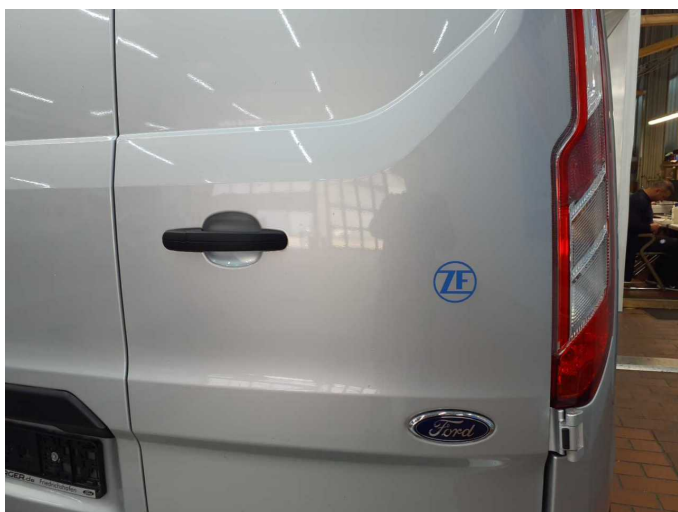
**Damage 2:** Body: Body - Glued / labelled - De-glue / neutralise

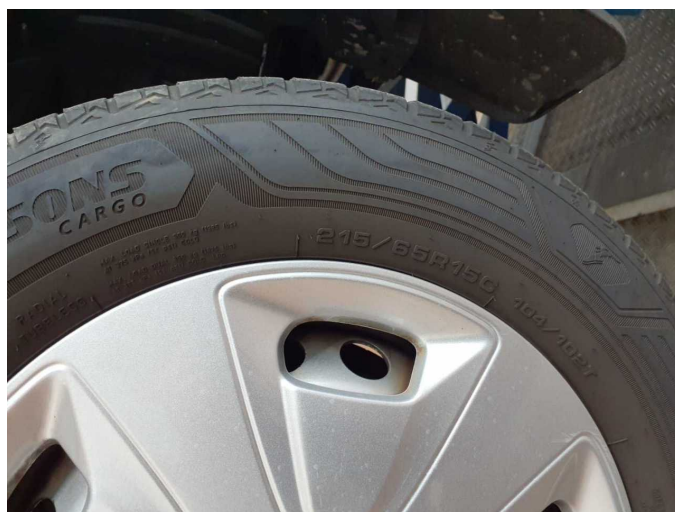
**Damage 3:** Wheel / tyres: Tyre - front - Does not meet the leasing specifications - Replace
