Expertise

Protocol number: 41826461
Order number / reference: 25246402
Inspection date: 6 Oct 2025

Manufacturer: Ford

Model: Transit Custom 320 L2H1 LKW VA MH Trend

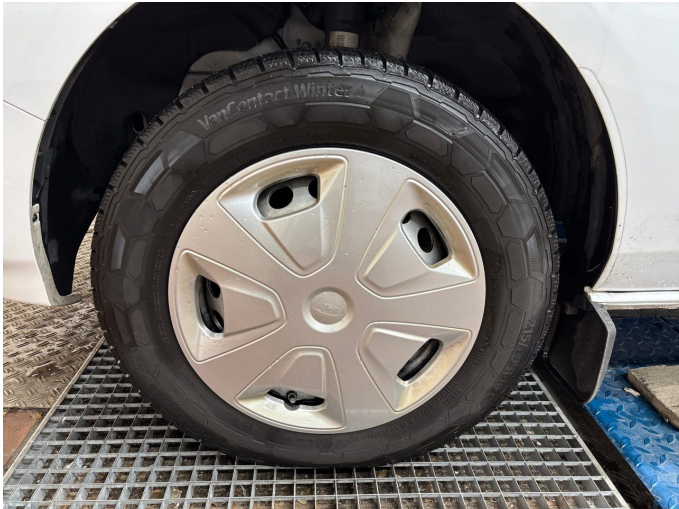
Figure 12: Mounted tyres

#	Tyre size	Type of tyre	Manufacturer	Tread depth
1)	215/65 R16 109R	Winter tyres on Steel rim with wheel cover	Continental	6mm / 6mm
2)	215/65 R16 109R	Winter tyres on Steel rim with wheel cover	Continental	7mm / 7mm

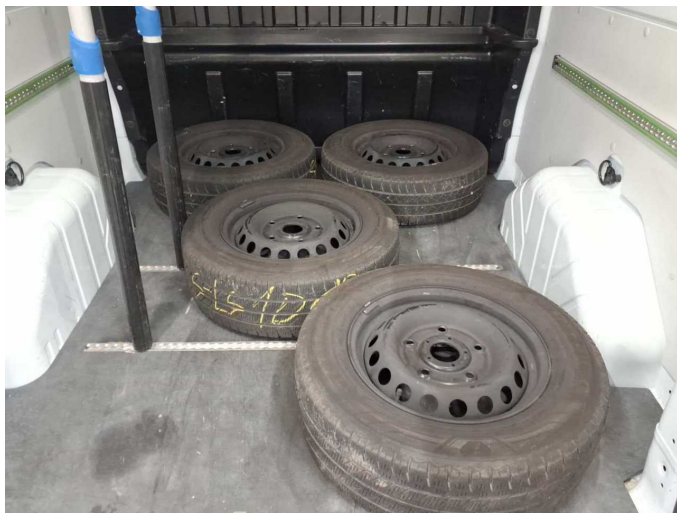
Figure 15: Additional tyres

#	Tyre size	Type of tyre	Manufacturer	Tread depth
1)	215/65 R16 109T	All-season tyres on Steel	Goodyear	7mm / 7mm
2)	215/65 R16 109T	All-season tyres on Steel	Goodyear	7mm / 7mm

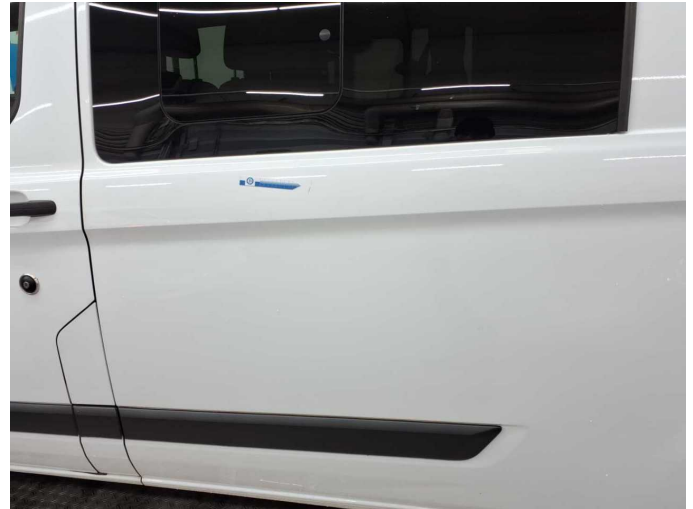
Damage 1: Side panel - rear left side: Side panel - Scratch(es) - Smart repair

No.	Component group	Description
1	Side panel - rear left side	Side panel - Scratch(es) - Smart repair
2	Side panel - rear right side	Side panel - dent(s) - Repair and paint

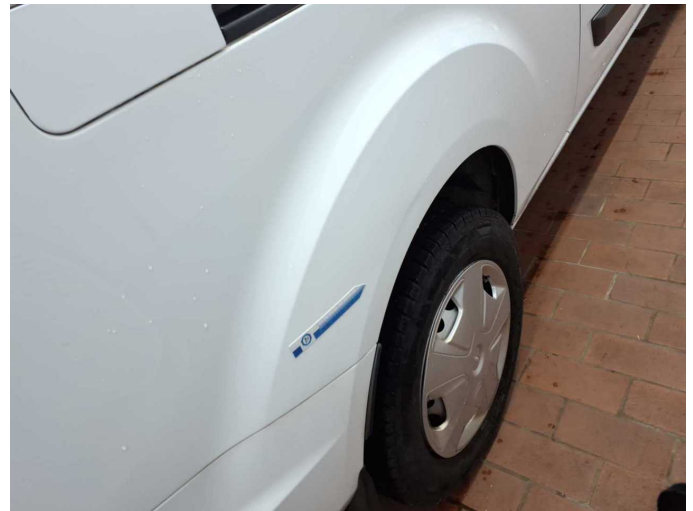
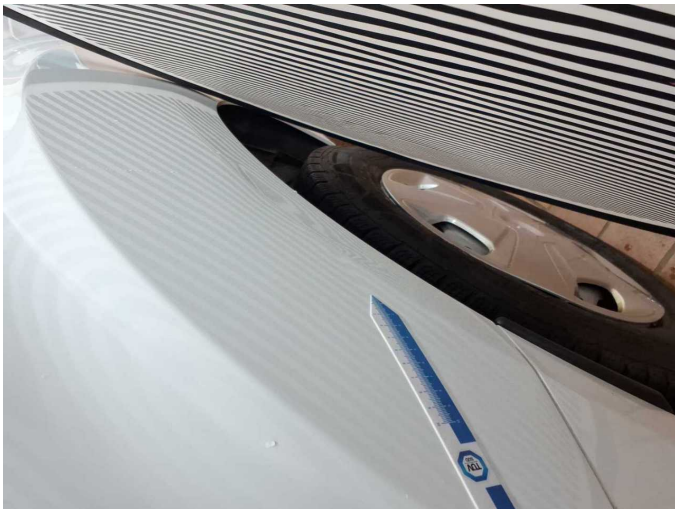
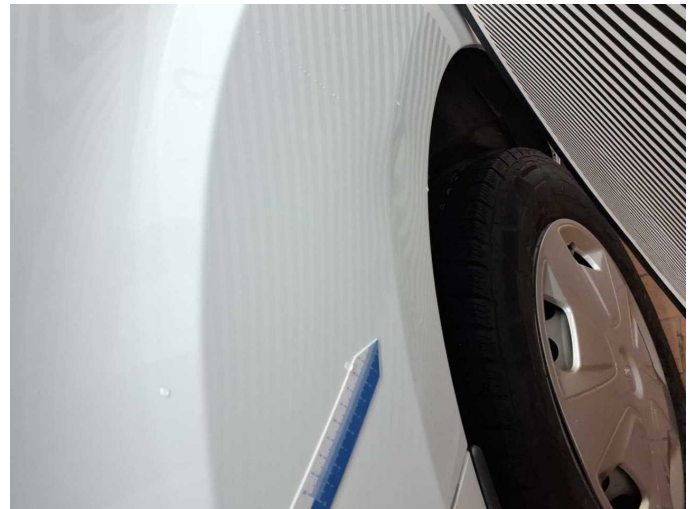
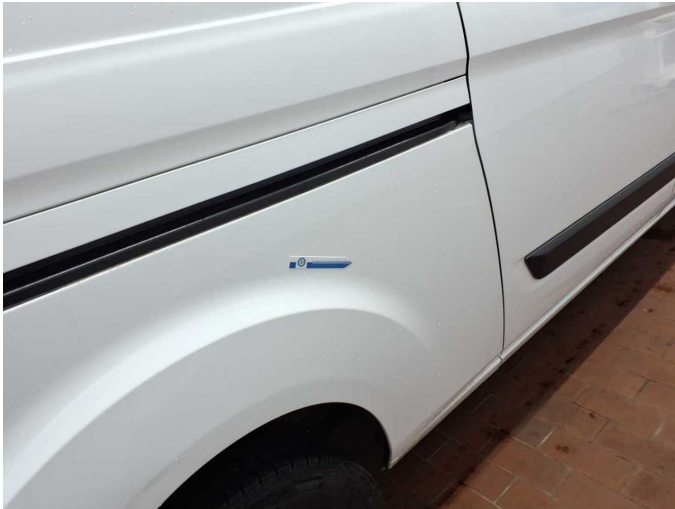
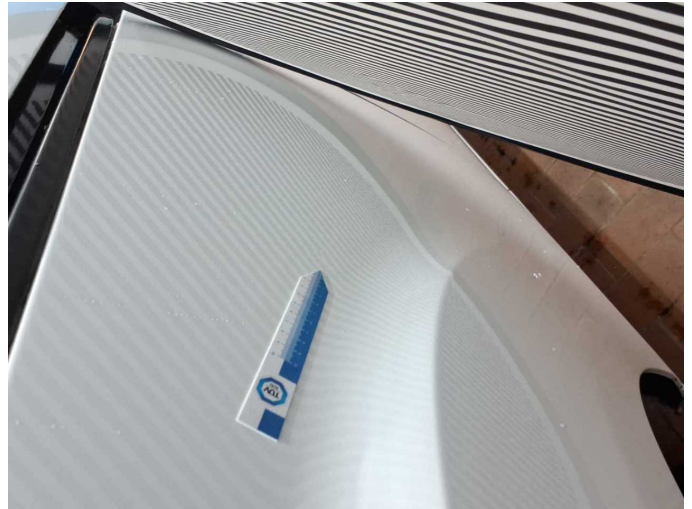
Damage 2: Side panel - rear right side: Side panel - dent(s) - Repair and paint

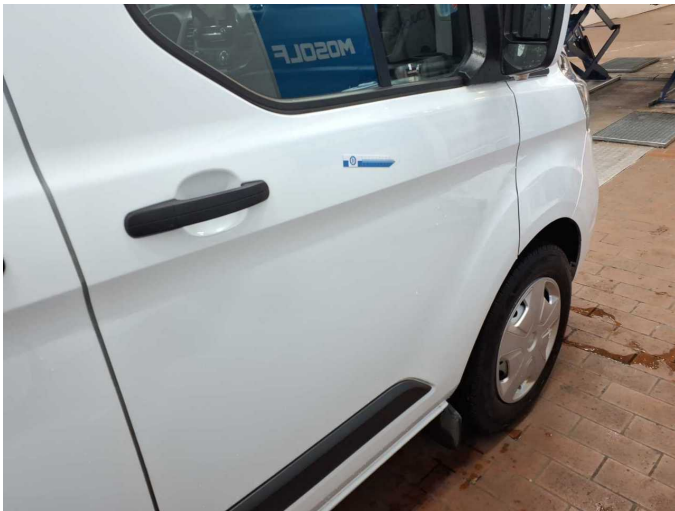
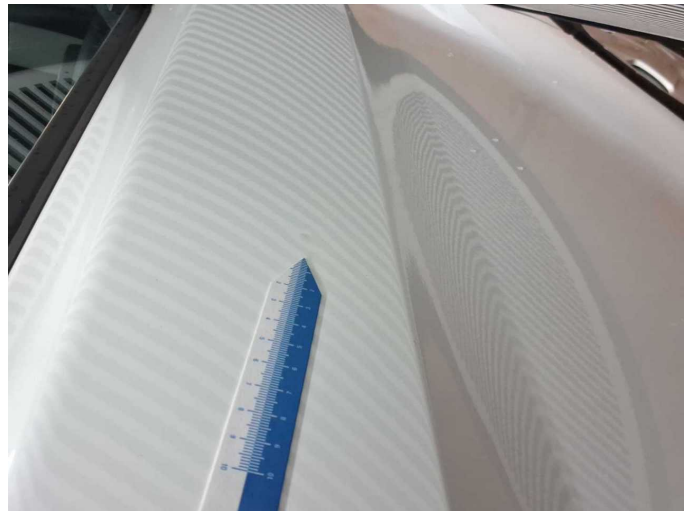
Wear and tear 4: Door - front right side: Door - dent(s) - No deduction

No.	Component group	Description
1	Interior	Interior - Scratch(es) - No deduction
2	Bonnet	Bonnet - Stone chips - No deduction
3	Vehicle glazing	Windscreen - Stone chips - No deduction
4	Door - front right side	Door - dent(s) - No deduction
