Expertise

Protocol number: 41206252  
Order No. / Reference: 25127901  
Inspection date: 21 Aug 2025

Manufacturer: Porsche	Model: 911 Carrera 4S PDK
VIN: WP0ZZZ99ZNS214384

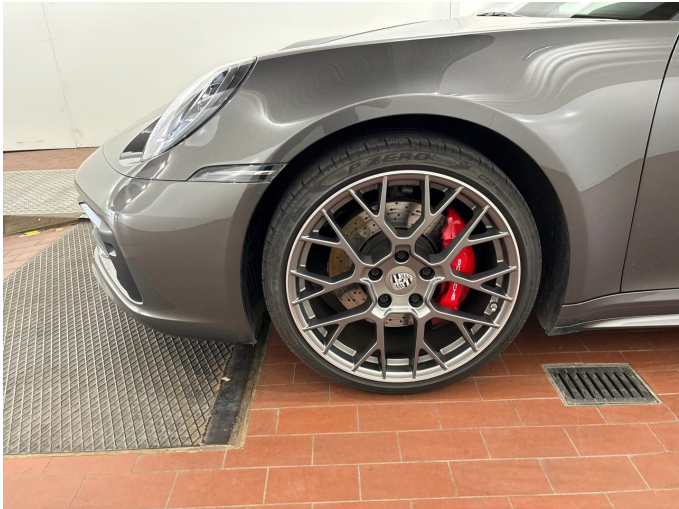
Figure 12: Mounted tyres

#	Tyre size	Type of tyre	Manufacturer	Tread depth
1)	245/35 R20 91Y	Summer tyres on Light alloy	Pirelli	4mm / 4mm
2)	305/30 R21 100Y	Summer tyres on Light alloy	Pirelli	6mm / 6mm

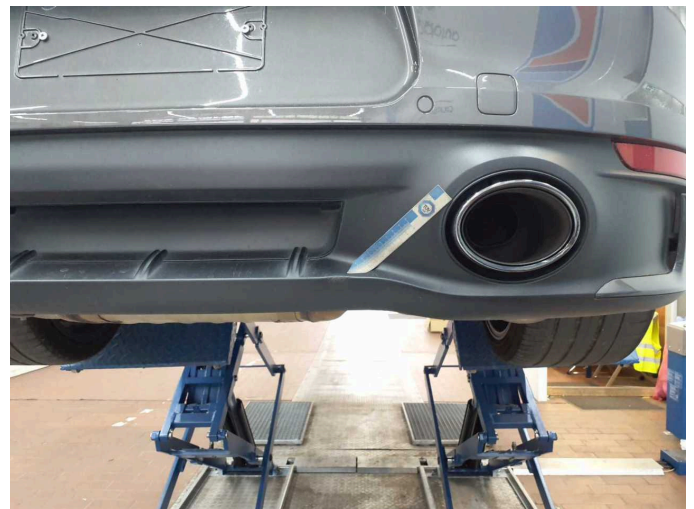
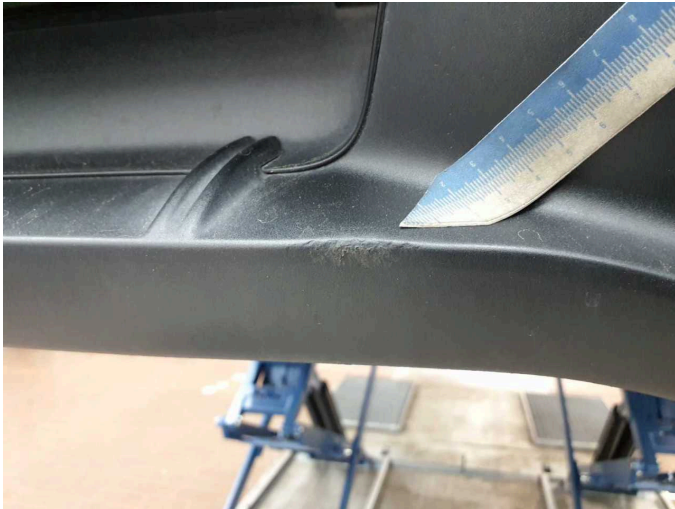
Damage 1: Rear bumper: Spoiler - Scratched - Loss in value

**Damage 1:** Rear bumper: Spoiler - Scratched - Loss in value

No.	Component group	Description
1	Rear bumper	Spoiler - Scratched - Loss in value
2	Wheel / tyres	Alloy rim - front right side - Scratched - Loss in value
3	Front bumper	Spoiler - Scratched - Repair and paint
4	Wheel / tyres	Alloy rim - rear right side - Scratched - Loss in value

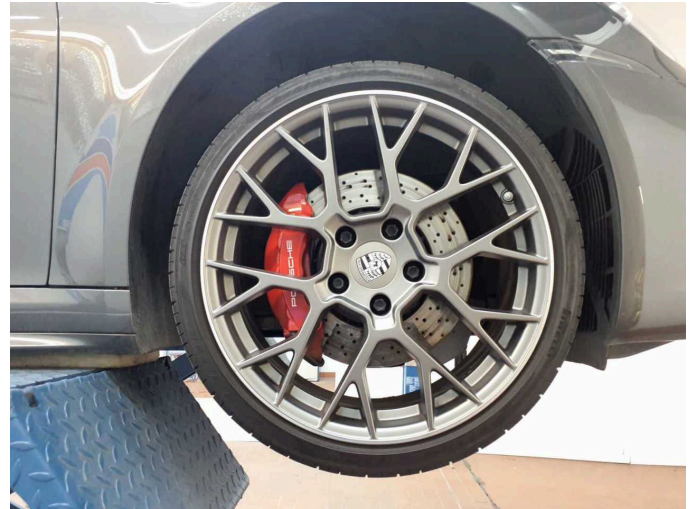
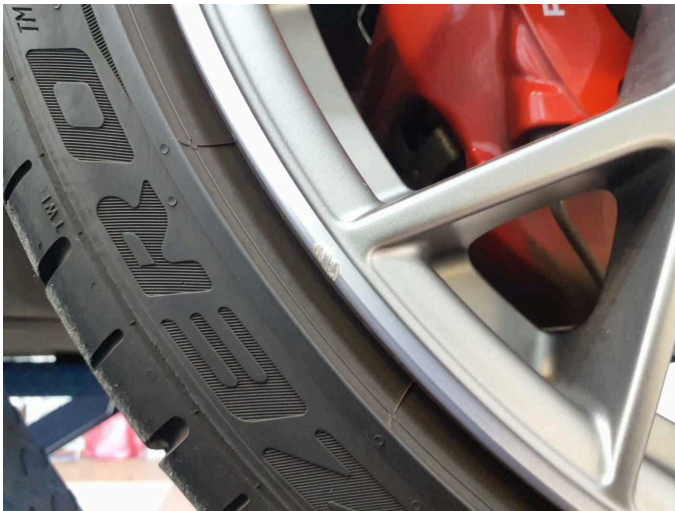
**Damage 2:** Wheel / tyres: Alloy rim - front right side - Scratched - Loss in value

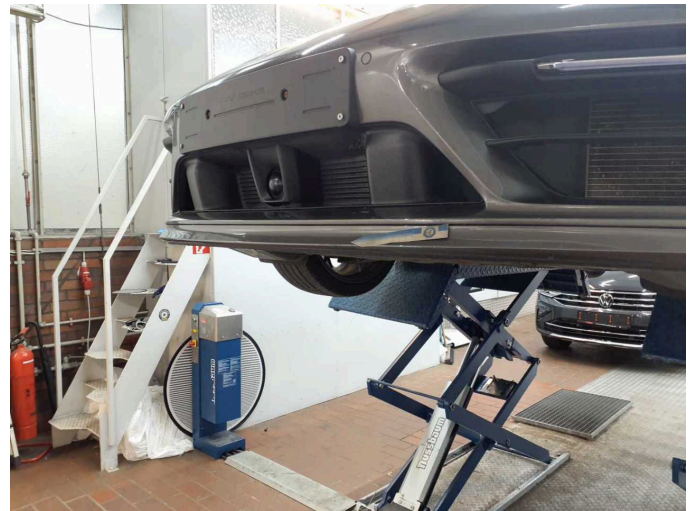
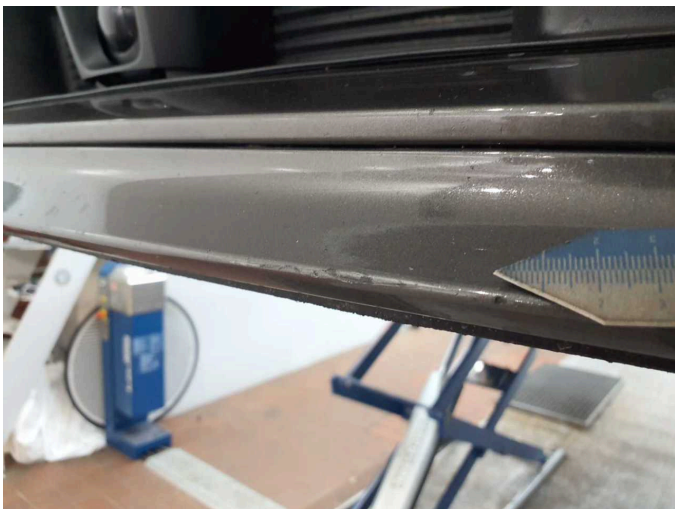
**Damage 3:** Front bumper: Spoiler - Scratched - Repair and paint

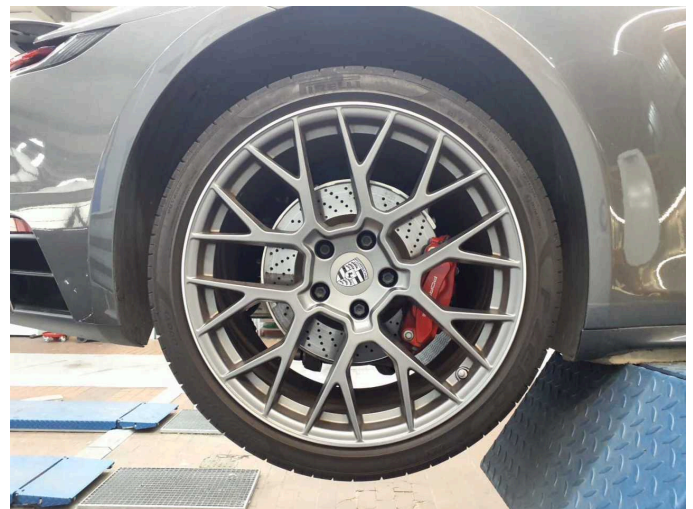
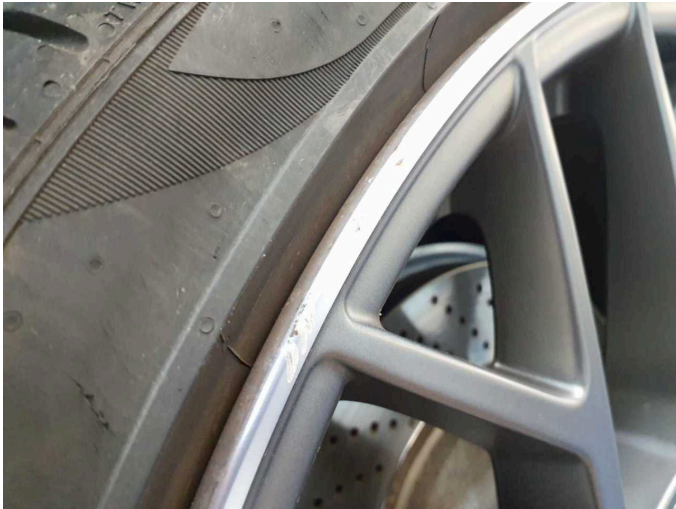
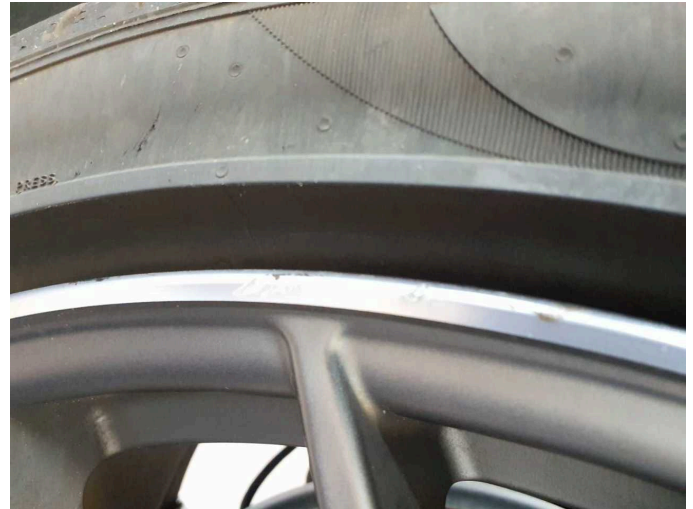
**Damage 4:** Wheel / tyres: Alloy rim - rear right side - Scratched - Loss in value

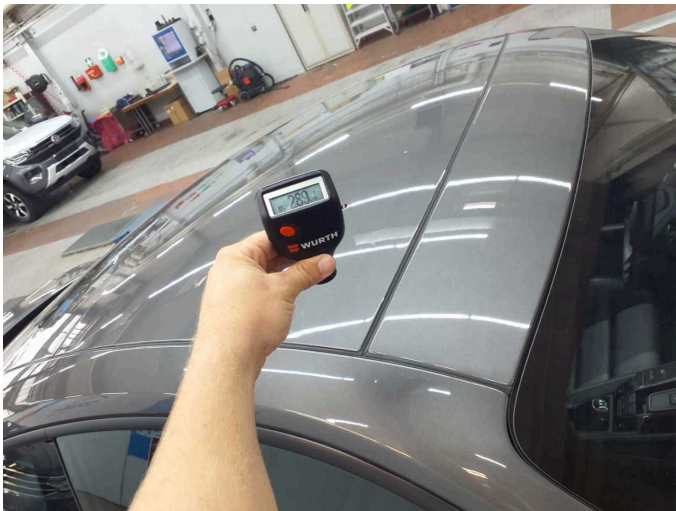
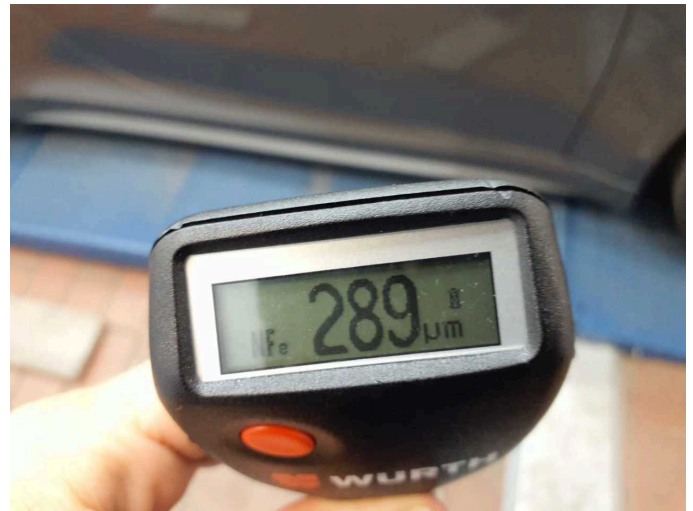
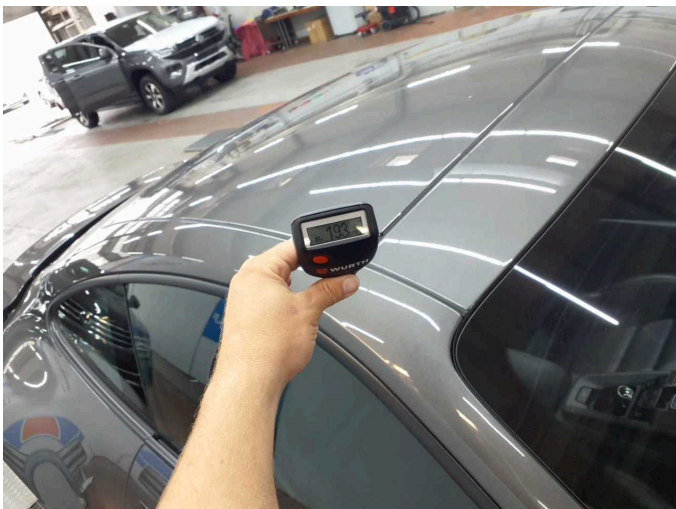
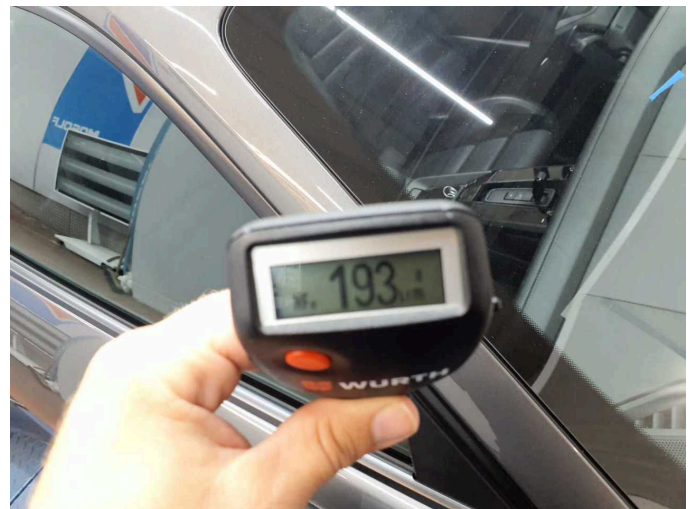
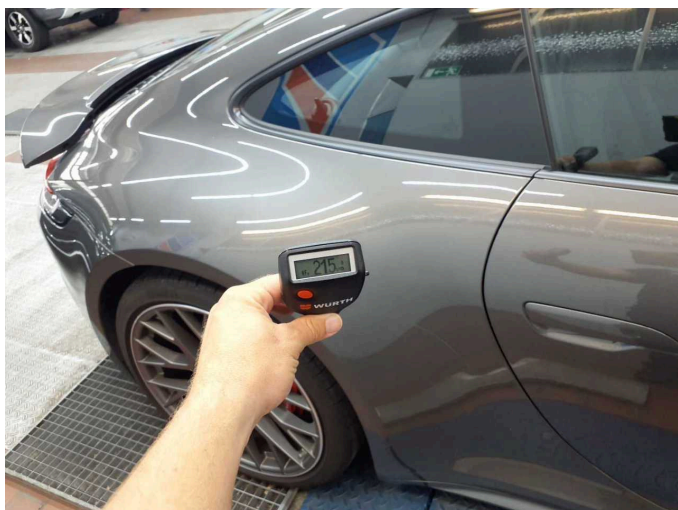
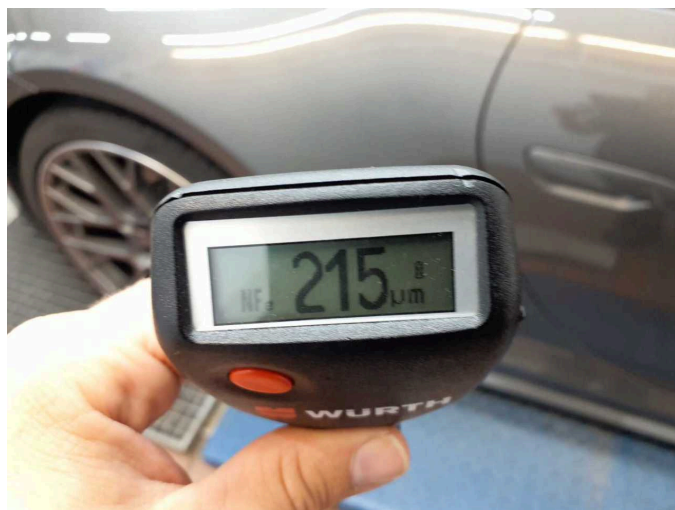
- 1 Roof, Roof rail - right side, Side panel - rear right side, Professionally carried out, Invoice of repair done Non-existent

Roof	289 µm	Roof rail - right side	193 µm
Side panel - rear right side	215 µm

**Repainting 1:** Roof, Roof rail - right side, Side panel - rear right side
