# Inspection Protocol

## VW CADDY MAXI 2.0 TDI BLUEMOTION 4MOTION

| License plate | JPP88A | Inspected by | M.H. |

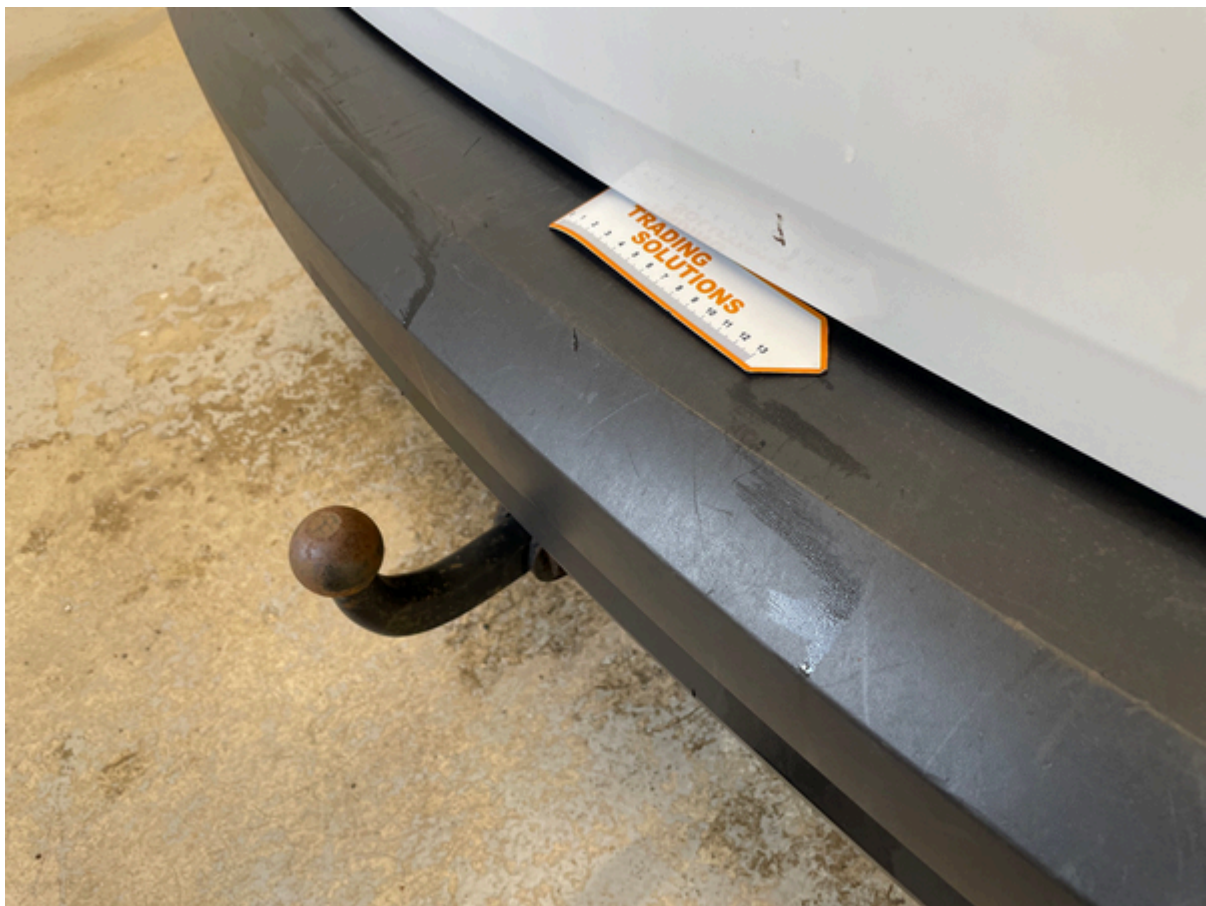
| Location | Damage | Comments | Costs excluding VAT |
|---|---|---|---|
| Bumper, Rear | Cargo scratches | | 150 € |

Stötfångare Bak Lastrepör 2 000 kr

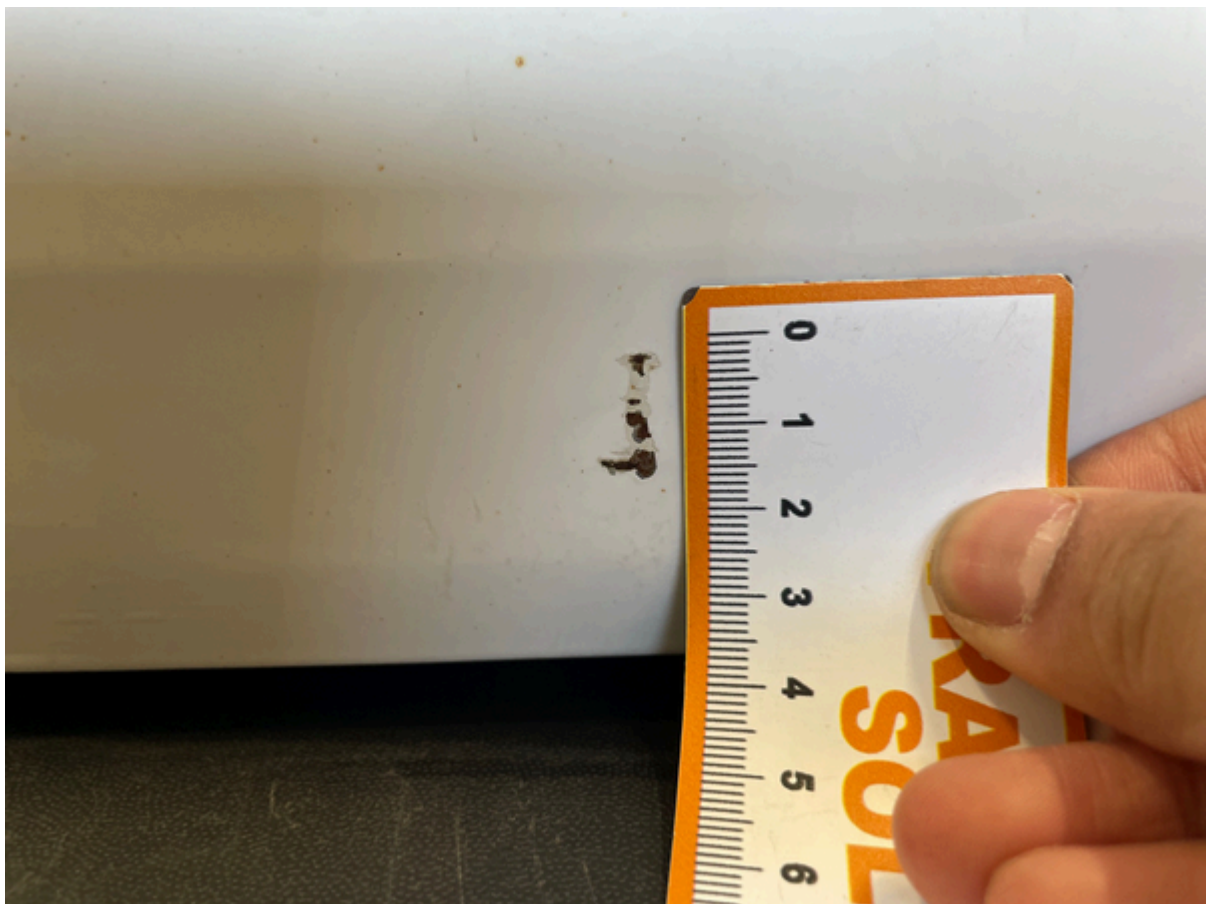
| Location | Damage | Comments | Costs excluding VAT |
|---|---|---|---|
| Boot lid, Boot lid | Scratches below 30 mm | | 60 € |

Bagagelucka Bagagelucka Repor under 3 cm 800 kr

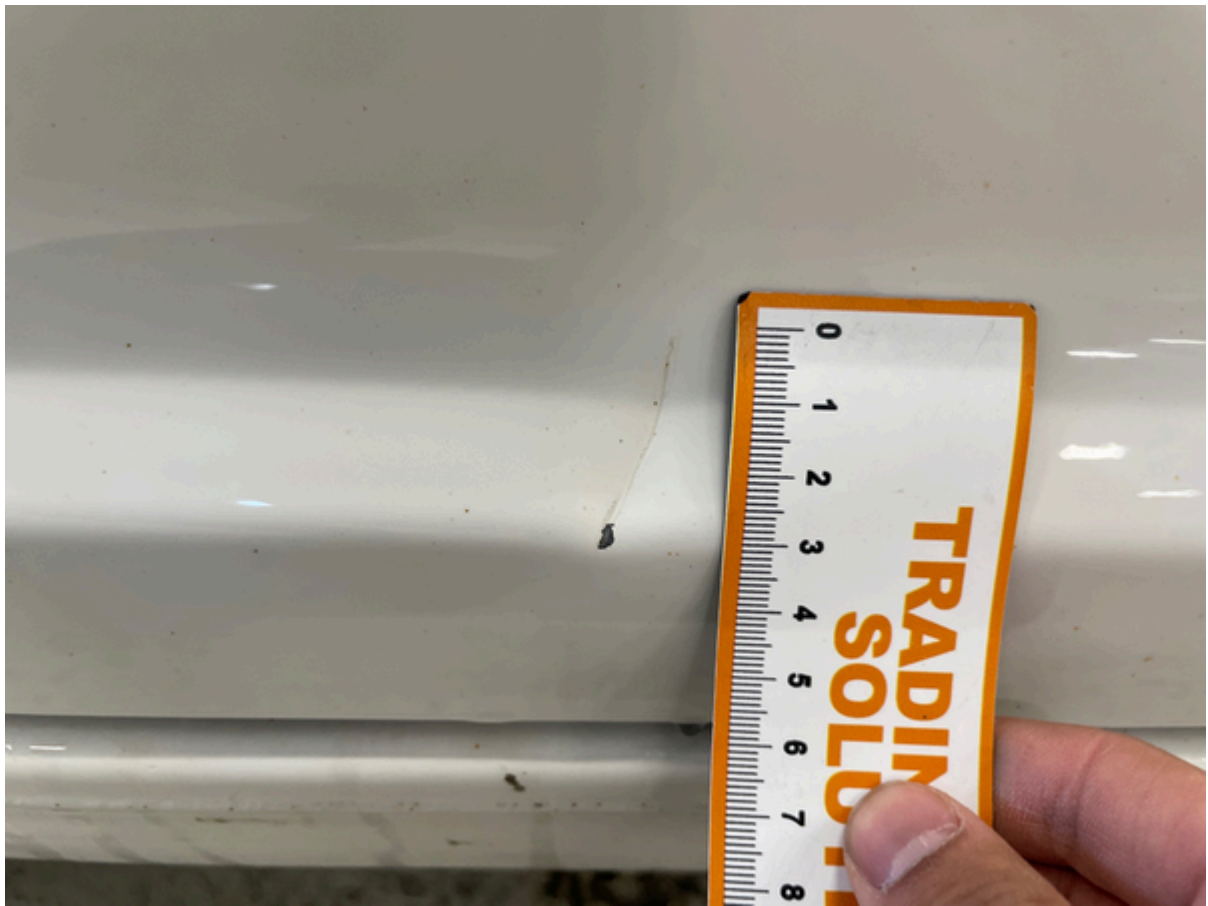
| Location | Damage | Comments | Costs excluding VAT |
|---|---|---|---|
| Door, Front right | Dents below 30 mm | | 60 € |

Dörr Höger fram Bucklor under 3 cm 800 kr

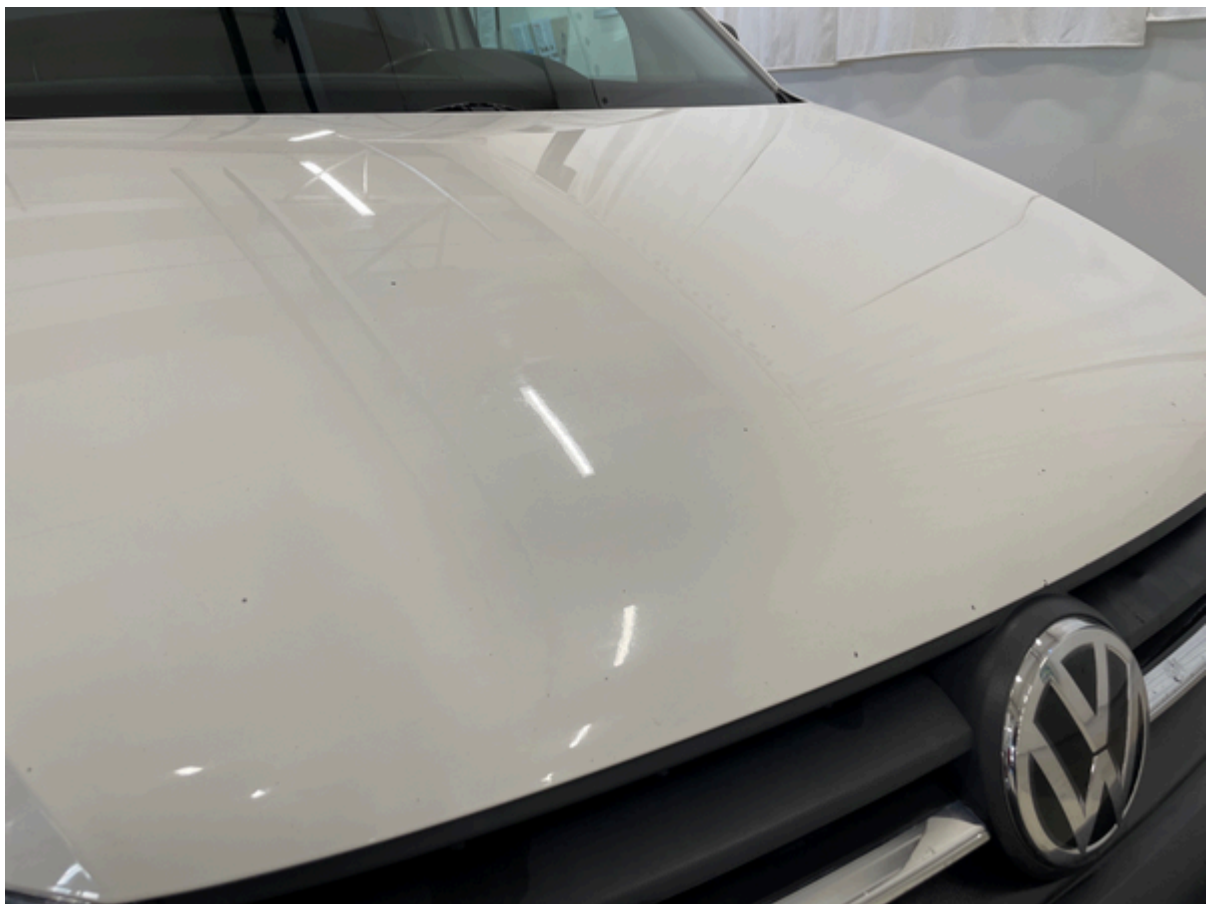
| Location | Damage | Comments | Costs excluding VAT |
|---|---|---|---|
| Bonnet | Chips, several | | 160 € |

Motorhuv Stenskott flertal 2 200 kr

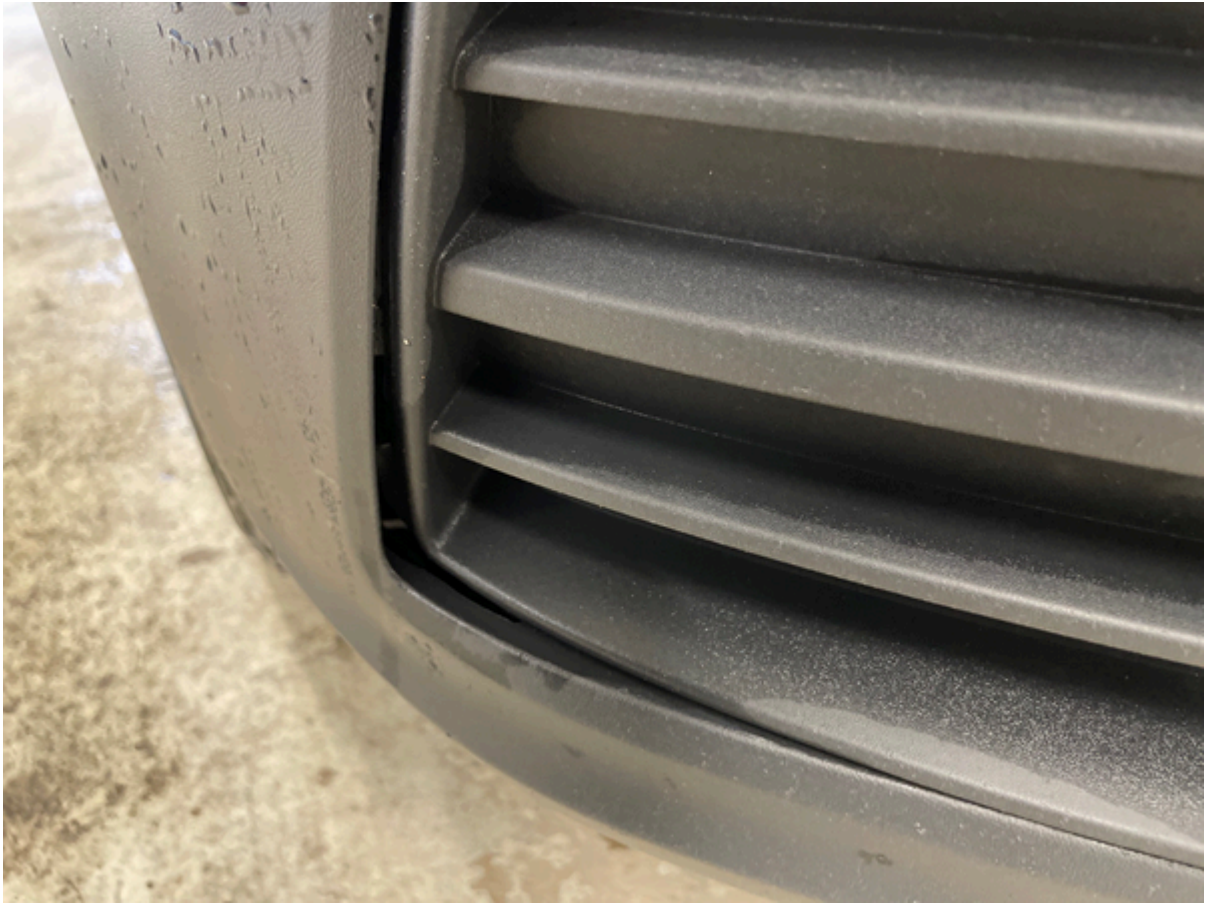
| Location | Damage | Comments | Costs excluding VAT |
|---|---|---|---|
| Bumper, Front | Other | Sitter ej | 20 € |

Stötfångare Fram Övrigt Sitter ej 300 kr

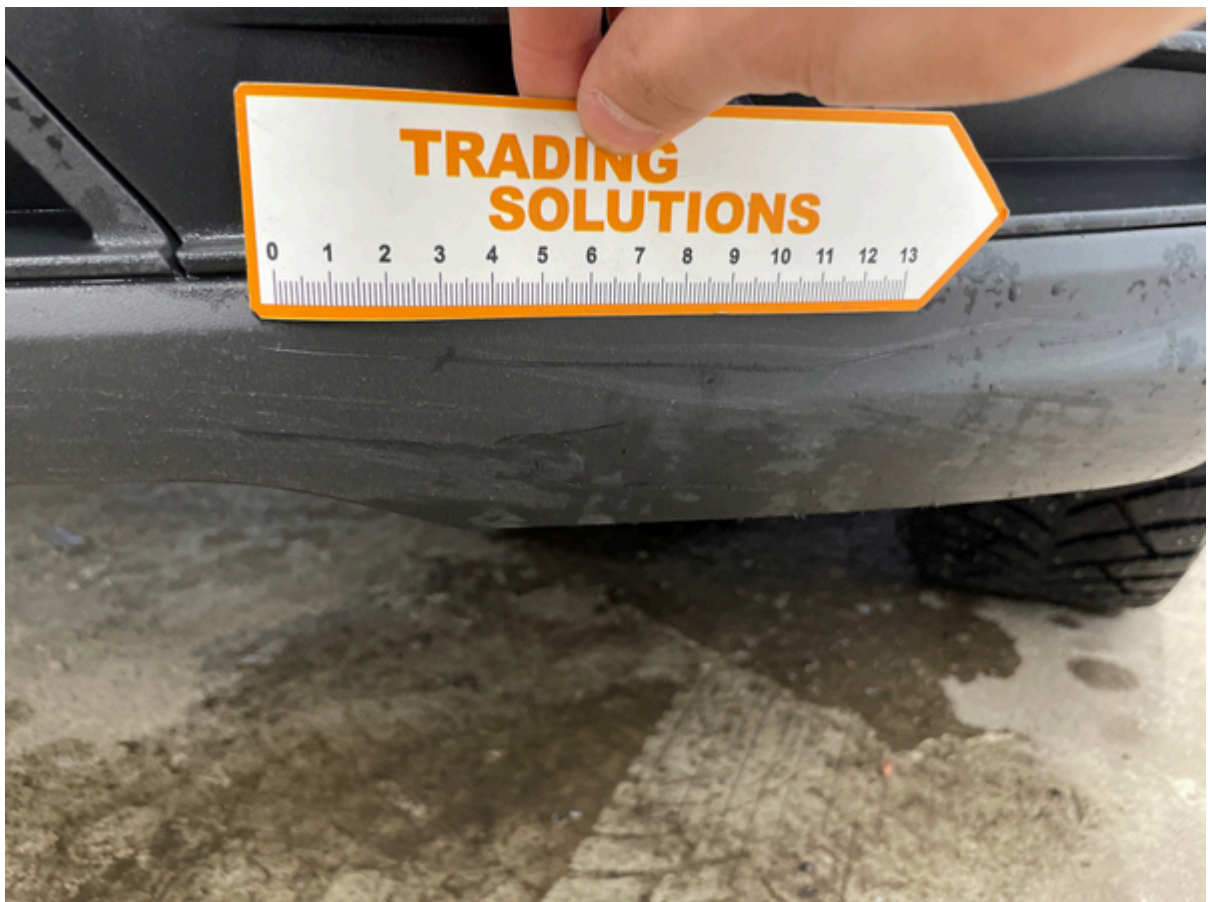
| Location | Damage | Comments | Costs excluding VAT |
|---|---|---|---|
| Bumper, Front | Wide scratch | | 240 € |

Stötfångare Fram Skrap 3 300 kr

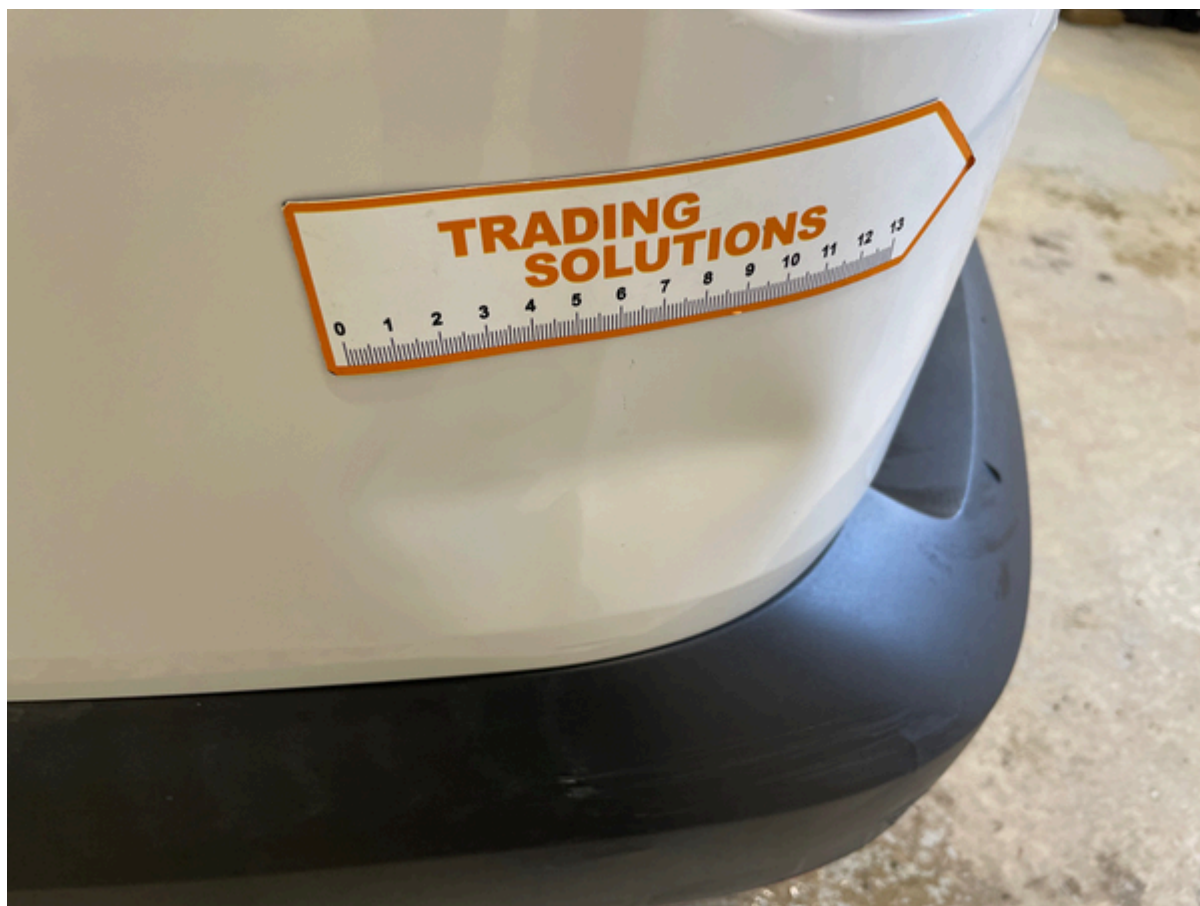
| Location | Damage | Comments | Costs excluding VAT |
|---|---|---|---|
| Wing, Rear left | Dents 30-100 mm | | 260 € |

Skärm Vänster bak Bucklor 3-10 cm 3 500 kr

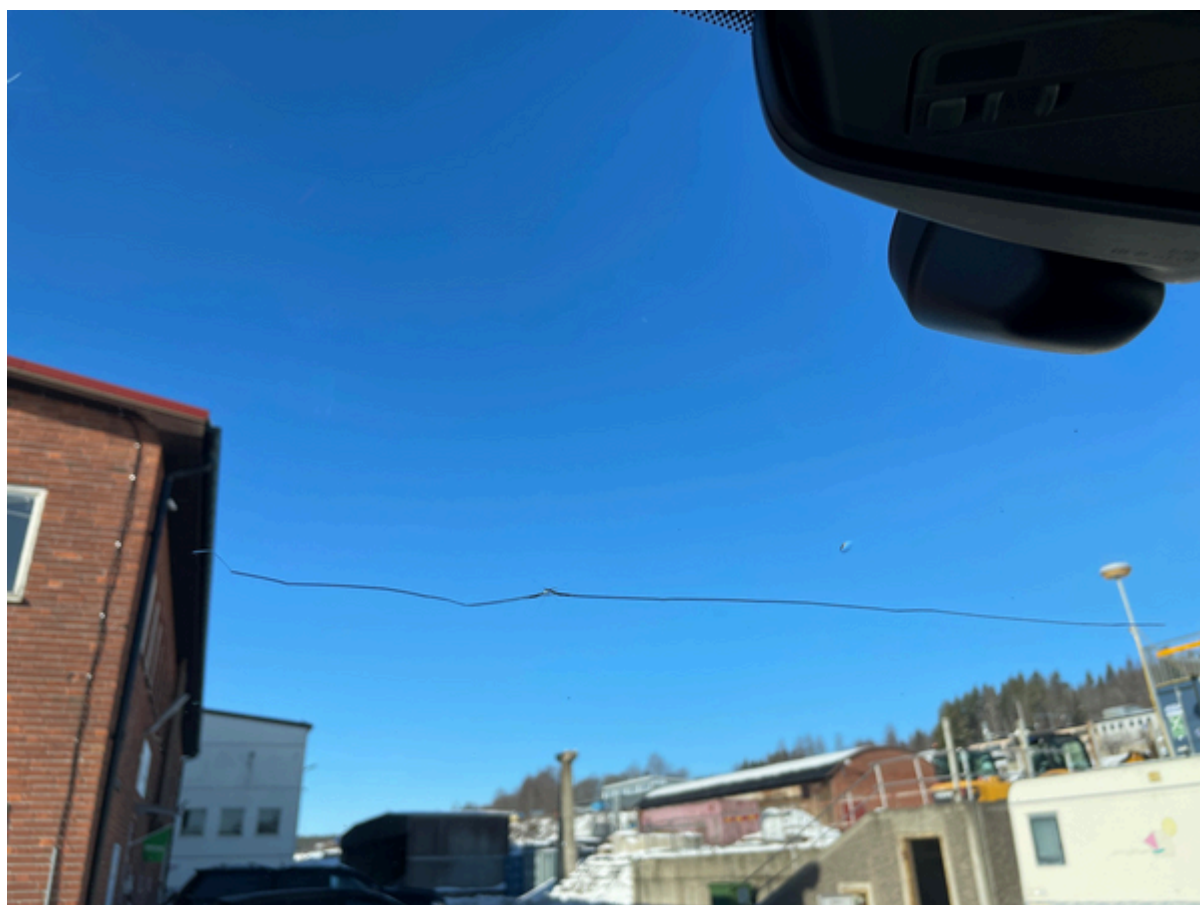
| Location | Damage | Comments | Costs excluding VAT |
|---|---|---|---|
| Glass, Windshield | Cracks long (Above 150 mm) | | 510 € |

Glas Vindruta Sprickor långa (Över 15 cm) 7 000 kr
