VW CADDY MAXI LIFE 2.0 TDI BLUEMOTION

Vehicle information

Damages

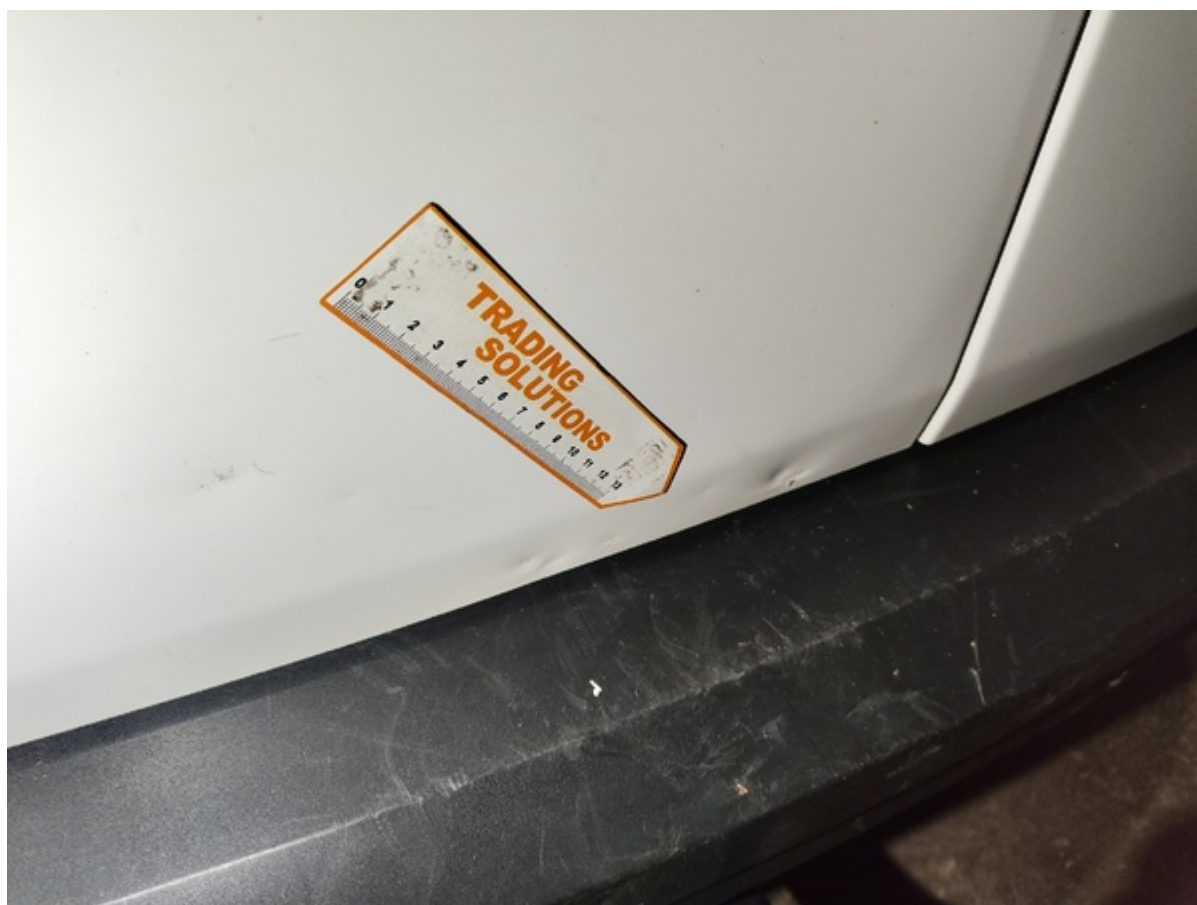
| Location | Damage | Comments | Costs excluding VAT |
|---|---|---|---|
| Wing, Rear left | Scratches 30-100 mm | | 100 € |

Skärm Vänster bak Repor 3-10 cm 1 100 kr

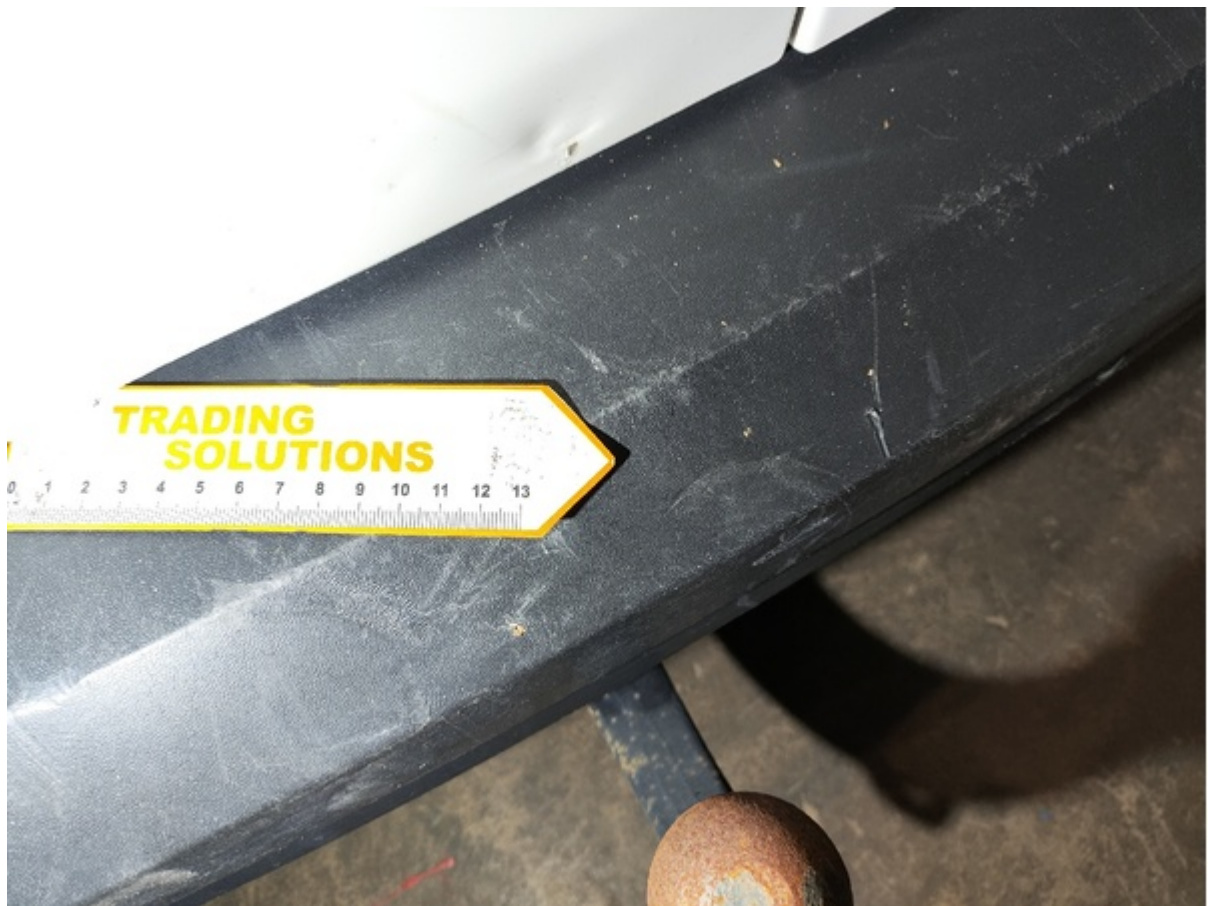
| Location | Damage | Comments | Costs excluding VAT |
|---|---|---|---|
| Door, Rear left | Dents below 30 mm | Vänster transport dörr | 70 € |

Dörr Vänster bak Bucklor under 3 cm Vänster transport dörr 800 kr
