Expertise

Protocol number: 41174287  
Order No. / Reference: 25118451  
Inspection date: 22 Aug 2025

Manufacturer: Volkswagen

Model: Touran 2.0 TDI SCR Comfortline

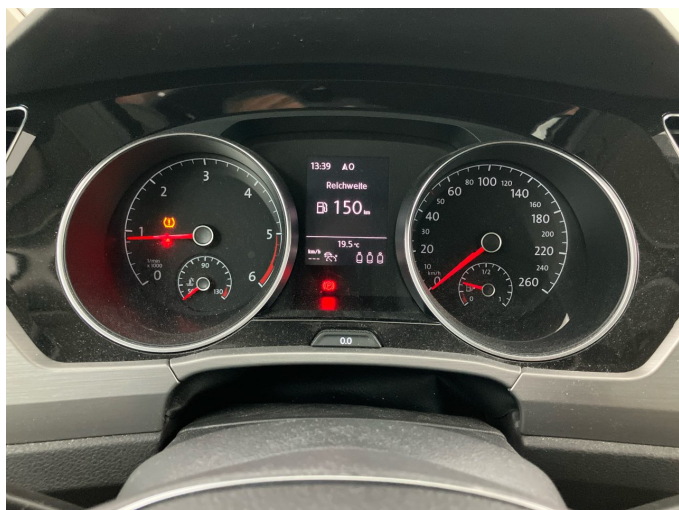
Figure 7: Instrument cluster

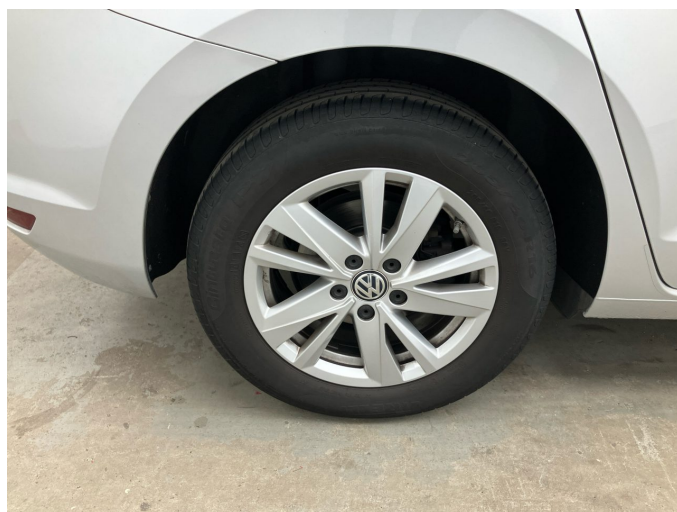
#	Tyre size	Type of tyre	Manufacturer	Tread depth
1)	205/60 R16 96V	Summer tyres on Light alloy	Pirelli	6mm / 6mm
2)	205/60 R16 96V	Summer tyres on Light alloy	Pirelli	6mm / 6mm

Figure 12: Mounted tyres

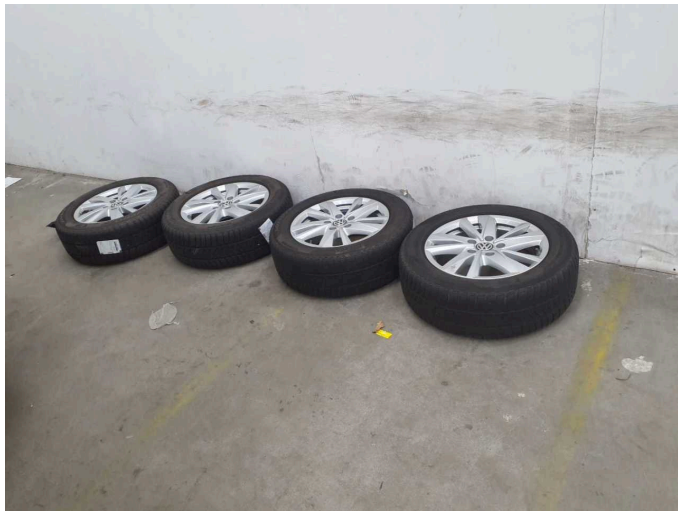
#	Tyre size	Type of tyre	Manufacturer	Tread depth
1)	205/60 R16 96H	Winter tires (with run-flat tires) on Light alloy	Pirelli	6mm / 6mm
2)	205/60 R16 96H	Winter tires (with run-flat tires) on Light alloy	Pirelli	6mm / 6mm

Figure 15: Additional tyres

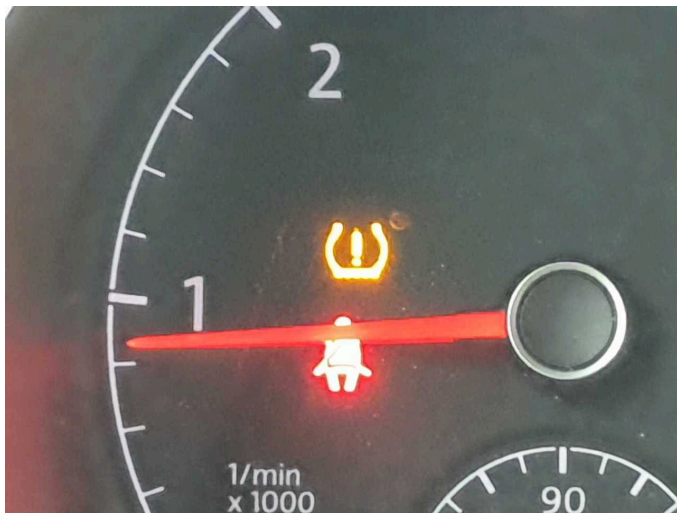
**Damage 1:** Instrument panel: Indicator light (RDK) - on - Perform diagnosis

No.	Component group	Description
1	Instrument panel	Indicator light (RDK) - on - Perform diagnosis
2	Door - front left side	Door - Scratch(es) - Paint

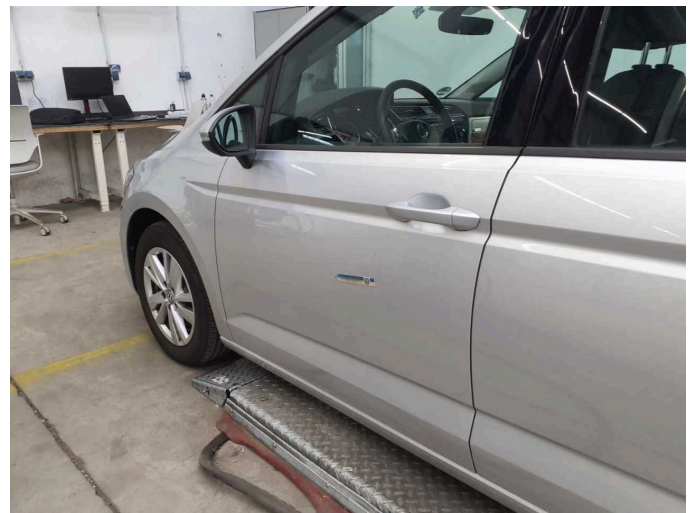
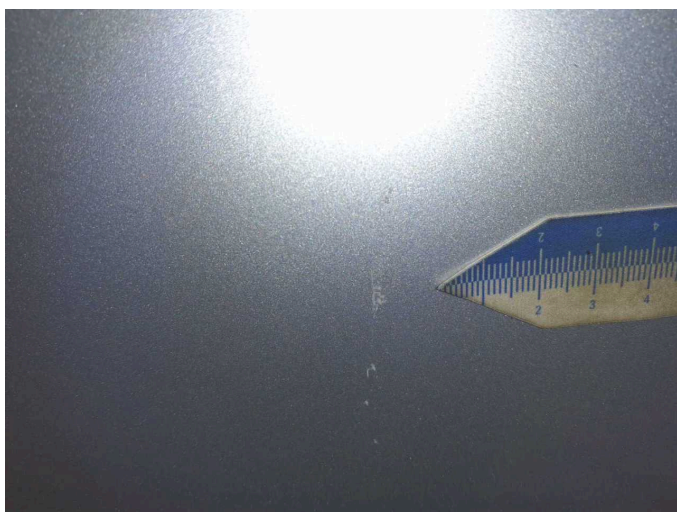
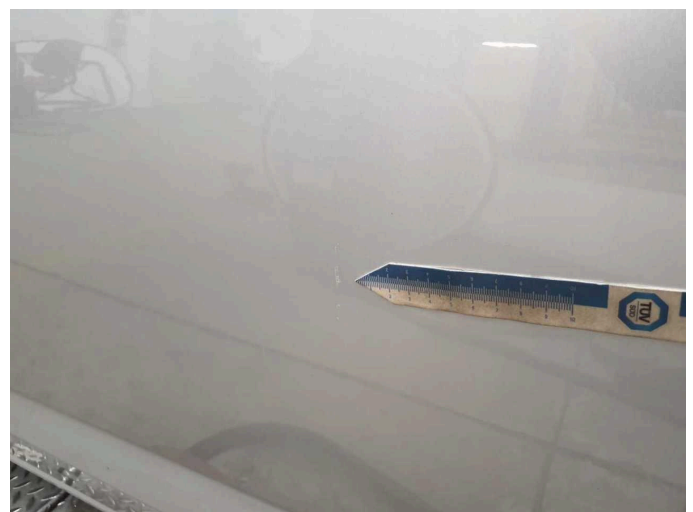
**Damage 2:** Door - front left side: Door - Scratch(es) - Paint
