Expertise

Protocol number: 40851415  
Order No. / Reference: 24981778  
Inspection date: 31 Jul 2025

Manufacturer: Volkswagen

Model: Touran 1.5 TSI ACT OPF DSG Comfortline

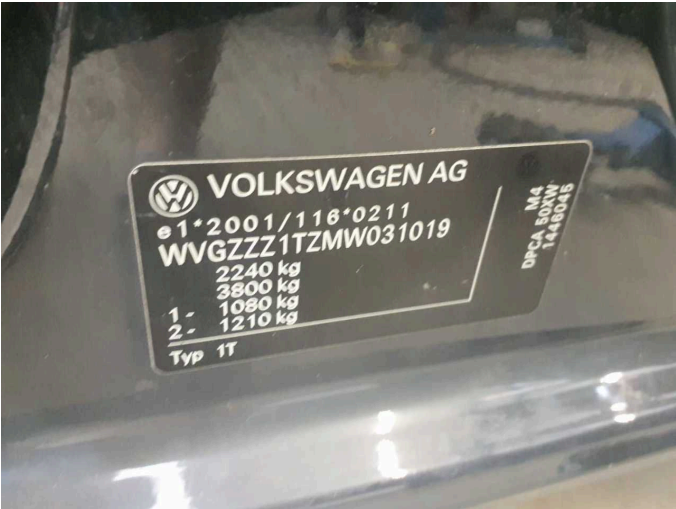
Documents submitted	At the time of the inspection, the registration certificate Part 2 (letter) was available, but the registration certificate Part 1 (certificate) was not. (Copy)
VIN comparison	The vehicle identification number (VIN) was read and the undersigned verified that it matched the documents submitted during the inspection.
Inspection	The inspection conditions were sufficient for the assessment of the vehicle. Lifting equipment and a pit were available for examining the vehicle.
Test drive	No test drive/maneuvering was carried out during the inspection of the vehicle.
Engine function test	An engine test run was performed.

Figure 11: VIN

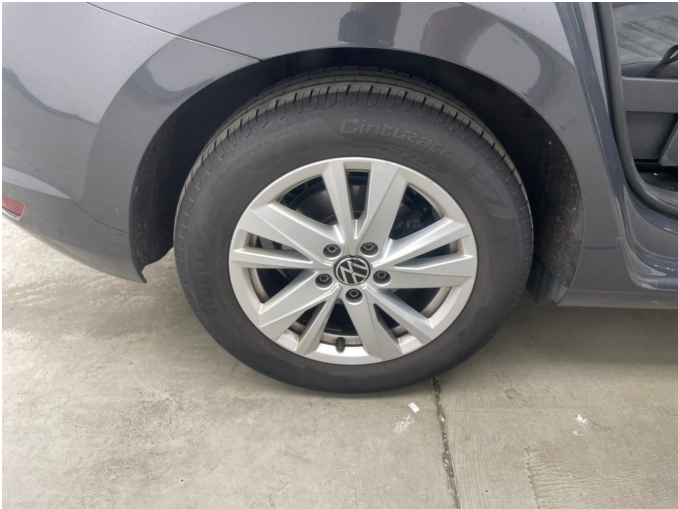
#	Tyre size	Type of tyre	Manufacturer	Tread depth
1)	205/60 R16 96V	Summer tyres on Light alloy	Pirelli	6mm / 6mm
2)	205/60 R16 96V	Summer tyres on Light alloy	Pirelli	6mm / 6mm

Figure 12: Mounted tyres

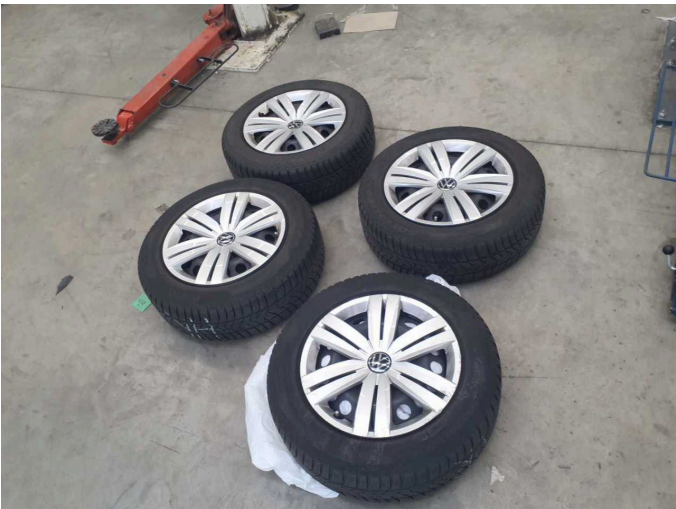
#	Tyre size	Type of tyre	Manufacturer	Tread depth
1)	205/60 R16 96H	Winter tires (with run-flat tires) on Steel rim with wheel cover	Pirelli	6mm / 6mm
2)	205/60 R16 96H	Winter tires (with run-flat tires) on Steel rim with wheel cover	Pirelli	6mm / 6mm

Figure 17: Additional tyres

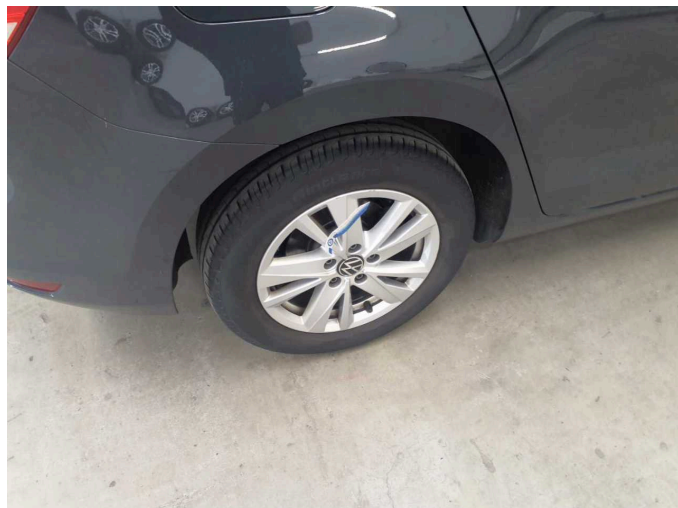
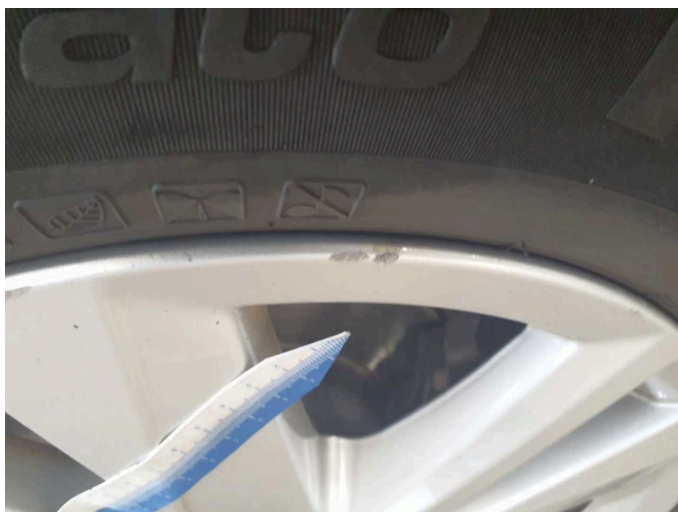
**Damage 2:** Wheel / tyres: Alloy rim - rear right side - Scratched - Loss in value

No.	Component group	Description
1	Electrical system	Battery (entladen, Motorstart erschwert) - Specify findings - Perform diagnosis
2	Wheel / tyres	Alloy rim - rear right side - Scratched - Loss in value
3	Bonnet	Bonnet - dent(s) - Repair and paint
4	Rear bumper	Rear bumper - Scratched - Repair and paint
5	Front bumper	Front bumper - Deformed - Repair and paint

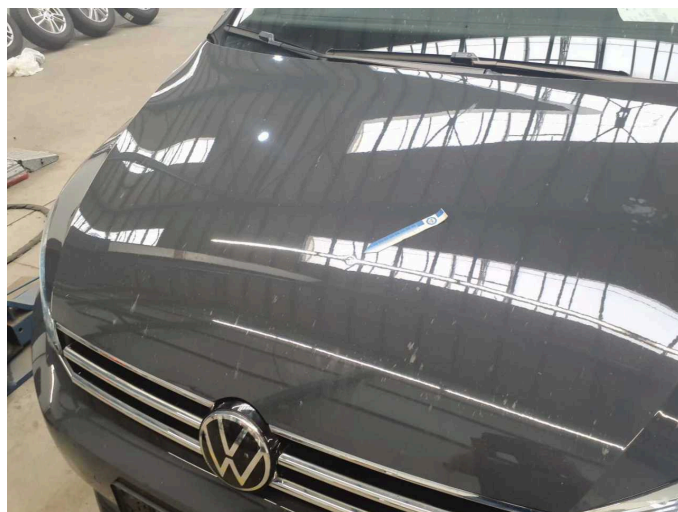
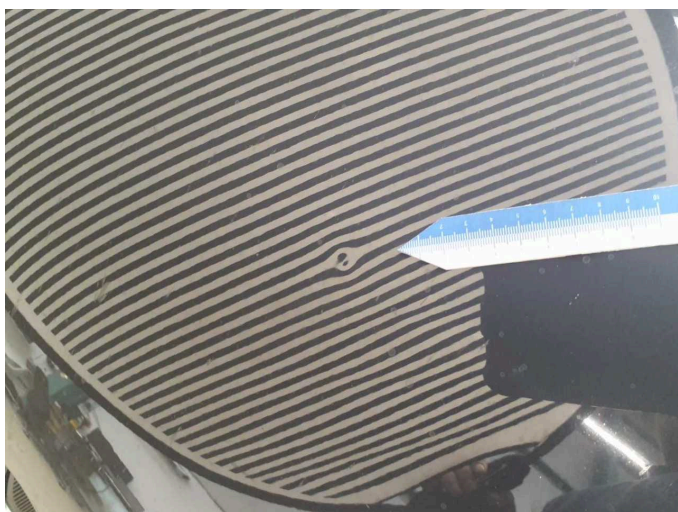
**Damage 3:** Bonnet: Bonnet - dent(s) - Repair and paint

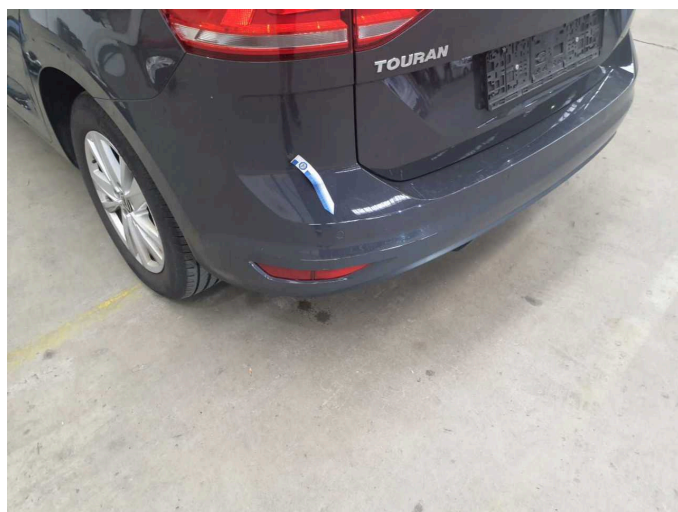
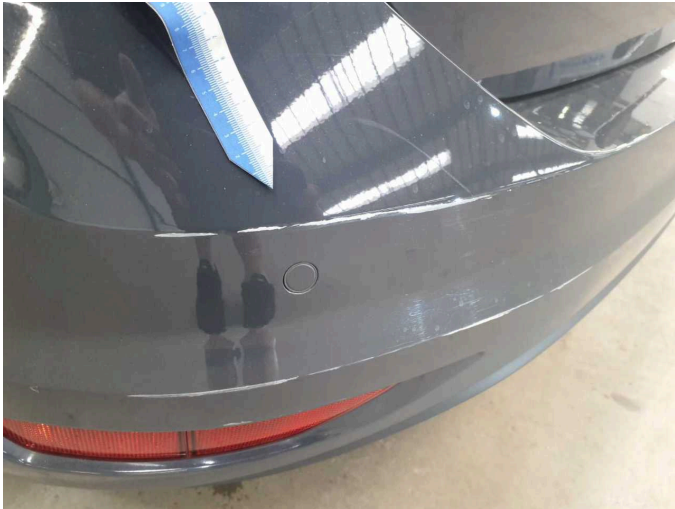
**Damage 4:** Rear bumper: Rear bumper - Scratched - Repair and paint

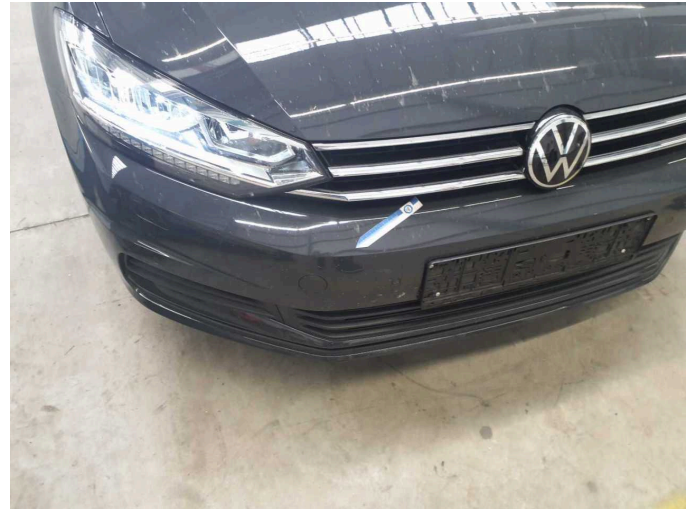
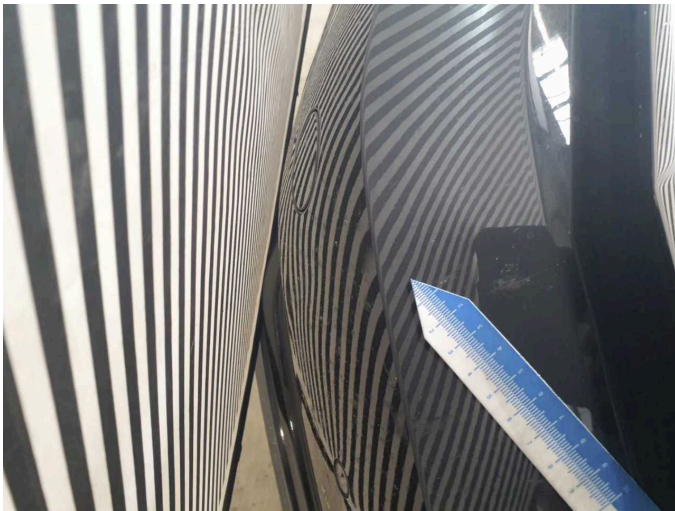
**Damage 5:** Front bumper: Front bumper - Deformed - Repair and paint
