Expertise

Manufacturer: Volkswagen

Model: Touran 2.0 TDI SCR DSG Highline

VIN: WVGZZZ1TZNW012580

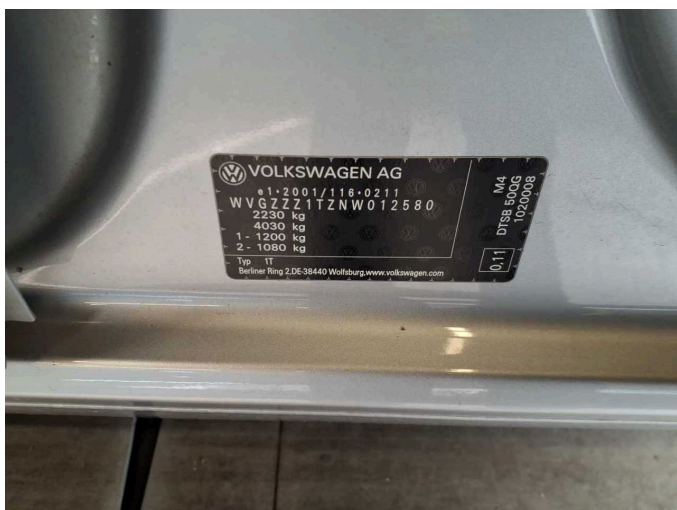
Figure 11: VIN

Documents submitted	At the time of the inspection, the registration certificate Part 2 (letter) was available, but the registration certificate Part 1 (certificate) was not. (Copy)
VIN comparison	The vehicle identification number (VIN) was read from the vehicle and its conformity with the submitted documents was verified during the inspection by the undersigned.
Inspection	The inspection conditions were sufficient for the assessment of the vehicle. Lifting equipment and a pit were available for examining the vehicle.
Test drive	No test drive/maneuvering was carried out during the inspection of the vehicle.
Engine function test	An engine test run was performed.

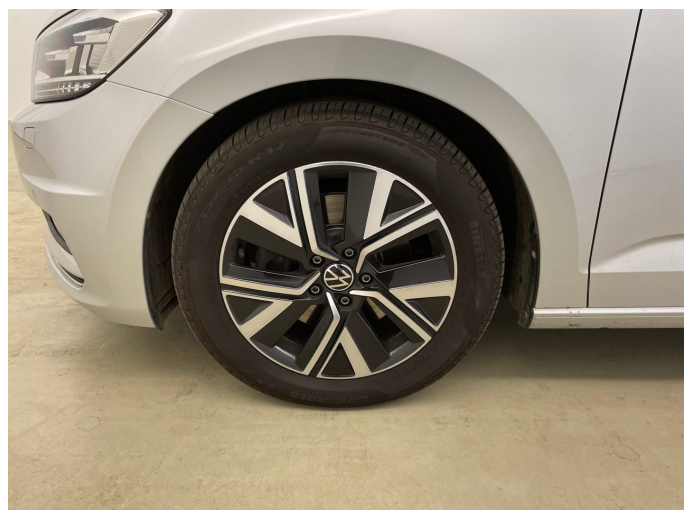
Figure 12: Mounted tyres

#	Tyre size	Type of tyre	Manufacturer	Tread depth
1)	215/55 R17 94W	Summer tyres on Light alloy	Pirelli	6mm / 6mm
2)	215/55 R17 94W	Summer tyres on Light alloy	Pirelli	6mm / 6mm

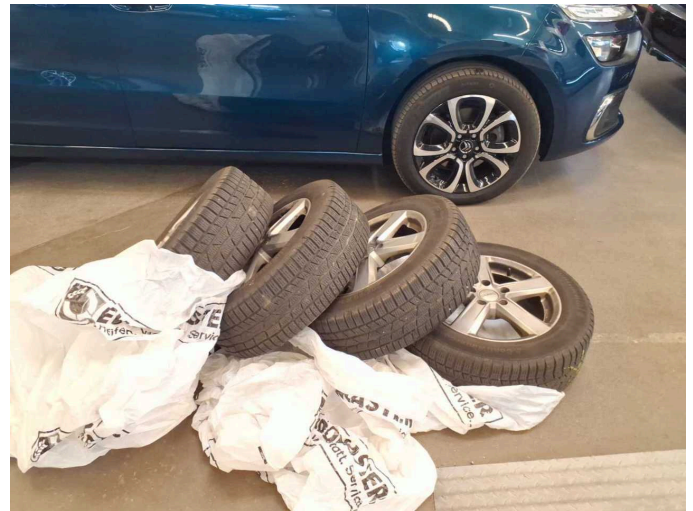
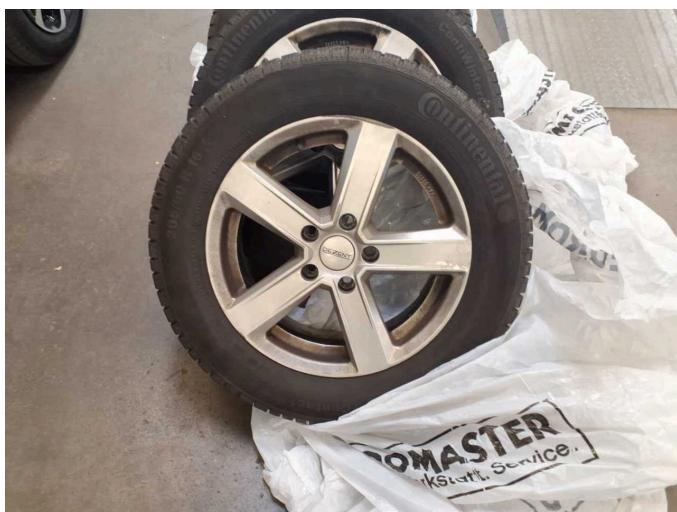
Figure 16: Additional tyres

#	Tyre size	Type of tyre	Manufacturer	Tread depth
1)	205/60 R16 96H	Winter tyres on Light alloy	Continental	5mm / 5mm
2)	205/60 R16 96H	Winter tyres on Light alloy	Continental	5mm / 5mm

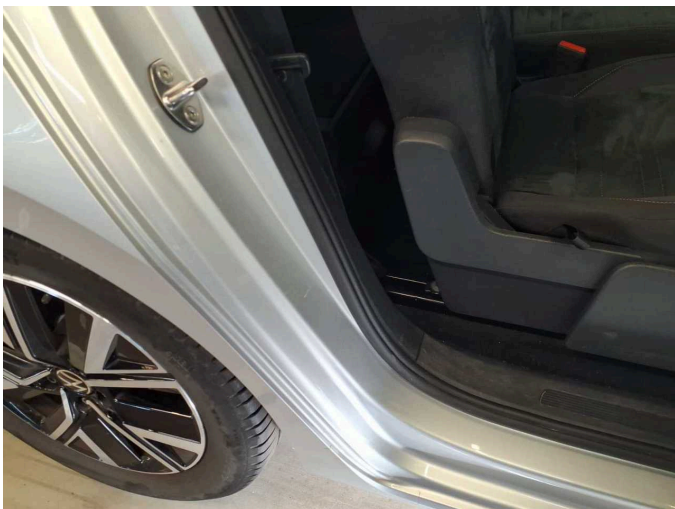
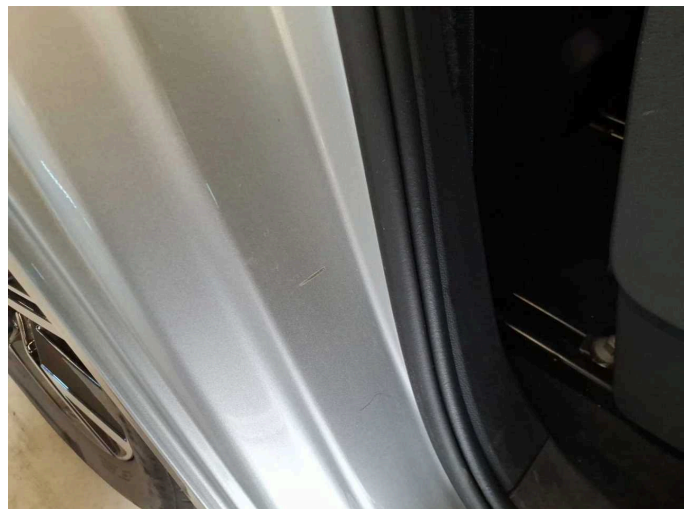
Damage 1: Side panel - rear right side: Sill - Scratch(es) - Smart repair

No.	Component group	Description
1	Side panel - rear right side	Sill - Scratch(es) - Smart repair
2	Side panel - rear left side	Side panel - Dent / paintcoat damage - Smart repair
3	Door - rear left side	Door - Scratch(es) - Paint
4	Bonnet	Bonnet - Stone chips - Paint

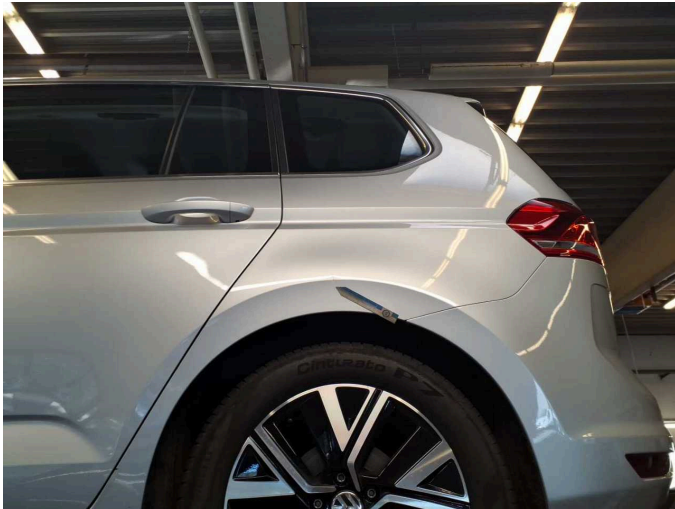
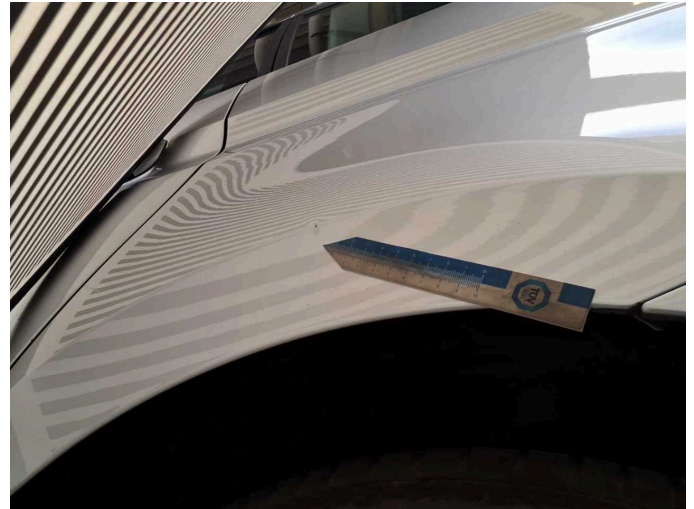
Damage 2: Side panel - rear left side: Side panel - Dent / paintcoat damage - Smart repair

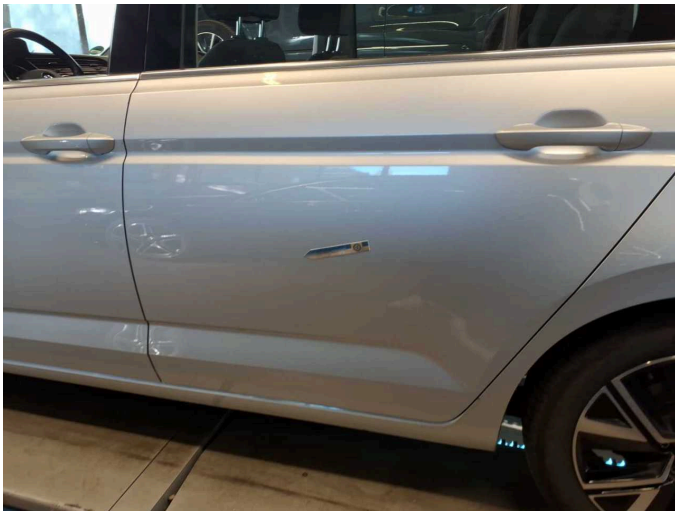
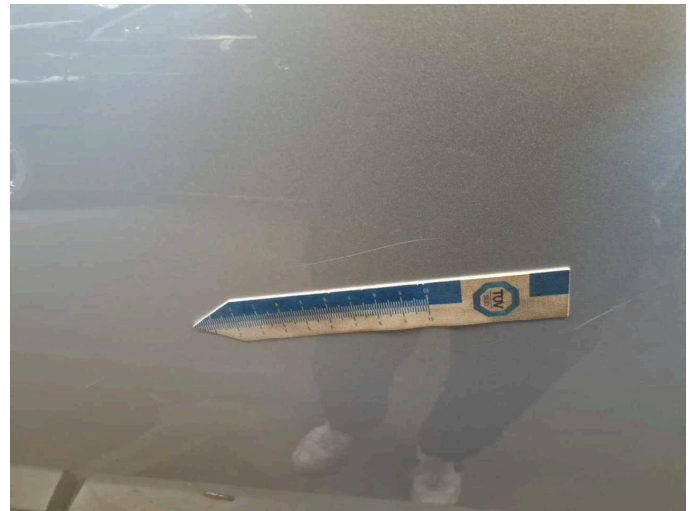
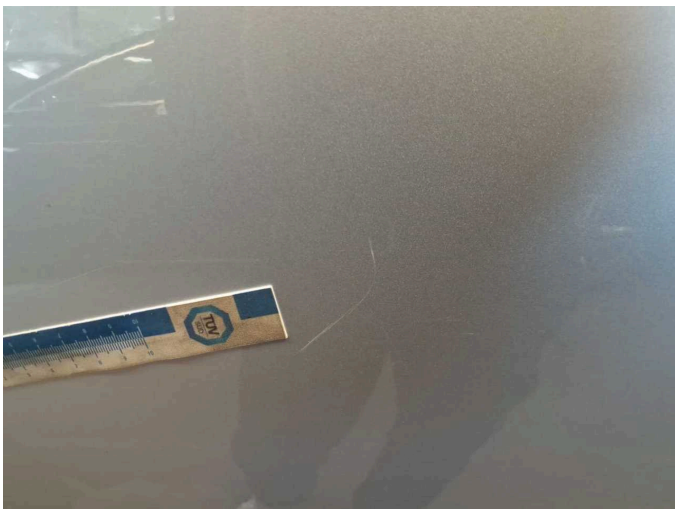
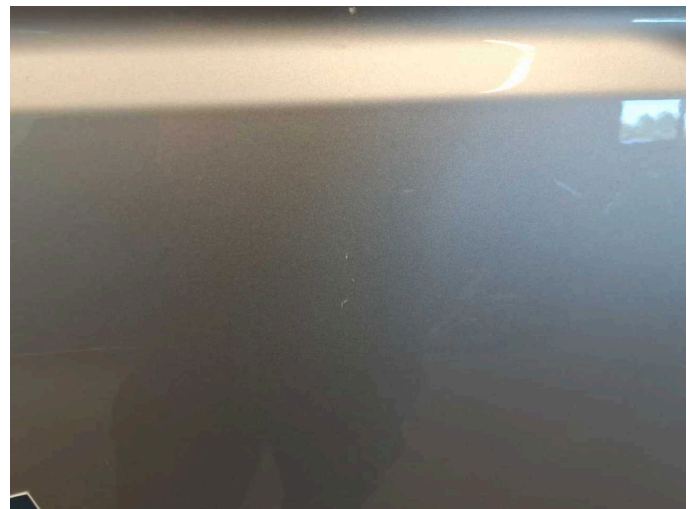
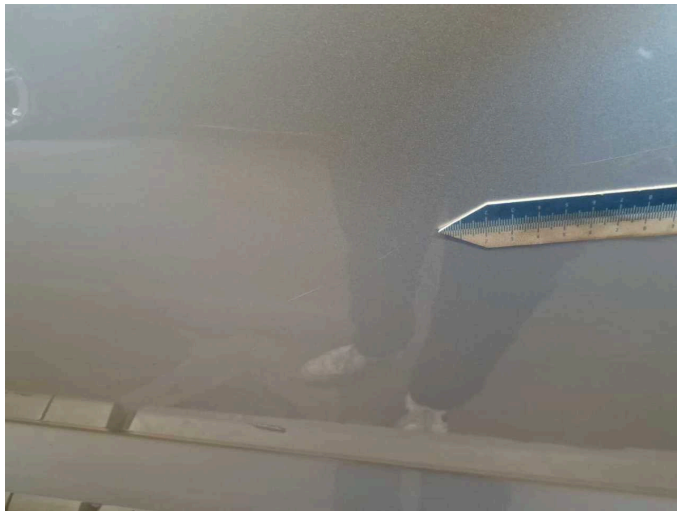
Damage 3: Door - rear left side: Door - Scratch(es) - Paint

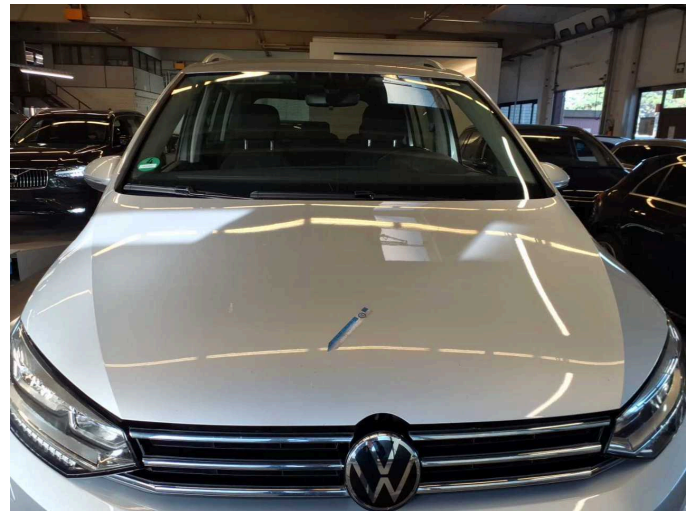
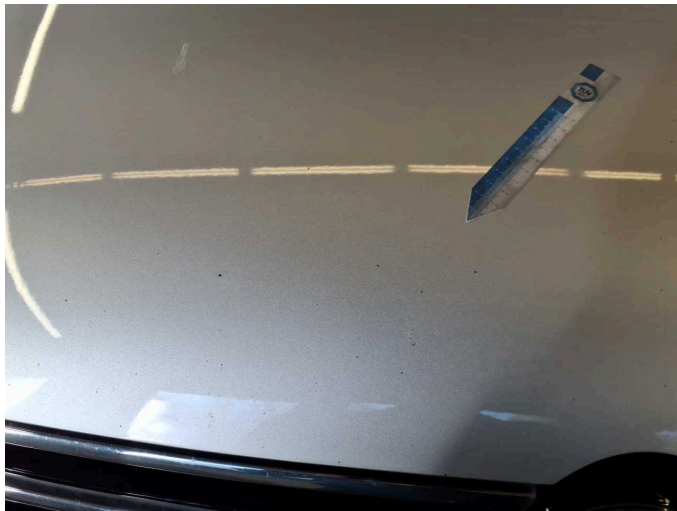
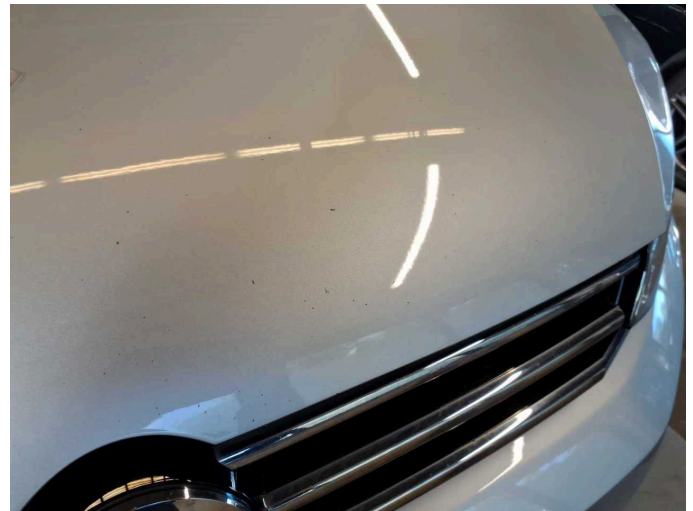
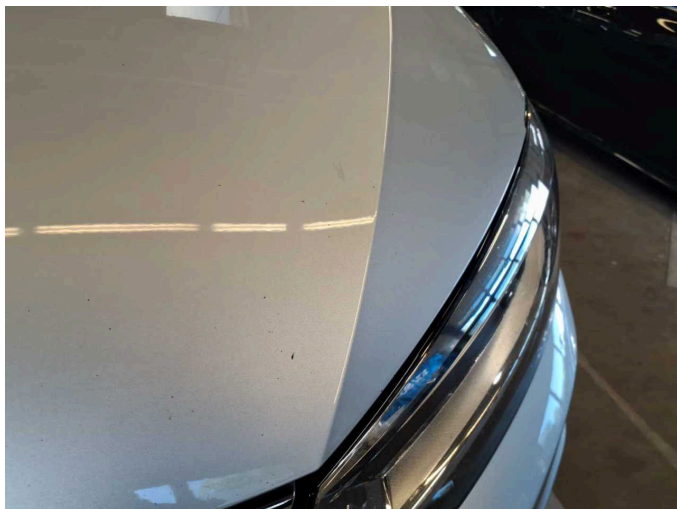
Damage 4: Bonnet: Bonnet - Stone chips - Paint

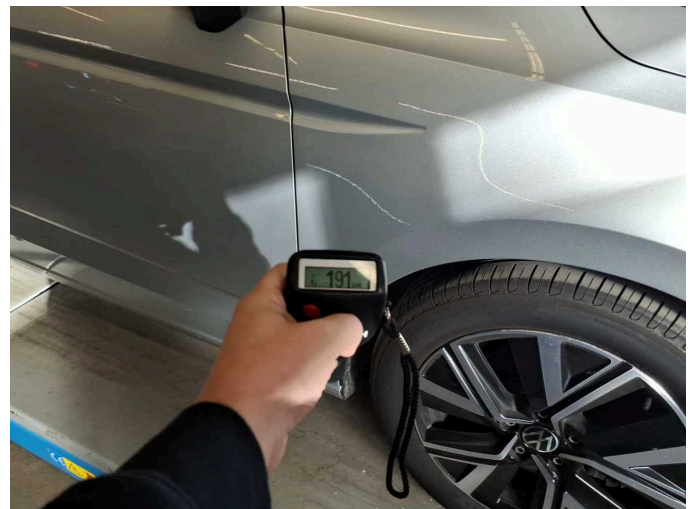
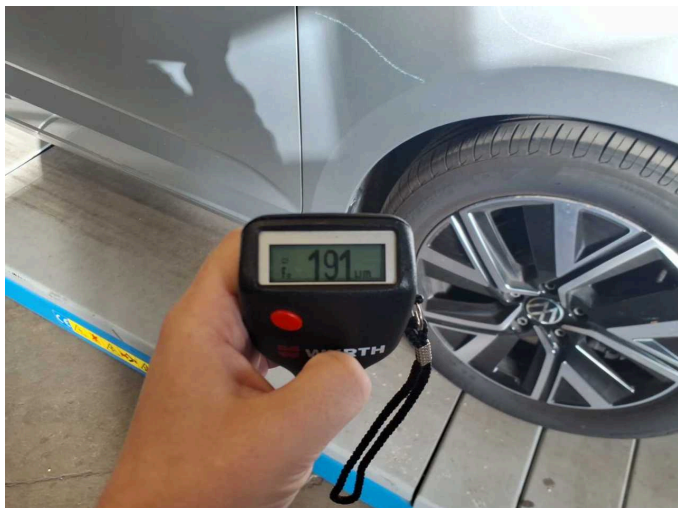
No.	Repainting
1	Mudguard - right side, Professionally carried out, Invoice of repair done Non-existent

191 μm

Repainting 1: Mudguard - right side
